***Birch Island Lake
Water Level Investigation***

***Prepared for
Nine Mile Creek Watershed District***

July 2005

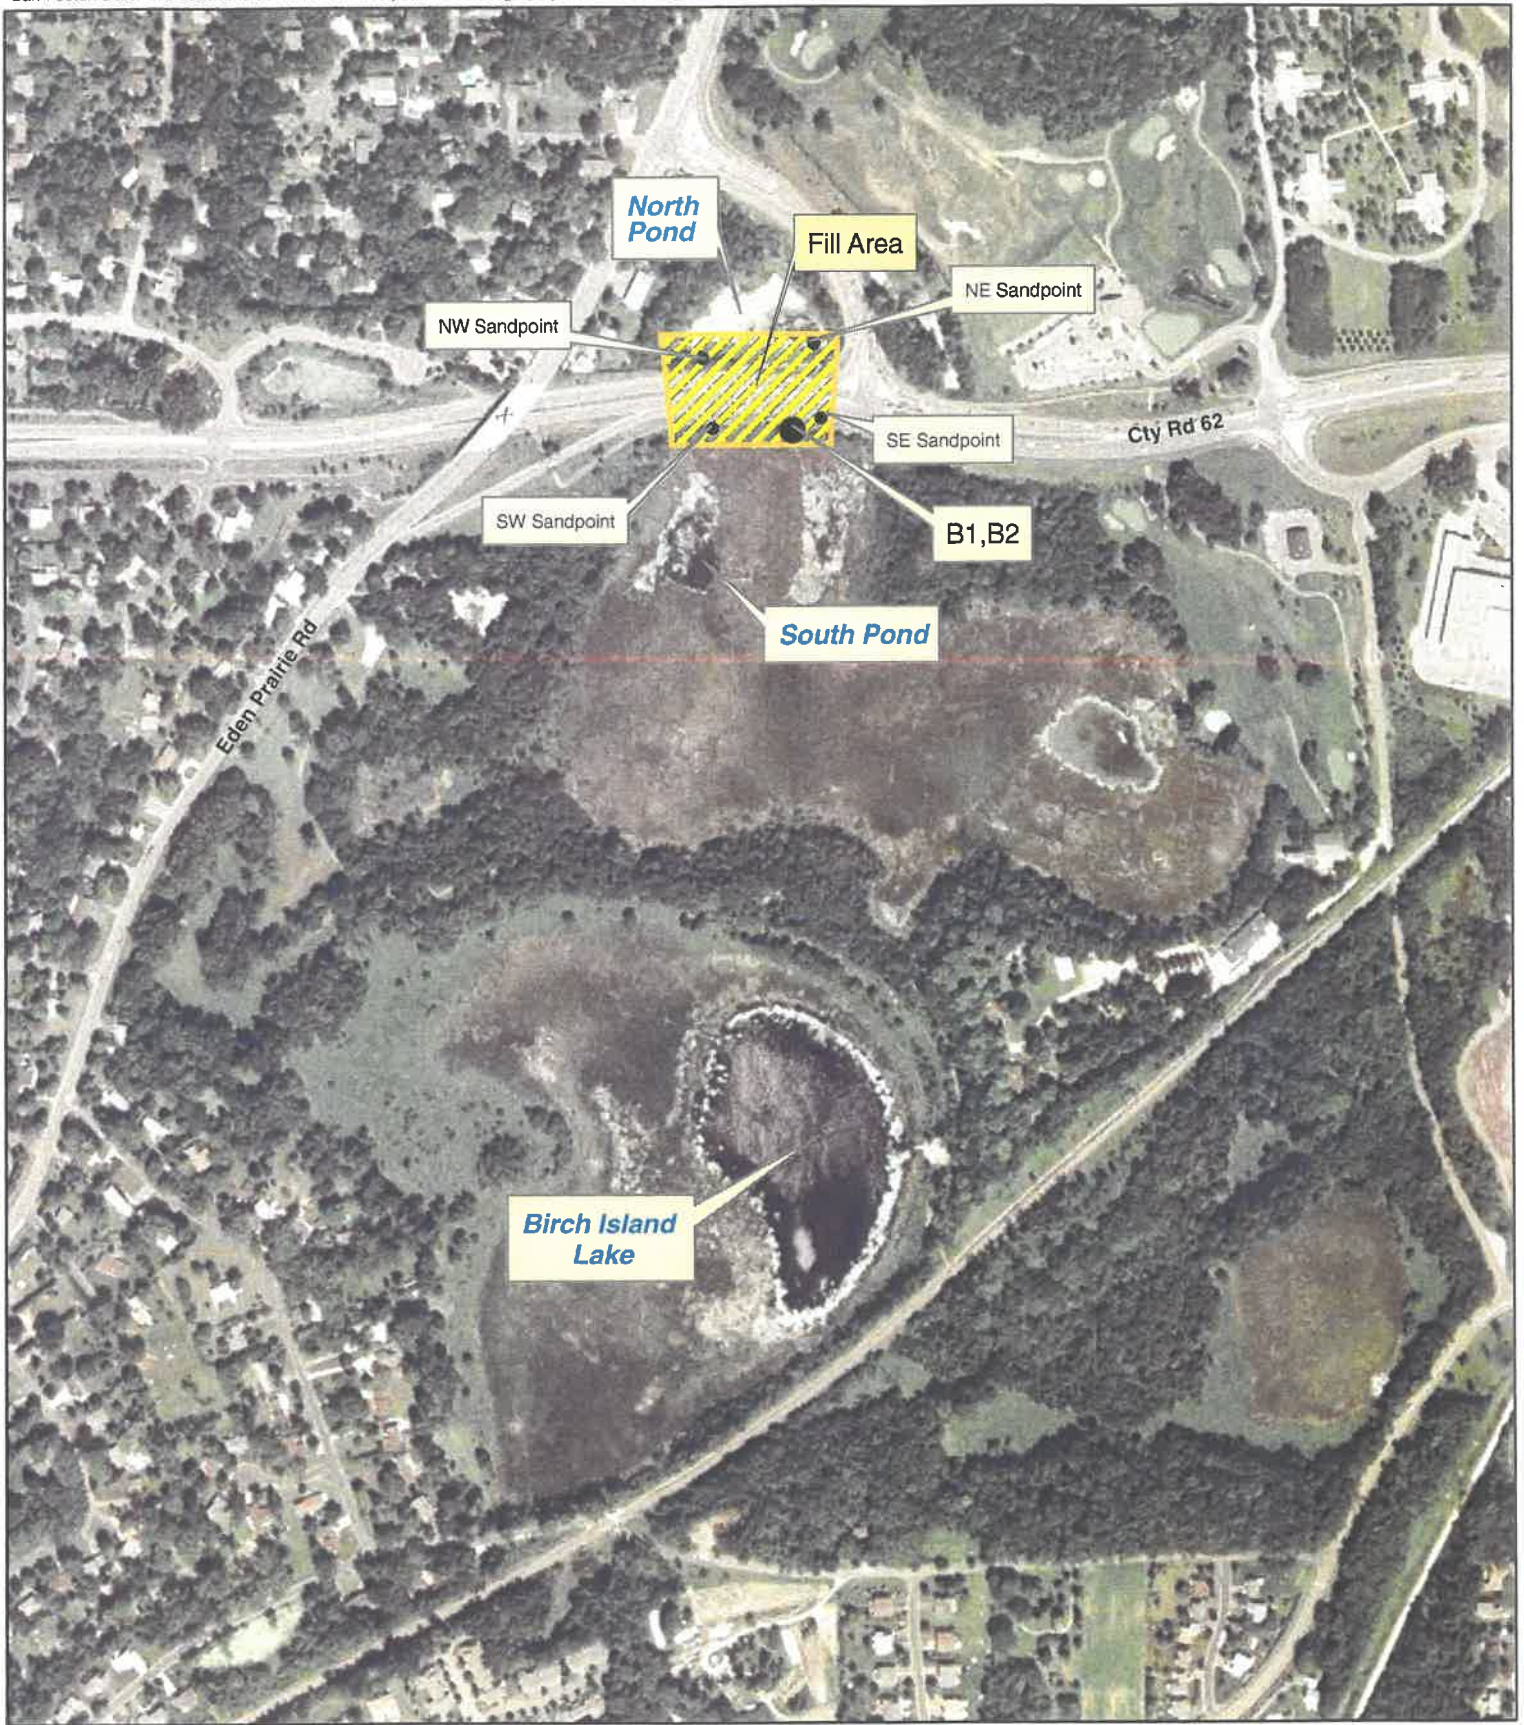
Figure 2

In order to determine groundwater characteristics along the T.H. 62 roadway embankment, four sand point wells were installed along the shoulder of the roadway. The location of these wells is shown on Figure 2. These wells have been monitored on a monthly basis from 1994 to the present. In addition to these wells, the ponding basins both upstream and downstream were also surveyed. The location of the ponding basins are also shown on Figure 2.

On two occasions, September 1996 and January 1999, the water levels in the roadway embankment, as represented by the sand points, were lower than the elevation of the South Pond. This indicates a

groundwater flow through the roadway embankment flowing easterly to a sand lens, rather than toward South Pond prior to the roadway construction.

The data collected indicates that the North Pond and the piezometers generally correspond with each other. The levels of Birch Island Lake and the South Pond, however, do not seem to correspond with the piezometers. This indicates that the hydraulic connection between the piezometers and the South Pond is not strong, supporting the assumption that groundwater flow has been diverted likely easterly to an existing underlying sand lens.

The first option is to bypass the roadway embankment with both surface and groundwater flow. This would require a pipe, (cross culvert), 12-inch, be installed through the roadway embankment from the North Pond with an upstream invert elevation lower than the existing pipe. This new pipe would extend past the wetland and directly outlet to Birch Island Lake. The bypass would be installed by directional drilling through the roadway embankment and wetland.

To provide a more efficient means to intercept flow, a drain tile system paralleling the roadway embankment to intercept groundwater flow is recommended. The cost of this option is estimated to be \$225,000.

It is recommended that the pipe/drain tile system be implemented to restore the level of Birch Island Lake to pre-roadway construction conditions. It is estimated that for normal climatic conditions, the lake level will rise between 0.5 and 1.0 feet per year.

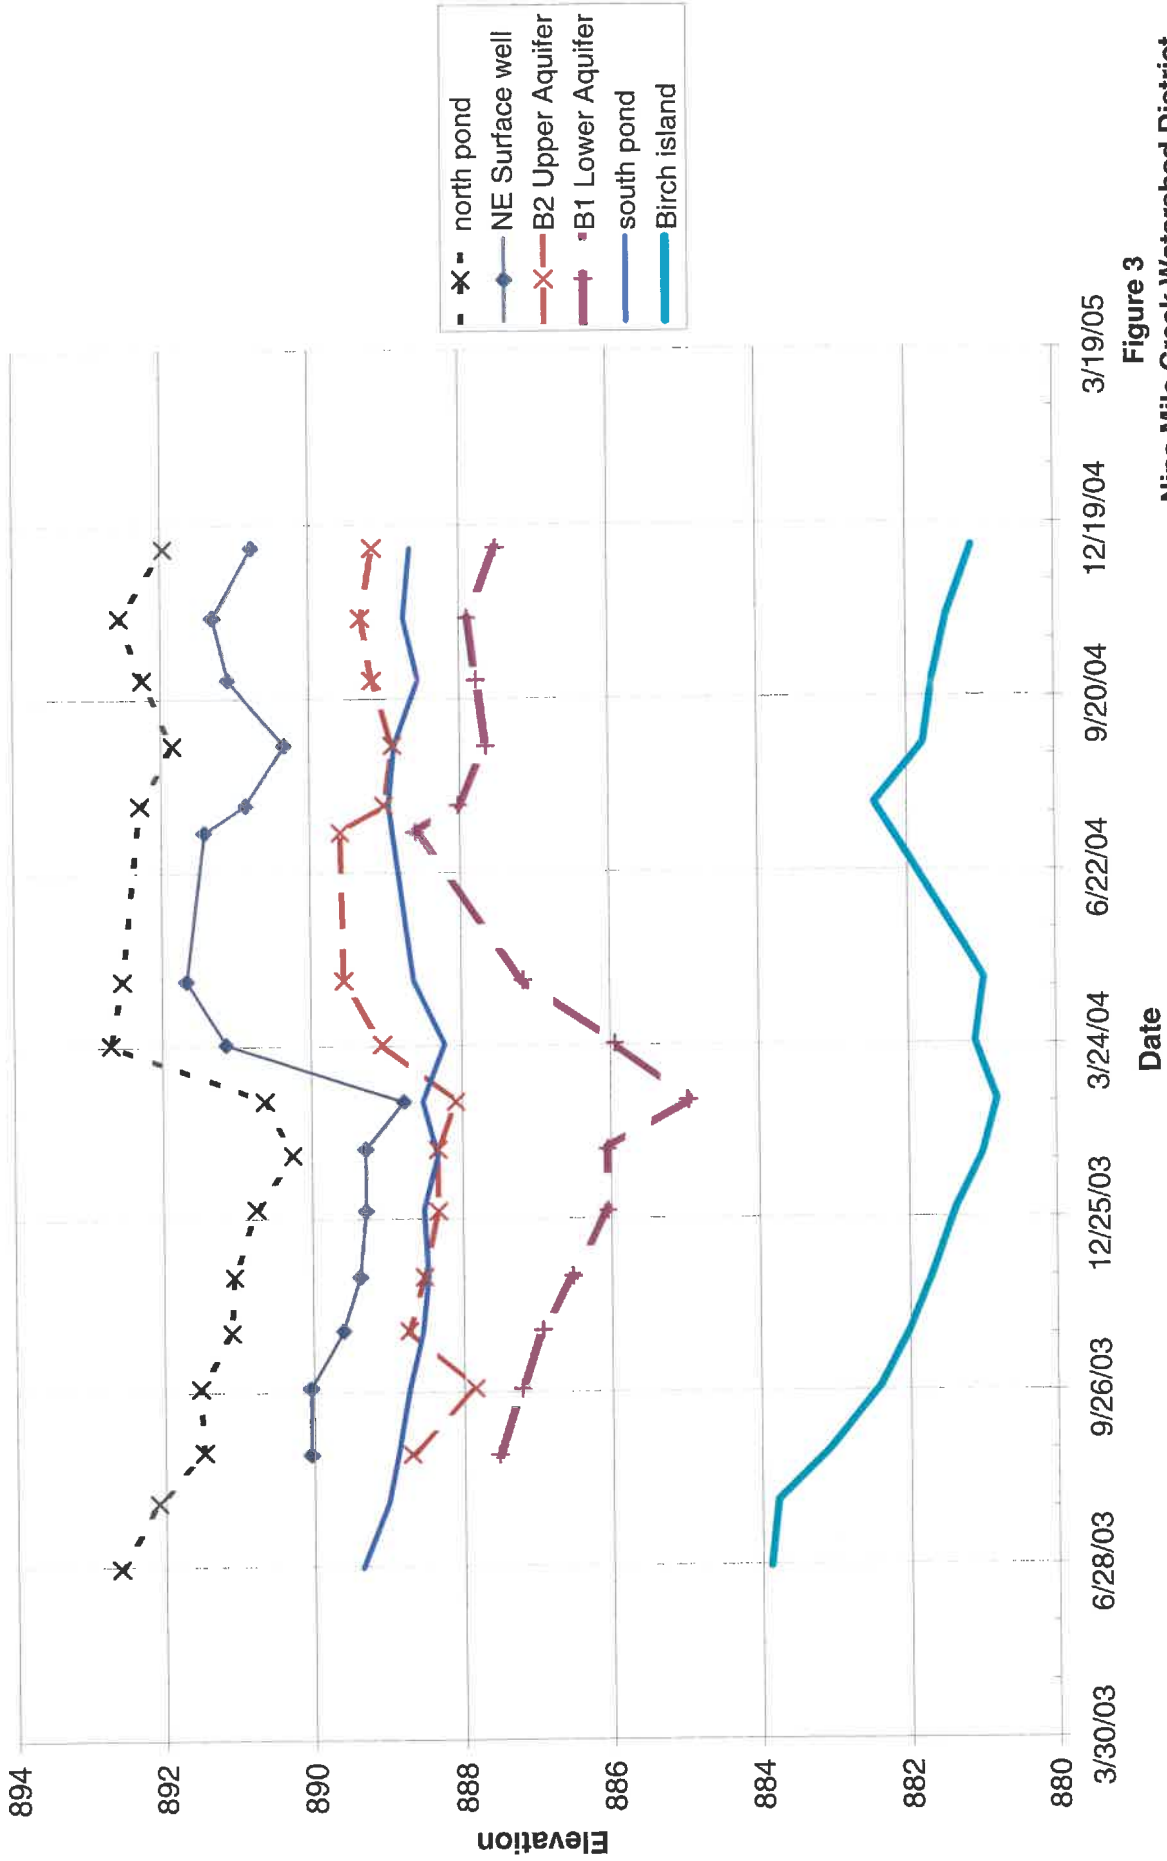
In addition to the new piezometers, elevation data has been collected at the four shallow sand point piezometers installed in the roadway embankment in 1994, the ponds north and south of the road, and Birch Island Lake. Figure 3 shows selected data for the period of record of the piezometer.

A review of the water level data trends indicates three different groupings:

- Birch Island Lake and the South Pond, which have fairly steadily declined throughout the monitoring period.
- The new piezometers and three of the sand point piezometers (NE, NW and SW) which declined through March 2004 and thereafter rose.
- Sand point piezometer SE, which has gone up and down irregularly.

The water level in the lower piezometer (B2) closely parallels the water levels in the shallow sand points, the new shallow piezometer (B1), and the North Pond based on the monthly readings. The water levels in the lower piezometer (B2) are approximately 2 feet lower. This appears to indicate that the lower aquifer is connected with the aquifer within the roadway embankment.

The water levels in the South Pond and Birch Island Lake do not change in concert with the sand points in the embankment and the new piezometers installed in the natural sand lens and glacial outwash deposit on the eastern end of the roadway embankment. This indicates that the hydrologic factors affecting these ponds are not directly connected with the factors affecting the piezometers. Similarly, the SE sand point appears to be in an isolated system, which rises and falls dramatically during rainfall events.

A graph (Figure 3) of the water surface elevations in the North Pond the South Pond and the new piezometers (B1 and B2) shows the elevations of the South Pond and Birch Island Lake do not react to the rainfall events as the piezometers do. This indicates that the hydraulic connection between Birch Island Lake and the drainage area upstream of the roadway embankment is no longer functioning. The watershed area north of T.H. 62 is no longer contributing surface and groundwater to Birch Island Lake.

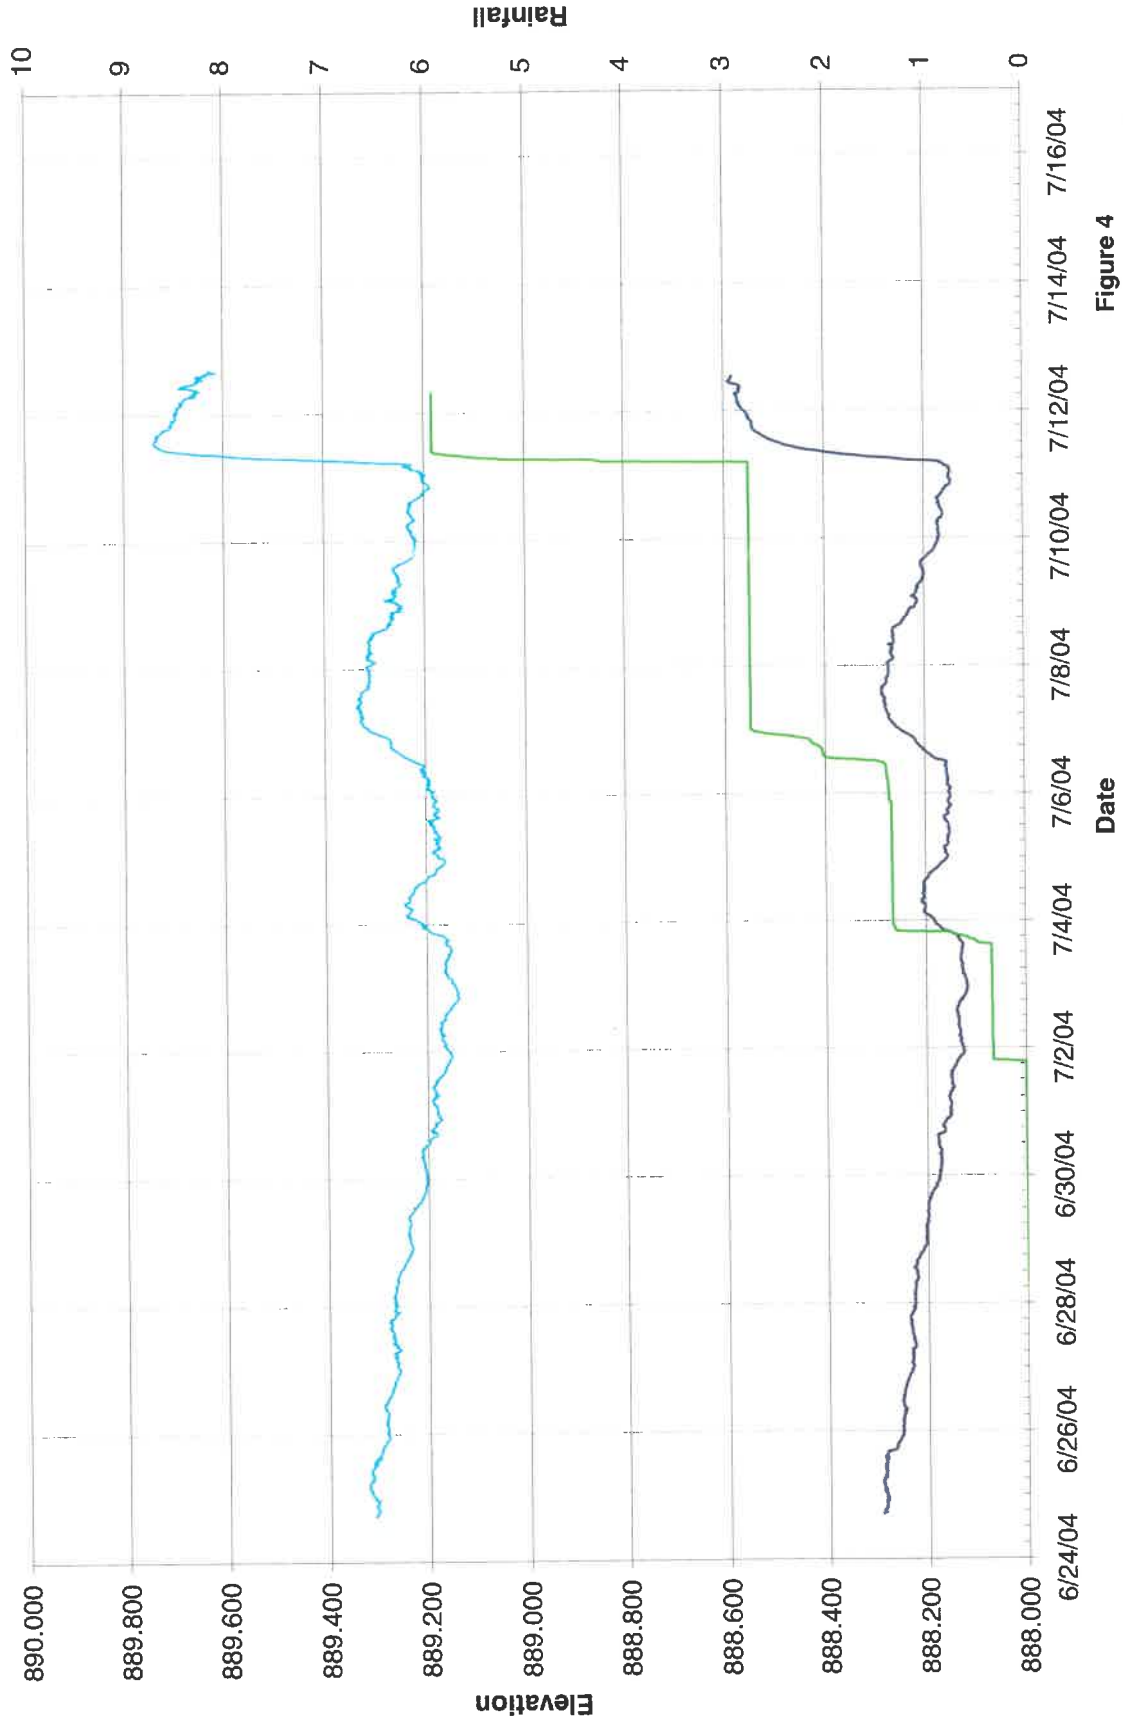
Figure 4
Nine Mile Creek Watershed District
One Minute Water Levels

The data recording devices were installed within the piezometers (B1 and B2) on June 24, 2004 and removed on August 16, 2004. These data recorders were installed to record water levels in each well at one-minute intervals. Plotting the water level in each of the piezometers shows that the aquifers are directly connected. The water level in the lower aquifer responds at the same time as the upper aquifer, but with a slightly smaller magnitude. The Nile Creek Watershed District maintained a rainfall gauge at the Mn/DOT maintenance facility in Eden Prairie. The data from this rainfall gauge was plotted for four rainfall events that occurred during the period of June 24, 2004 through August 16, 2004. Figure 4 shows the relationship between the rainfall and the piezometer elevations and that both piezometers (B1 and B2) react without delay to the rainfall.
