**Project Name** | South Fork Nine Mile Creek Bank Stabilization

**Date** | 11/19/2021

**Regarding** | Baseline Stream Assessment

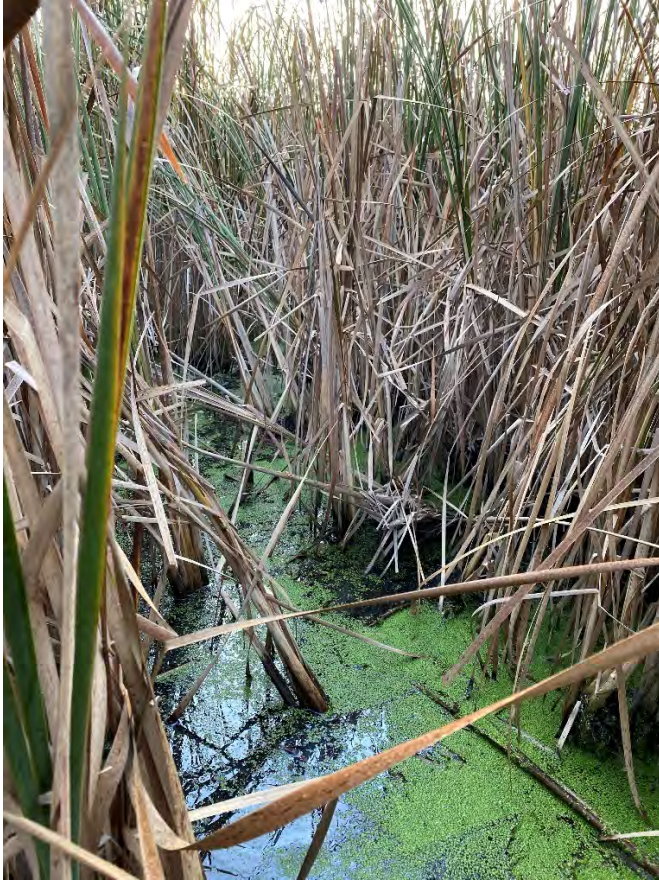
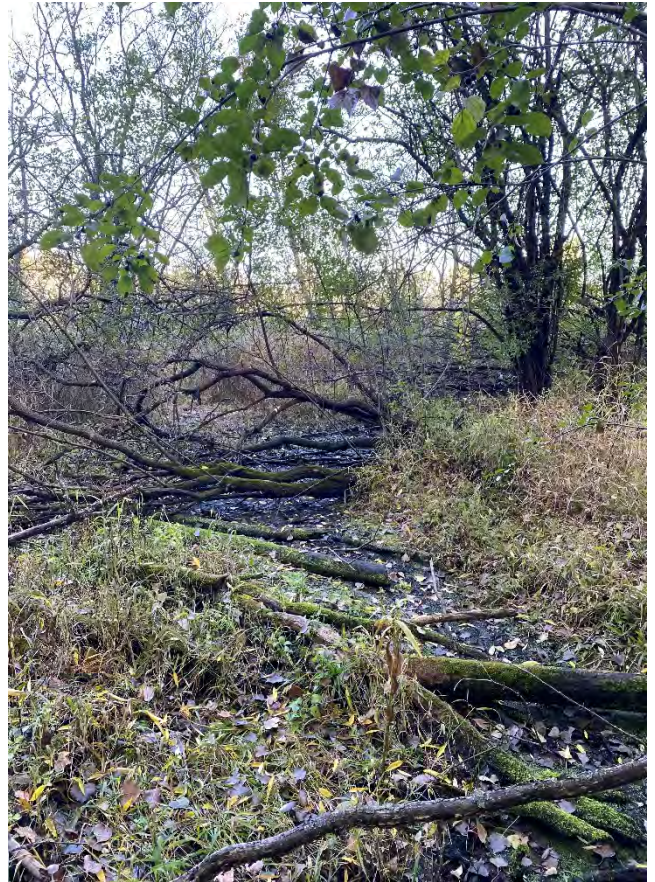
#### Reach 1

Reach 1 occurs from Jorrissen Road to the railroad crossing. The flow channel meanders through a shrub wetland complex comprised of a variety of native shrubs, grasses, and forbs but also contains invasive species including reed canary grass, narrowleaf cattail, glossy buckthorn, and common buckthorn. The channel banks are well vegetated and show little sign of erosion. The stream gradient is low with no perennial baseflow; some areas along the reach did not contain water. The stream channel is fully connected to the floodplain and contained dense herbaceous vegetation. Stream type: E, Pfankuch Condition: Stable.

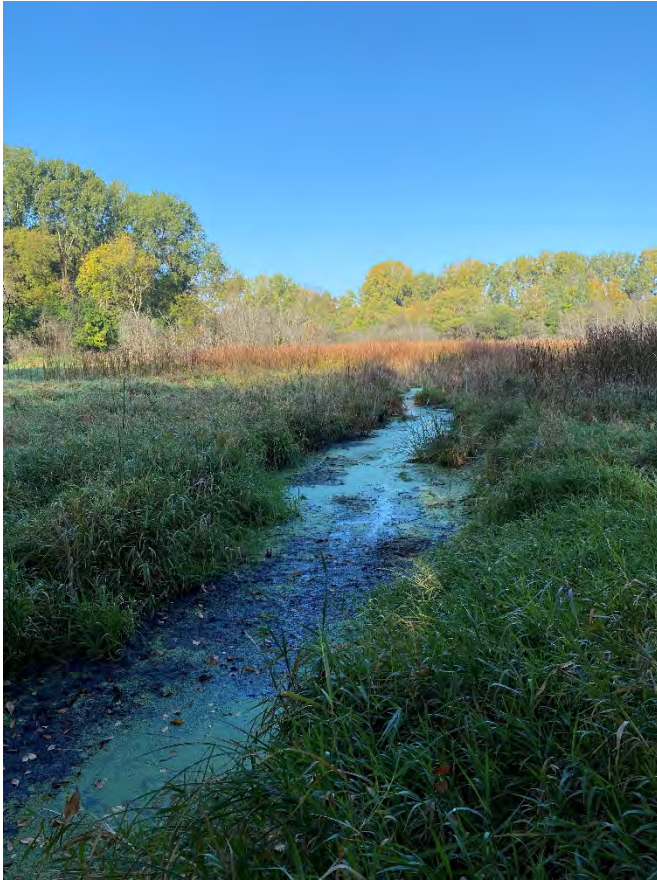
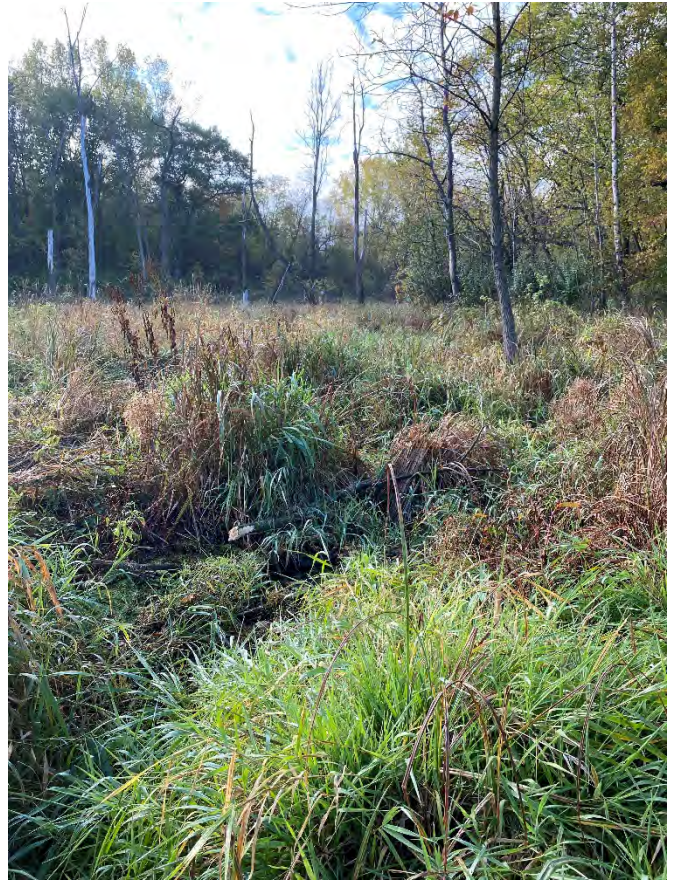
Reach 2 begins downstream of the railroad crossing and extends to Lone Lake Park. The flow channel meanders through a wetland complex dominated by narrowleaf cattail and reed canary grass. The open canopy in this reach provides for dense herbaceous vegetation, resulting in channel banks that are well vegetated and show little sign of erosion. The stream gradient is low with no perennial baseflow; the channel downstream of the cattail marsh was dry during the assessment. Stream type: E, Pfankuch Condition: Stable.

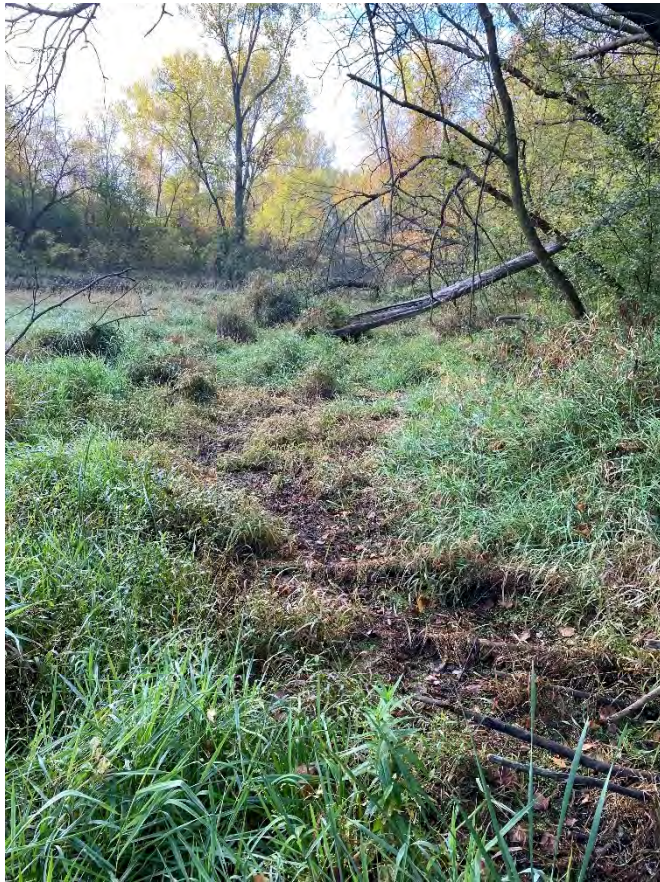
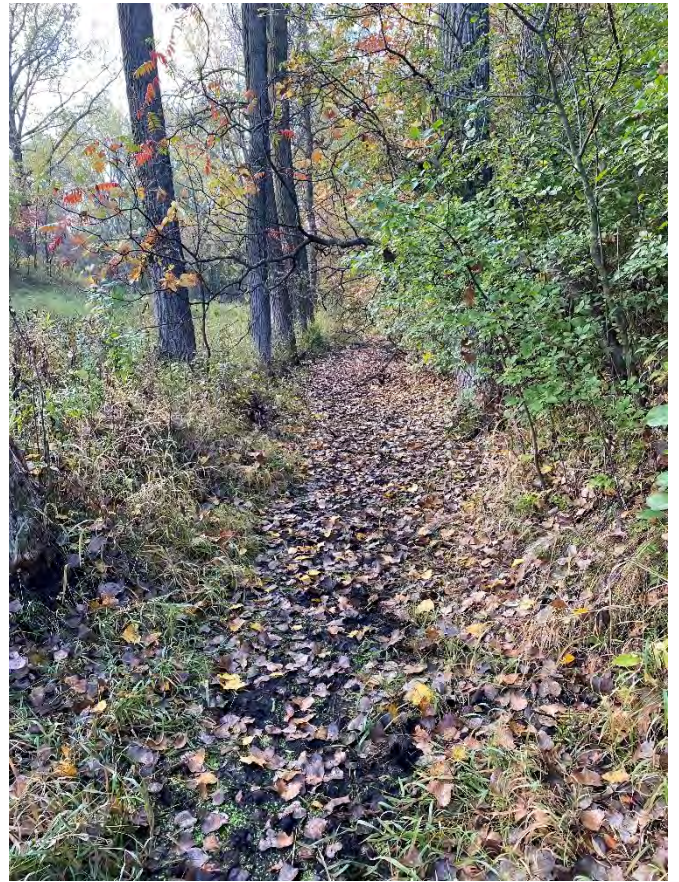
Reach 3 occurs in Lone Lake Park upstream of the parking lot north of Rowland Road. The flow channel winds through a grassy meadow that contains dense herbaceous vegetation and a very stable channel that shows little sign of erosion. The stream gradient is low with no perennial baseflow; much of the channel was dry during the assessment. The floodplain becomes constricted in this reach but it is mostly connected to the floodplain during bankfull events. Stream type: E transitioning to a C, Pfankuch Condition: Stable.

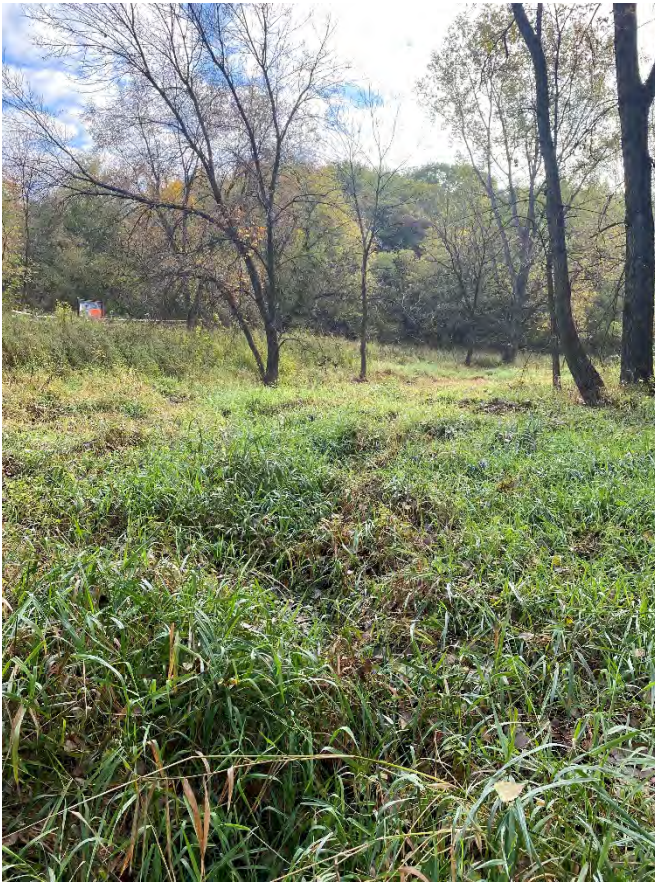
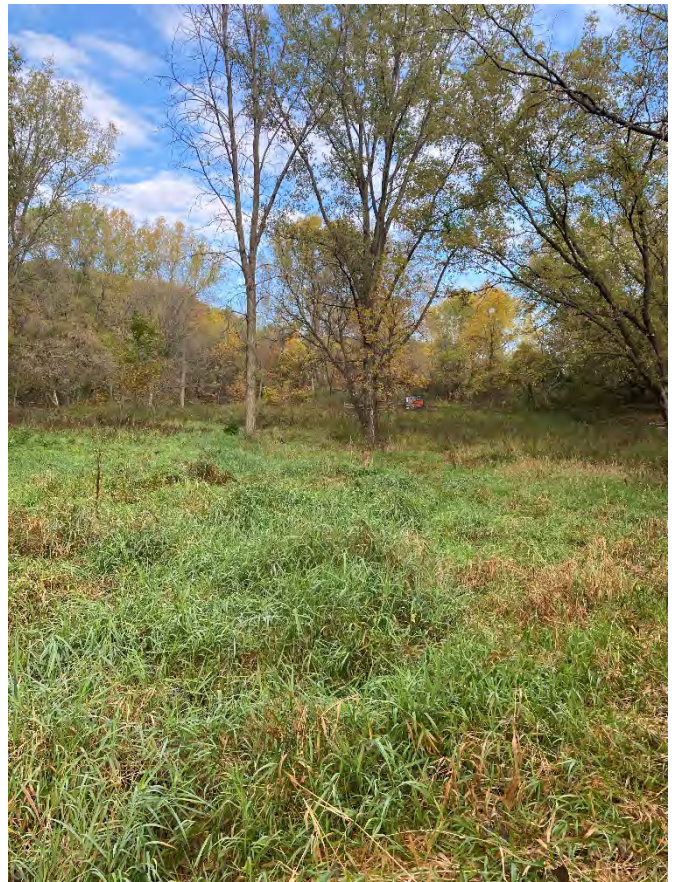
Reach 4 occurs within a wetland meadow in Lone Lake Park and extends downstream to Rowland Road. The flow channel is much wider than the reaches upstream yet it is well connected to the floodplain. Herbaceous vegetation is dominated by reed canary grass which provides ample surface protection of the channel banks. As with the reaches upstream, the stream gradient is very low with no perennial baseflow; the stream channel was completely dry during the assessment. Stream type: C, Pfankuch Condition: Stable.

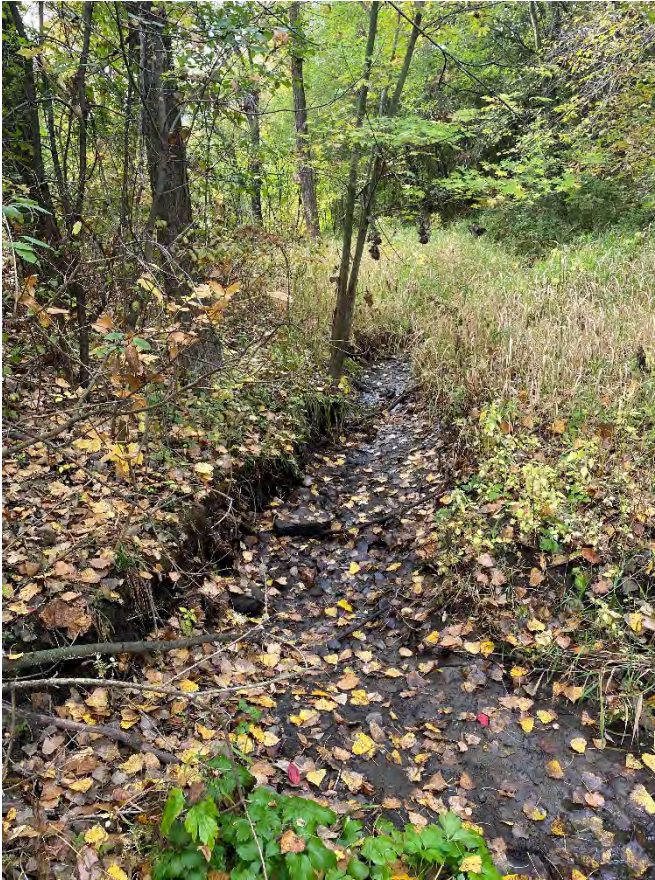
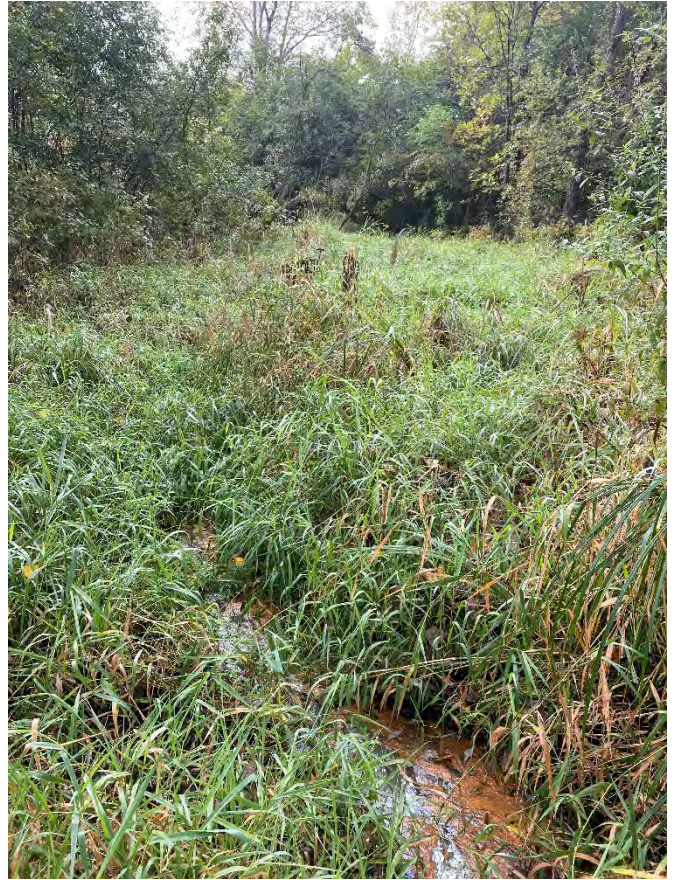
Reach 5 begins at Rowland Road and extends downstream approximately 600 feet. A large stormwater outfall is present at the upstream end of the reach and contributes a significant volume of runoff to the flow channel. Dense herbaceous vegetation within the reach provides good surface protection of the channel banks, though minor bank erosion does occur in the area downstream of the storm water outfall. The reach contains a low gradient channel that is well connected to the floodplain. A small groundwater spring occurs in the middle of the reach and provides a low volume of perennial baseflow. Stream type: C transitioning to E, Pfankuch Condition: Fairly Stable.

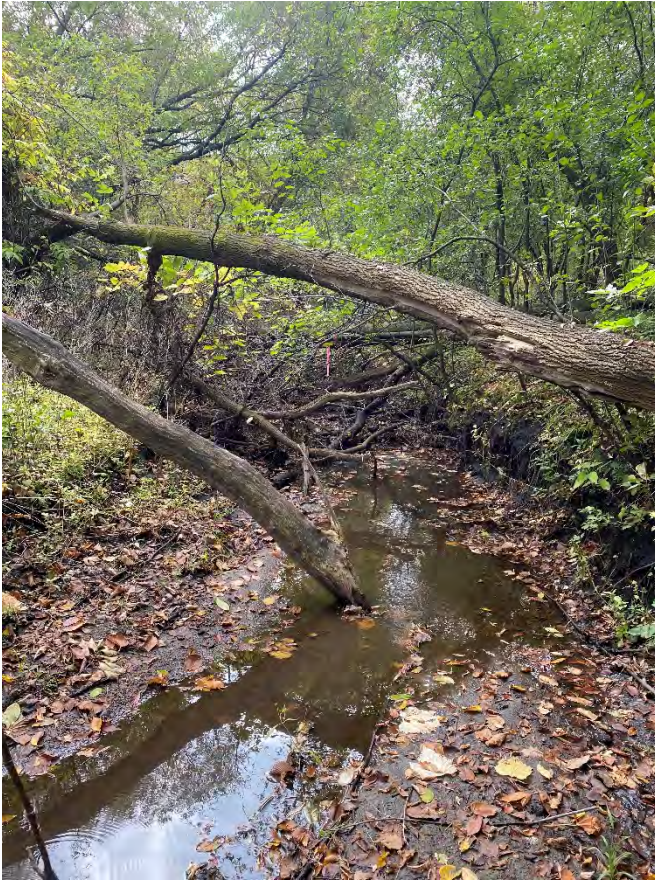
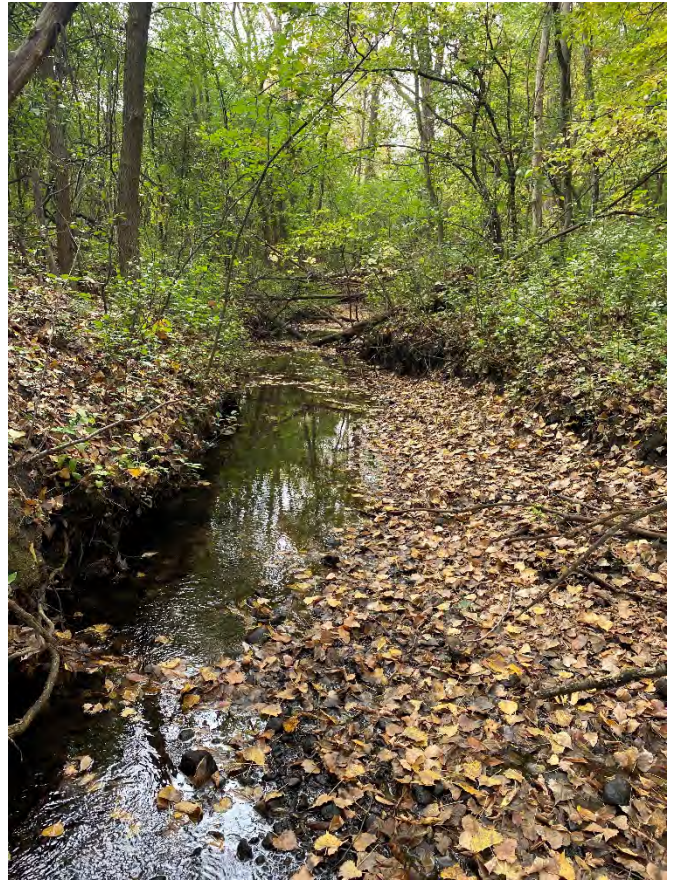
Reach 6 begins approximately 300 feet upstream of Highway 62 and extends downstream of Highway 62 approximately 800 feet. Channel downcutting (incision) begins in this reach and increases downstream.

Bank heights range from 1.5-3 feet with some banks over 6 feet in height, resulting in a floodplain that is mostly disconnected from the creek except during high flow events. A dense tree canopy occurs throughout the reach with invasive species (buckthorn) dominating the shrub layer. Dense shading has resulted in poor streambank vegetation with raw banks common throughout the corridor. Bank erosion is substantial in this reach, yet exposed gravel and cobble substrates occur within the stream. Perennial flow from groundwater supports a small assemblage of minnows and macroinvertebrates that were observed during the assessment. Stream type: C transitioning to F, Pfankuch Condition: Severely Unstable.

Reach #	Pfankuch Channel Condition	Approximate Reach Length (ft.)	Proposed Bank Stabilization Options	Construction Cost	Engineering Cost*
6	Severely Unstable	1365	#1, #3	\$163,800	(Implementation of all 5 Priority Reaches)
7	Severely Unstable	895	#1, #3	\$107,400	
8	Moderately Unstable	1134	#1, #3	\$113,400	
16	Moderately Unstable	1493	#1, #2	\$149,300	
17	Severely Unstable	1135	#1, #2	\$136,200	
<b>TOTAL</b>		<b>6,022</b>		<b>\$670,100</b>	<b>\$115,241</b>

EOR has identified five potential bank stabilization project reaches along the South Fork Nine Mile Creek based on existing channel conditions and the degree of bank stability/ erosion (Table 4). It is recommended that the Severely Unstable reaches are prioritized for stabilization in the near future based on the severity of bank erosion in these reaches and the potential for impacts to existing infrastructure if erosion continues to advance. Although reaches 14 and 18 have a Moderately Unstable Pfankuch condition, overall bank erosion in these reaches is low compared to other sites. The greatest functional lift and benefit to the resource in terms of listed biotic impairments for the creek would be to prioritize the reaches that are contributing the greatest amount of sediment and nutrients to the system. Therefore, the reaches identified in Table 4 should be prioritized for restoration with consideration to improve reaches 14 and 18 at a later date. Reaches 6-8 are located upstream of the listed impairments for the creek but were included as a priority with reaches 16 and 17 due to excessive bank erosion and subsequent sediment loading to Bryant Lake.

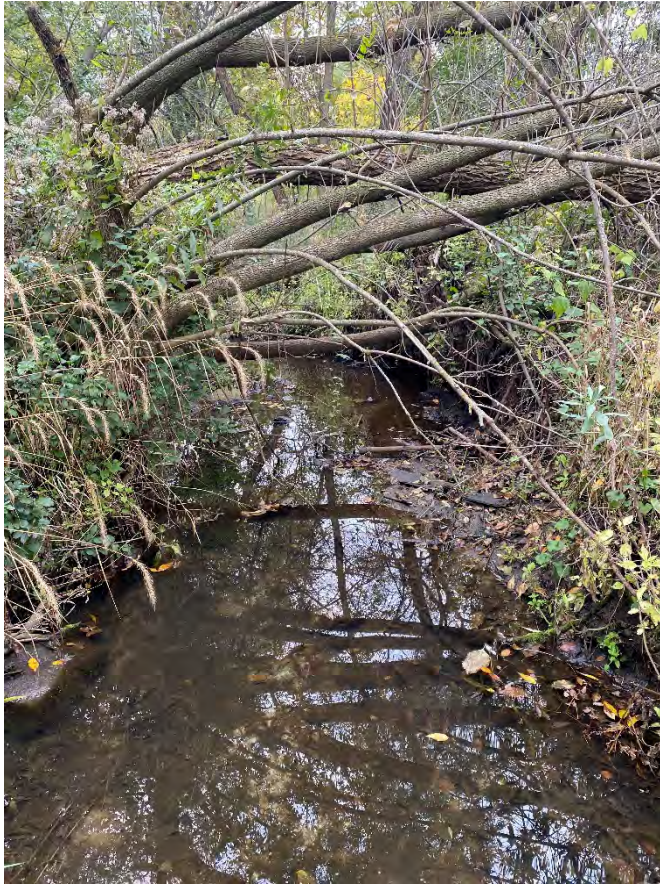
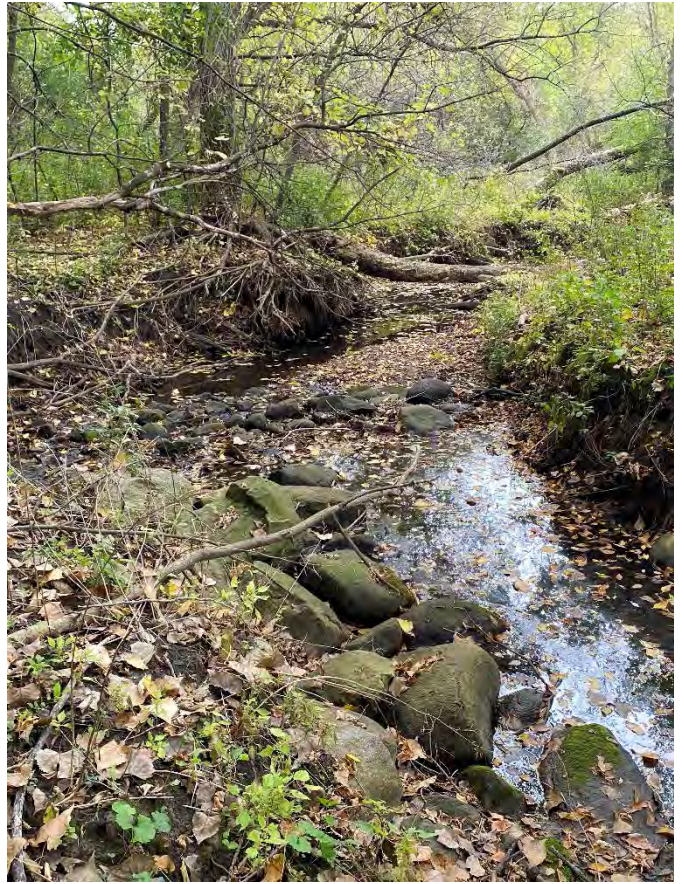
Reach 7 begins at the downstream terminus of Reach 6 and extends downstream to a paved walking path due west of Bryant Lake Dog Park. Similar to Reach 6, channel incision has resulted in bank heights that range from 1.5-4 feet, resulting in a floodplain that is mostly disconnected from the creek except during high flow events. A dense tree canopy occurs throughout the reach with buckthorn dominating the shrub layer. Dense shading has resulted in poor streambank vegetation with raw banks common along the corridor. Bank erosion is substantial in this reach, yet exposed gravel and cobble substrates occur within the stream, including numerous large fieldstone boulders scattered within the channel. Perennial flow from groundwater discharge supports a small assemblage of minnows and macroinvertebrates that were observed during the assessment. Pools are limited by sediment aggradation with depths that range from 0.8-1.25 feet. Stream type: F, Pfankuch Condition: Severely Unstable.

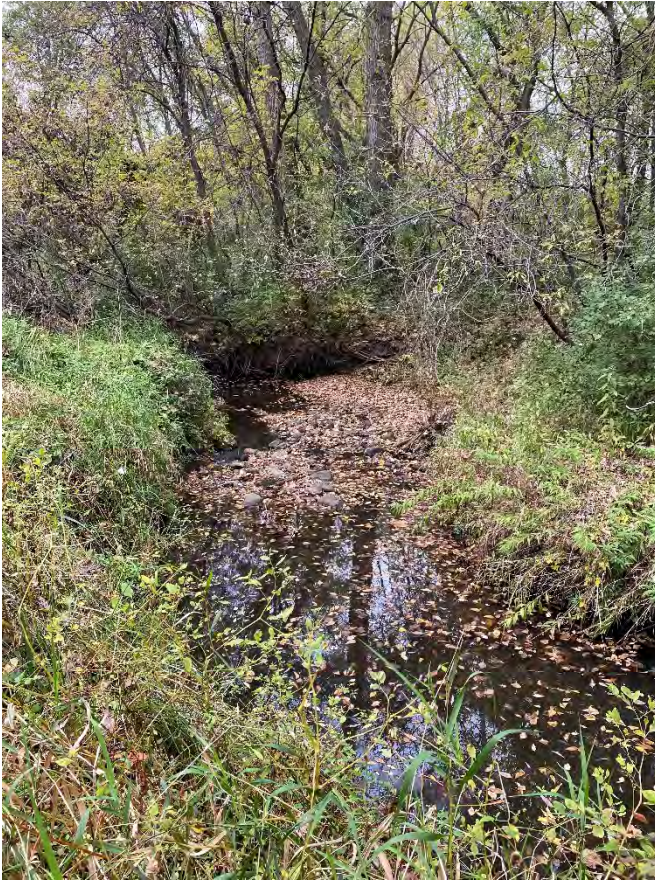
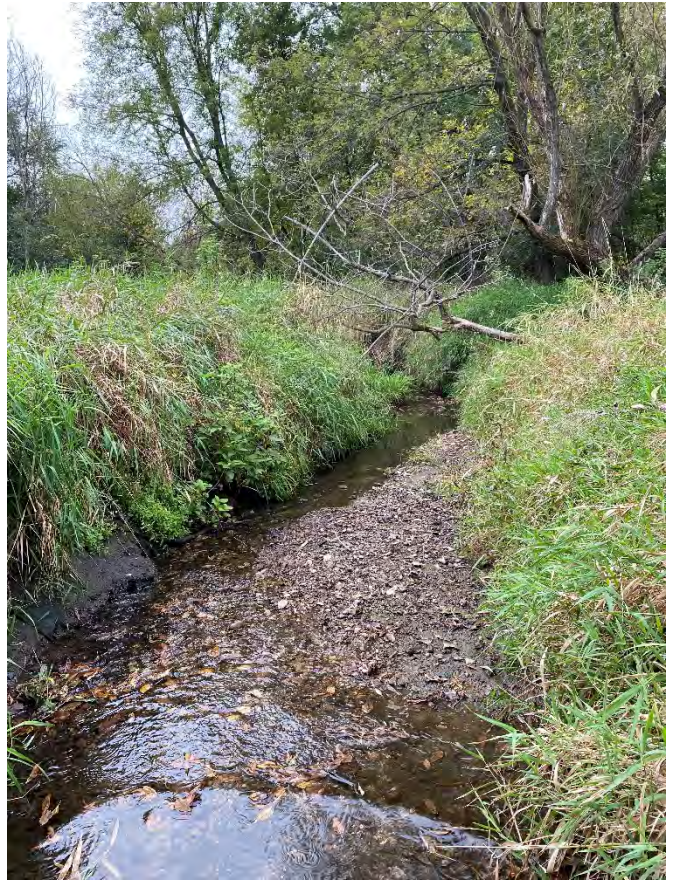
Reach 8 begins at the paved trail crossing due west of Bryant Lake Dog Park and extends downstream to the inlet to Bryant Lake. Reach 8 has a lower stream gradient compared to reaches 6-7 and is kept in check by the water elevation of Bryant Lake. The stream channel becomes narrower in areas with a reduced tree canopy, but bank erosion is still prevalent throughout the reach. A large sediment delta occurs at the inlet to Bryant Lake due to significant bank erosion that has occurred upstream. Stream substrates are predominantly sand with some gravel exposed in riffles and at channel constrictions. Pool depths are greatly diminished by the high sediment load and are on average less than one foot in depth. Stream type: F transitioning to a C, Pfankuch Condition: Moderately Unstable.

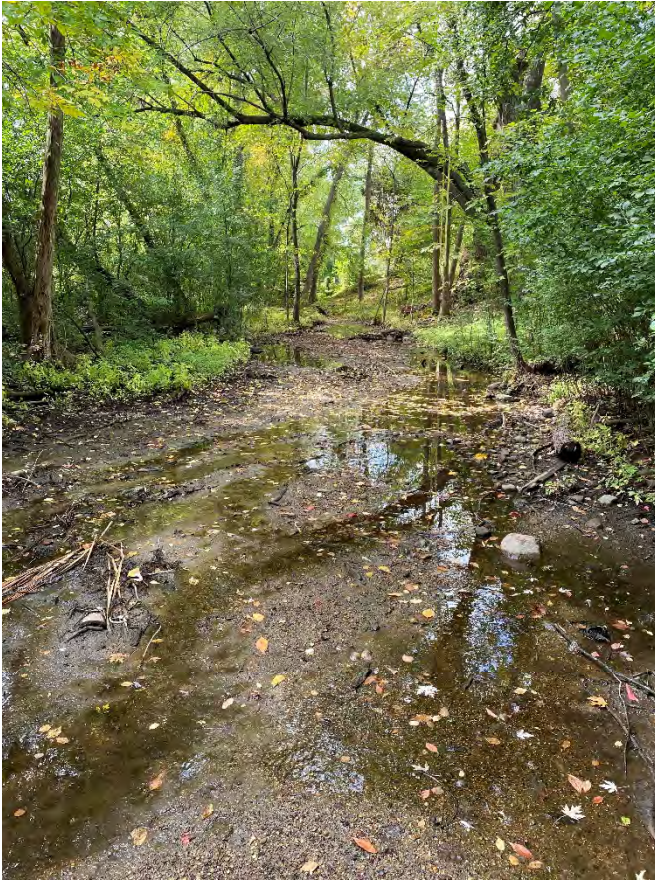
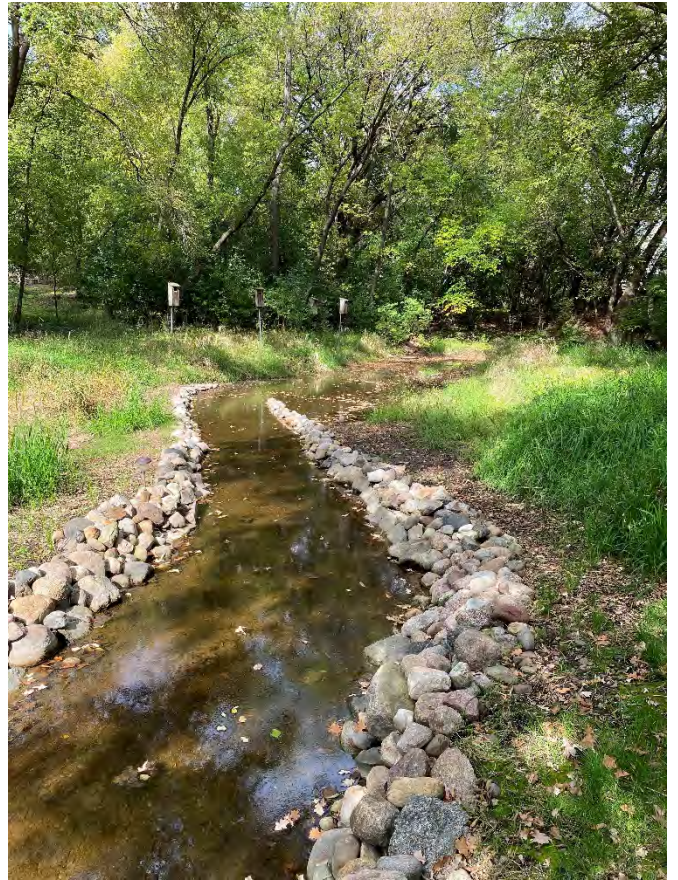
Reach 9 occurs from the outlet of Bryant Lake to an old channel crossing located approximately 275 feet upstream of Bryant Lake Drive. This reach has significantly less bank erosion compared to reaches 6-8, due in part to flow attenuation in Bryant Lake. The floodplain has been highly altered in this reach. The channel immediately downstream of Willow Creek Road is very wide (~20 feet) and shallow with no defined thalweg. Stream depths average less than 0.25 feet. The combination of very shallow stream depths and a very wide channel has resulted in poor channel substrates that are comprised of silt and sand. Conversely, a narrow stream channel occurs downstream of a private driveway crossing where the channel has been lined with fieldstone rock. Stream flow is concentrated within the rock channel which has resulted in greater stream depths and a defined thalweg. Stream type: DA transitioning to a C, Pfankuch Condition: Fairly Stable.

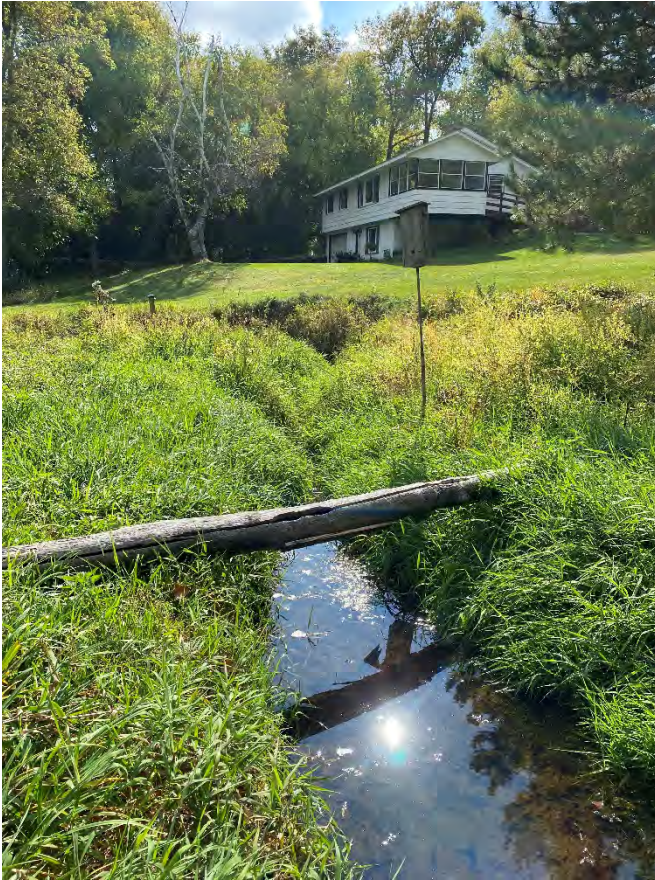
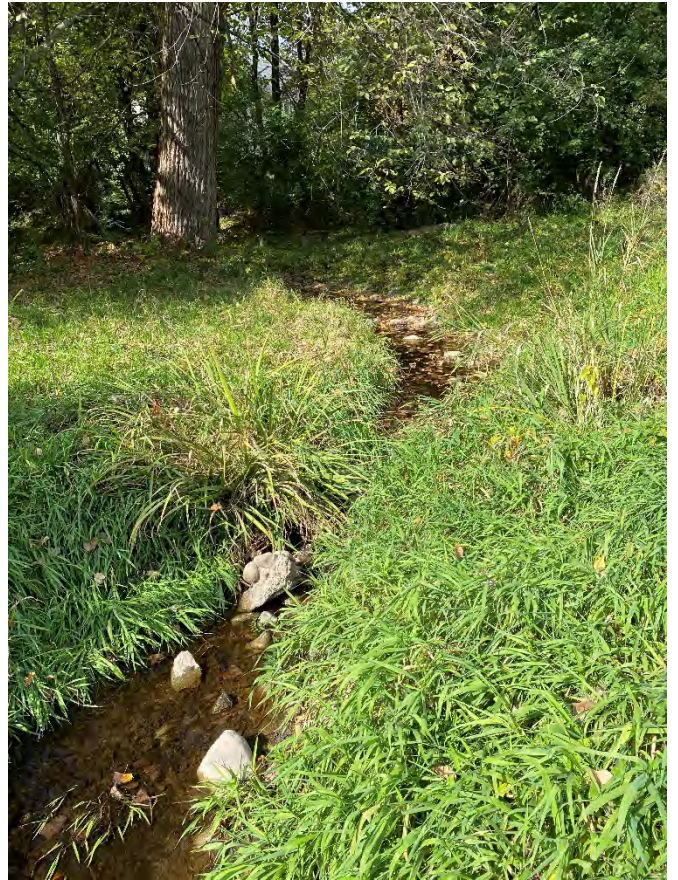
Reach 10 is a short section of the creek between the old channel crossing at the downstream terminus of Reach 9 and extends to Bryant Lake Drive. Reach 10 marks the end of the altered channel conditions documented in Reach 9. The tree canopy is reduced, resulting in well vegetated grassy stream banks. This reach contains a sinuous channel with a defined riffle-pool sequence. Although the channel is slightly incised, the floodplain is mostly connected to the stream due in part to three rock grade control structures that limit further channel incision. The channel is much narrower than Reach 9 and contains an increase in gravel substrates. Reach 10 marks the beginning of aquatic macrophyte growth within the creek and is

likely the result of seed dispersal from the existing macrophyte community in Bryant Lake. Species observed include curly-leaf pondweed, coontail, and floating-leaf pondweed. Stream type: E, Pfankuch Condition: Fairly Stable.

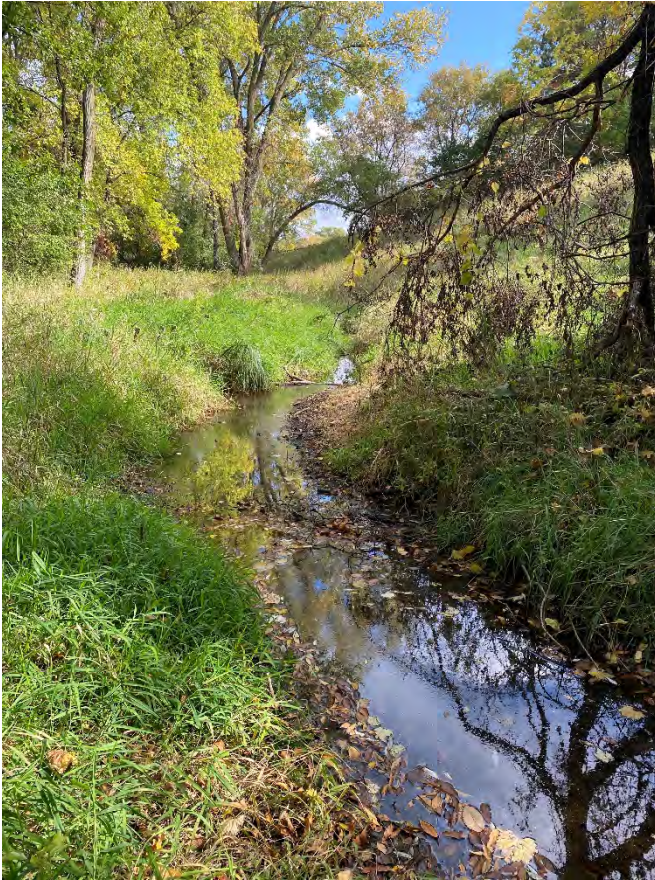
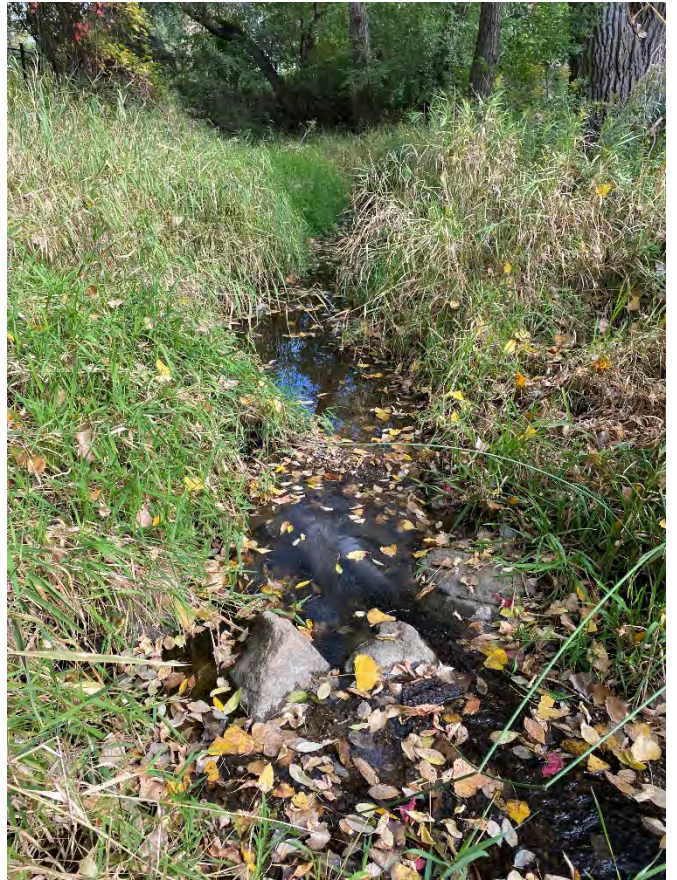
Reach 11 occurs from Bryant Lake Drive to Highway 212. A recent bank stabilization project has occurred in this reach that incorporated bank grading, boulder toe, and rock grade control structures. Stream gradient is low through the reach and is controlled by the rock grade control structures and the culvert elevation under Highway 212. Channel substrates include coarse gravel, sand, and silt with aquatic macrophytes occurring in areas where the tree canopy is open. Stream type: C, Pfankuch Condition: Fairly Stable.

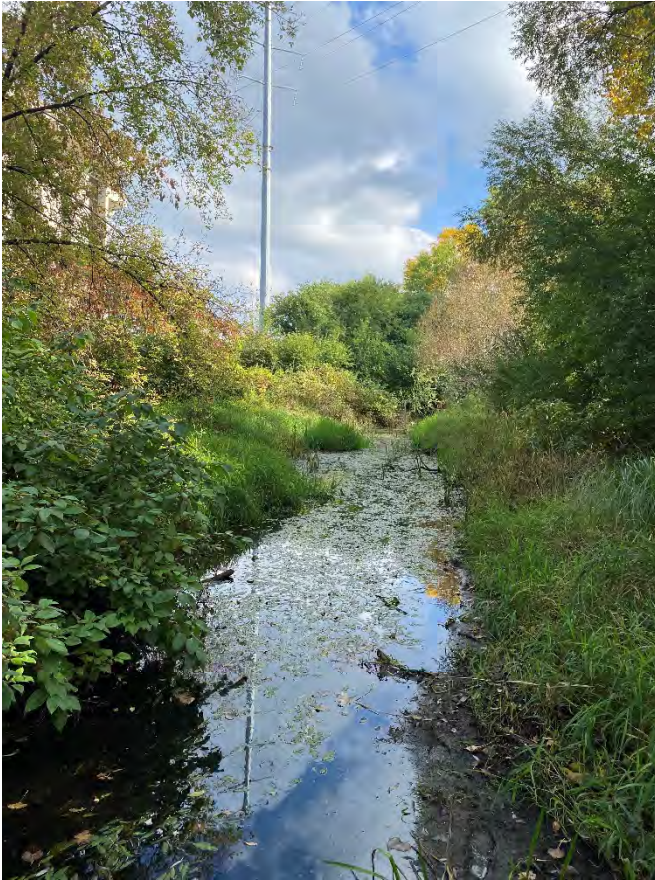
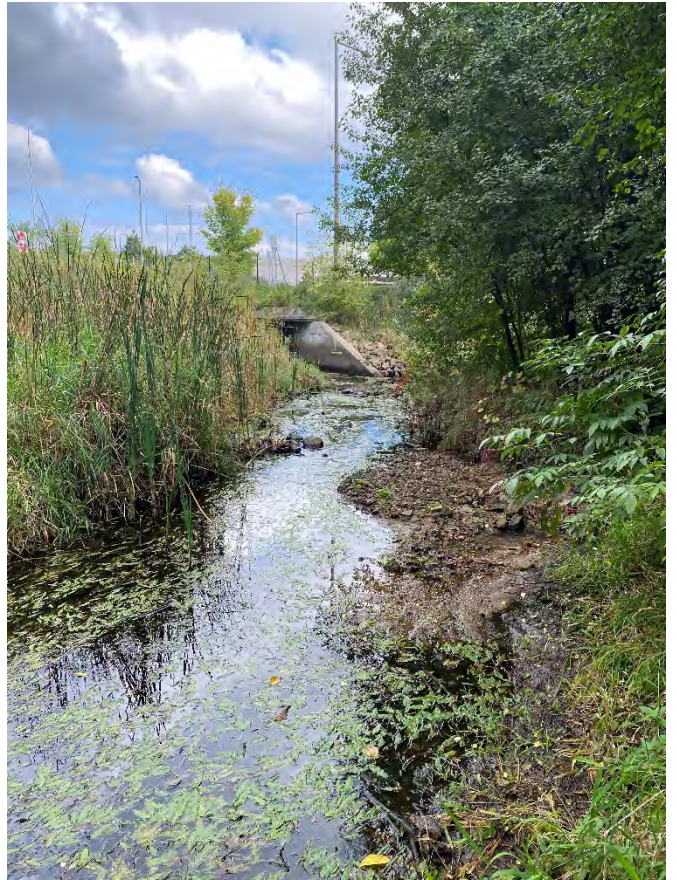
Reach 12 occurs from Washington Avenue to Highway 169. Stream gradient is very low through this reach and is controlled by the Highway 169 culvert elevation. The channel banks are well vegetated where the tree canopy is reduced, but bank erosion was observed in a few areas. The stream channel is relatively flat and wide, resulting in sediment aggradation and poor substrate composition dominated by silt, sand, and dense aquatic macrophyte beds. Stream type: C, Pfankuch Condition: Fairly Stable.

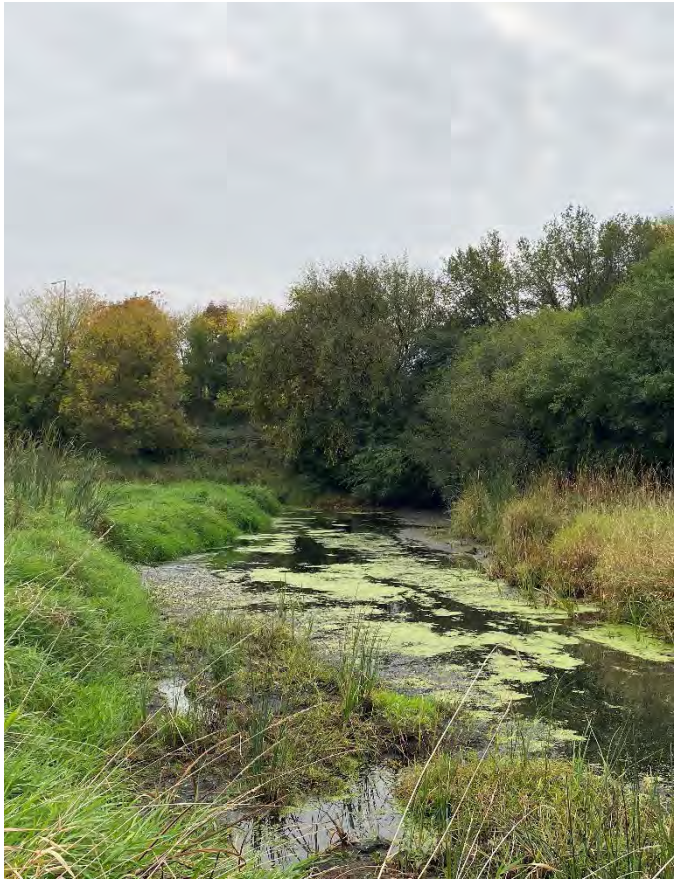
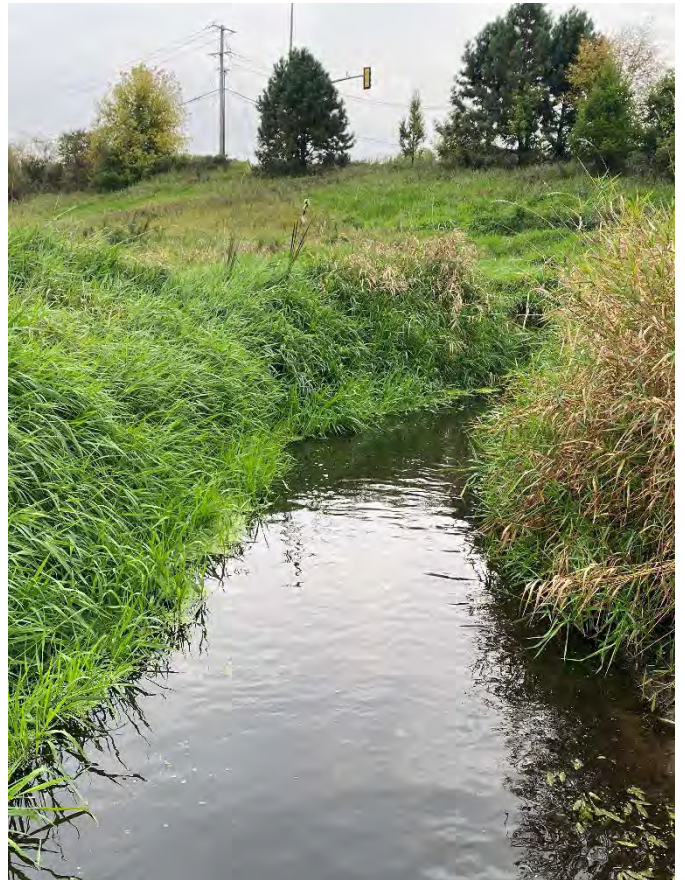
Reach 13 occurs from the eastern Braemer Golf Course Pond to the east edge of the wetland meadow approximately 400 feet upstream of 78<sup>th</sup> Street. The stream channel in this reach flows through a wetland meadow dominated by reed canary grass. Channel substrates are comprised of silt and sand, resulting in poor riffle habitat. However, this reach contained the deepest pools of all the reaches assessed and are maintained by channel sinuosity, a narrow channel, and flow obstructions including down wood and brush. Pool depths ranged from 1.5-3 feet, with a few pools over three feet in depth. A low stream gradient and fine channel substrates support a variety of aquatic macrophytes including floating-leaf pondweed, lesser duckweed, watermeal, sago pondweed, curly-leaf pondweed, Canada waterweed, and coontail. In addition, a few native mussels were found including giant floater and pea clam. Stream type: E, Pfankuch Condition: Fairly Stable.

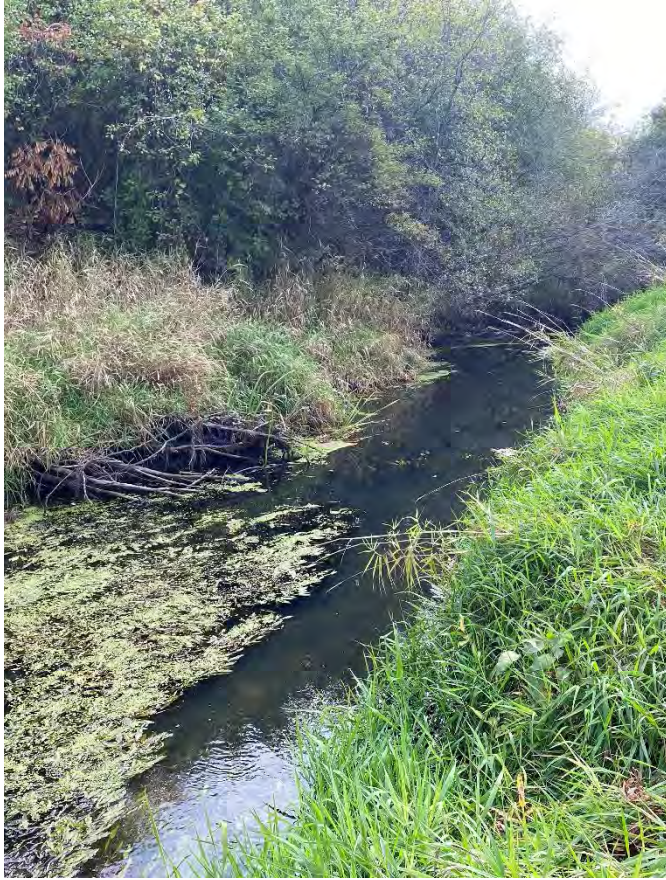
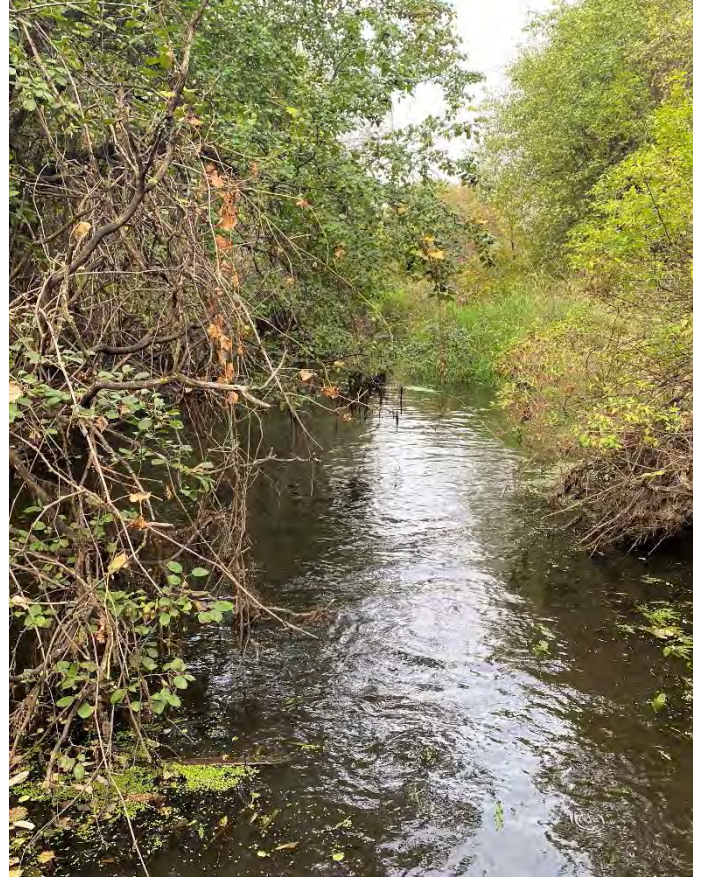
Reach 14 starts at the downstream terminus of Reach 13 and extends to 78<sup>th</sup> Street. The stream channel in this reach appears highly altered and ditched with a very narrow floodplain. The stream channel is wide and straight with substrates comprised of silt and sand. Riffle and pool features are diminished and affected by poor sediment transport and high composition of fine bed material. Pool depths range from 1-1.5 feet. Stream gradient is controlled by a rock grade control structure at the upstream end of the culvert under 78<sup>th</sup> Street. Minnows and giant floaters were observed in the reach along with dense macrophyte beds. Stream type: C, Pfankuch Condition: Moderately Unstable.

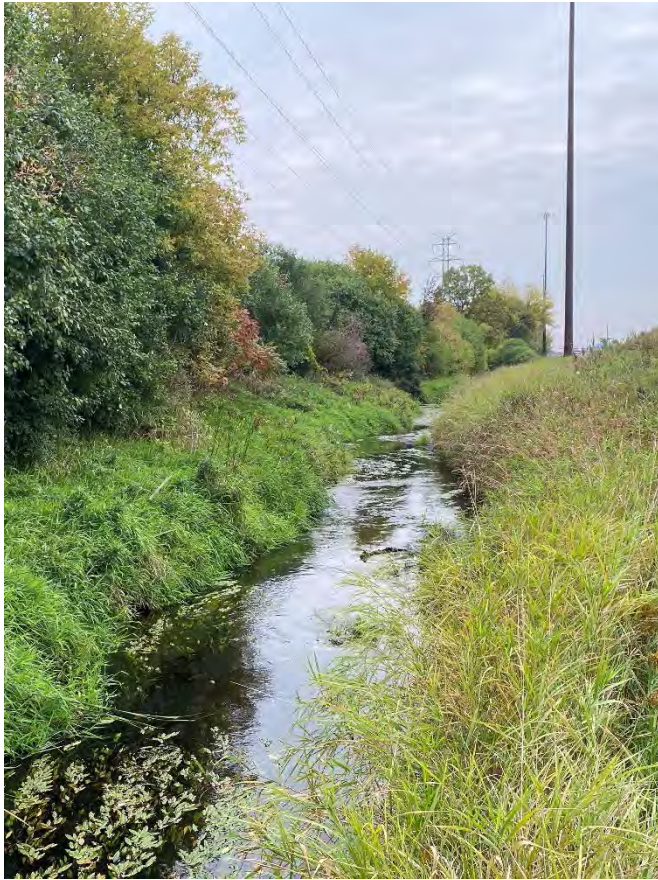
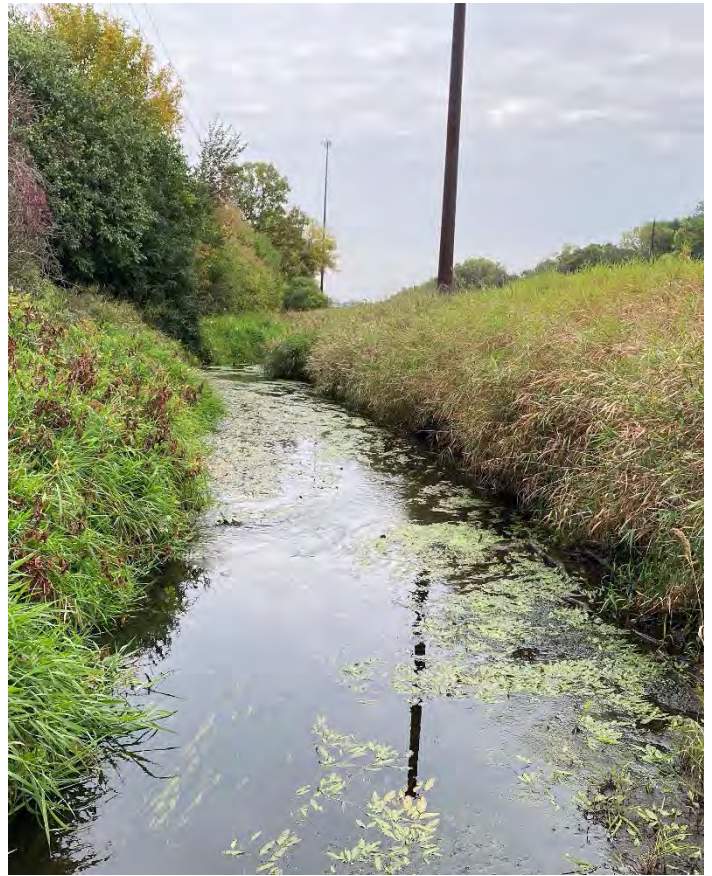
Reach 15 occurs from 78<sup>th</sup> Street and extends downstream approximately 700 feet. The stream channel in this reach has been ditched and runs parallel to I-494 with a floodplain that is almost non-existent. Stream bank vegetation is dominated by reed canary grass which provides ample surface protection. Although channel morphology is poor, little bank erosion was observed due in part to a low stream gradient, a wide channel, and densely vegetated stream banks. An increase in coarse substrates occurs in this reach, possibly derived from imported road base material from I-494. The open canopy along this reach allows for colonization of dense aquatic macrophyte beds comprised of floating-leaf pondweed, start duckweed, lesser duckweed, Canada waterweed, sago pondweed, and watermeal. Groundwater seepage was observed

along the north embankment along I-494. Stream type: C transitioning to F, Pfankuch Condition: Fairly Stable.
