**Project Name** | South Fork Nine Mile Creek Bank Stabilization

**Date** | 11/19/2021

**Regarding** | Baseline Stream Assessment

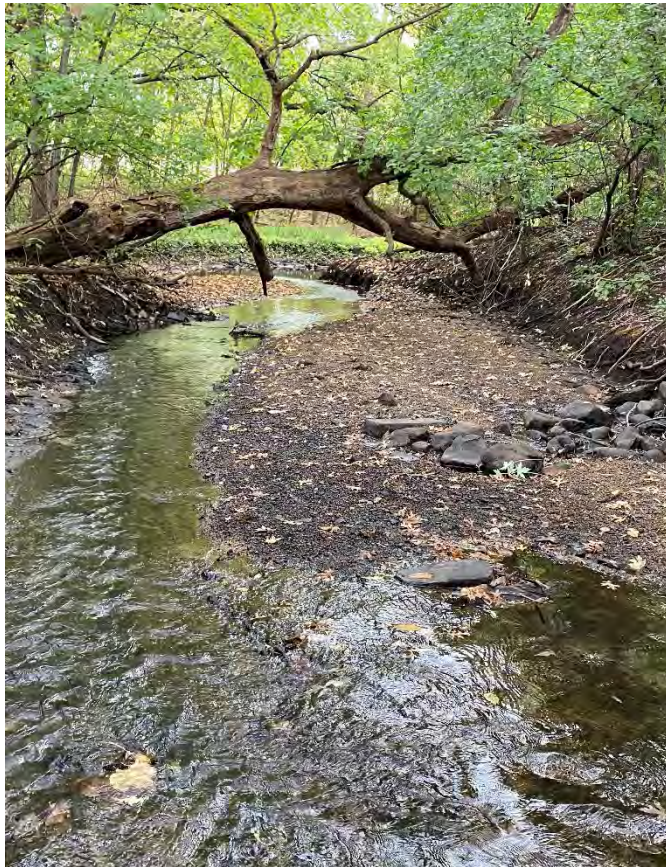
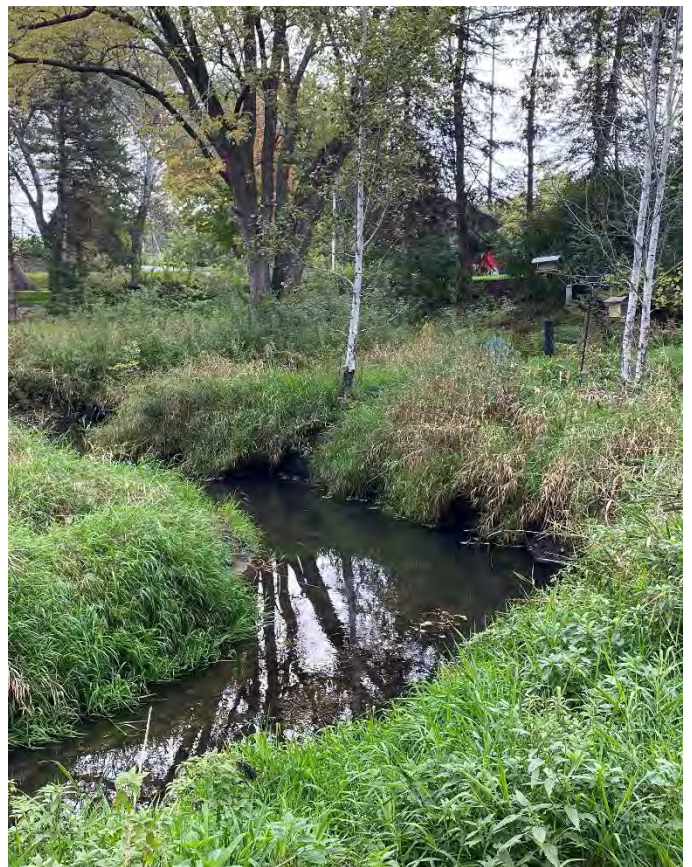
Reach 16 occurs from the downstream terminus of Reach 15 to Creek Ridge Drive. The stream channel courses through a dense forested corridor dominated by box elder, cottonwood, and common buckthorn. The dense tree and shrub canopy limits available sunlight, thereby reducing herbaceous ground cover. Lateral bank migration is exacerbated by a combination of high channel sinuosity, poor streambank vegetation, and numerous channel obstructions comprised of down trees, branches, and debris jams. Bank erosion has resulted in the formation of several mid-channel bars and side bars which has caused further bank erosion through deflection of high flow velocities into the adjacent stream banks. In areas with a reduced tree canopy, the stream channel is narrower with densely vegetated stream banks and limited bank erosion compared to the wooded areas. Pool depths in this reach range from 1-2 feet and provide habitat for a few species of fish including minnows and dace. In areas with an open tree canopy, some macrophyte growth was observed. Other aquatic species identified in the reach included pea clams and giant floaters. Stream type: C, Pfankuch Condition: Moderately Unstable.

Reach #	Pfankuch Channel Condition	Approximate Reach Length (ft.)	Proposed Bank Stabilization Options	Construction Cost	Engineering Cost*
6	Severely Unstable	1365	#1, #3	\$163,800	(Implementation of all 5 Priority Reaches)
7	Severely Unstable	895	#1, #3	\$107,400	
8	Moderately Unstable	1134	#1, #3	\$113,400	
16	Moderately Unstable	1493	#1, #2	\$149,300	
17	Severely Unstable	1135	#1, #2	\$136,200	
<b>TOTAL</b>		<b>6,022</b>		<b>\$670,100</b>	<b>\$115,241</b>

EOR has identified five potential bank stabilization project reaches along the South Fork Nine Mile Creek based on existing channel conditions and the degree of bank stability/ erosion (Table 4). It is recommended that the Severely Unstable reaches are prioritized for stabilization in the near future based on the severity of bank erosion in these reaches and the potential for impacts to existing infrastructure if erosion continues to advance. Although reaches 14 and 18 have a Moderately Unstable Pfankuch condition, overall bank erosion in these reaches is low compared to other sites. The greatest functional lift and benefit to the resource in terms of listed biotic impairments for the creek would be to prioritize the reaches that are contributing the greatest amount of sediment and nutrients to the system. Therefore, the reaches identified in Table 4 should be prioritized for restoration with consideration to improve reaches 14 and 18 at a later date. Reaches 6-8 are located upstream of the listed impairments for the creek but were included as a priority with reaches 16 and 17 due to excessive bank erosion and subsequent sediment loading to Bryant Lake.

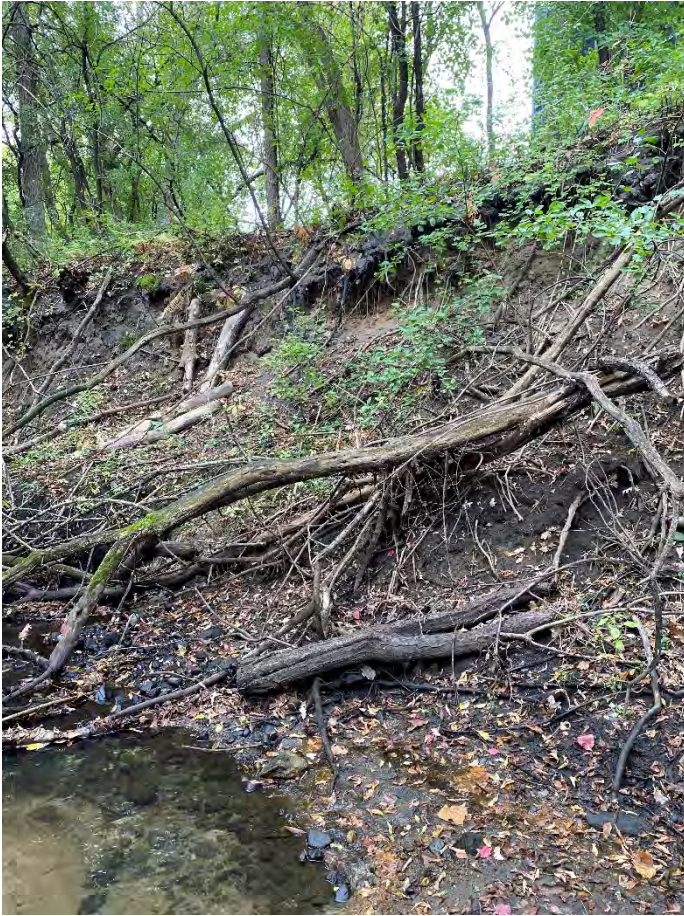
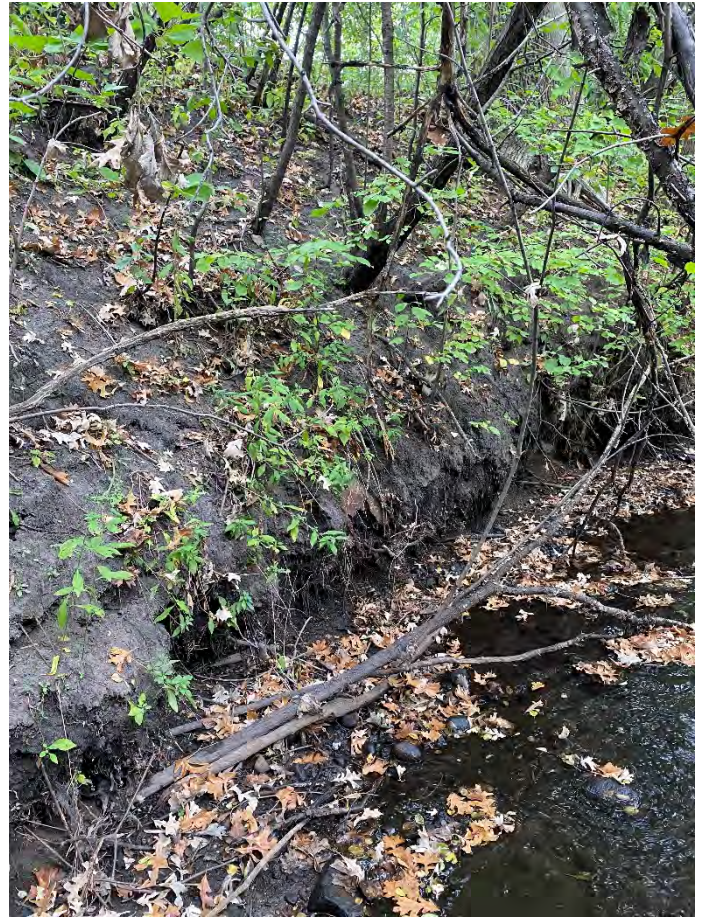
Reach 17 is located between Creek Ridge Drive and I-494. Similar to Reach 16, the stream channel courses through a dense forested corridor dominated by box elder, cottonwood, and common buckthorn. Herbaceous ground cover is limited due to the dense tree and shrub canopy. Bank erosion and sediment issues abound in this reach and are the result of lateral bank migration that is exacerbated by a combination of high channel sinuosity, poor streambank vegetation, and numerous log jams and down trees. The stream channel has migrated near significant infrastructure including the road embankment of 78<sup>th</sup> Street and a commercial building; therefore, this reach is considered a top priority for a stabilization project. Bank heights range from 2-6 feet with a few banks over 15 feet in height. Pool depths in this reach range from 1-2 feet and provide habitat for a few species of fish including minnows and dace. Stream type: C transitioning to F, Pfankuch Condition: Severely Unstable.

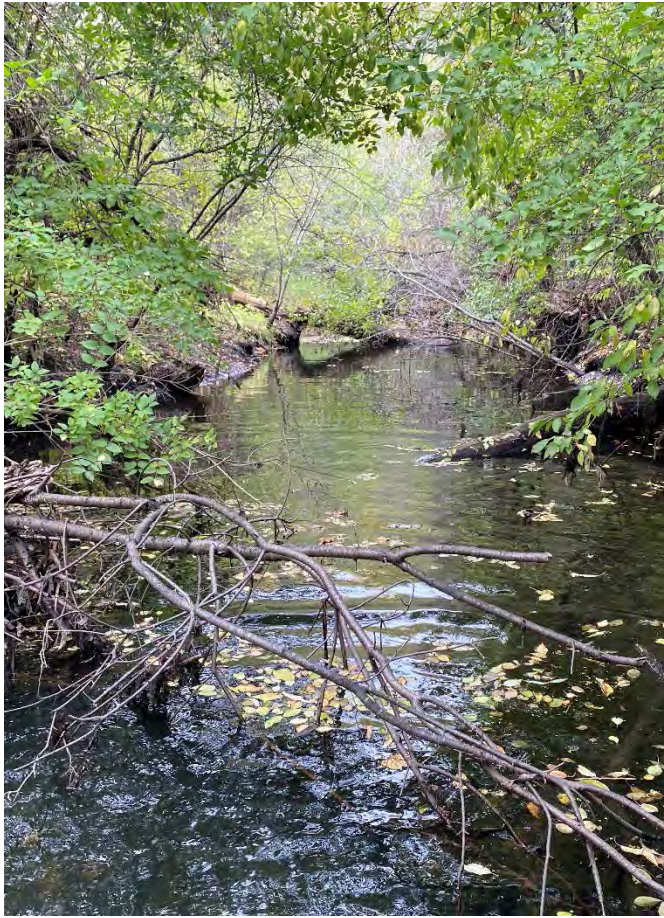
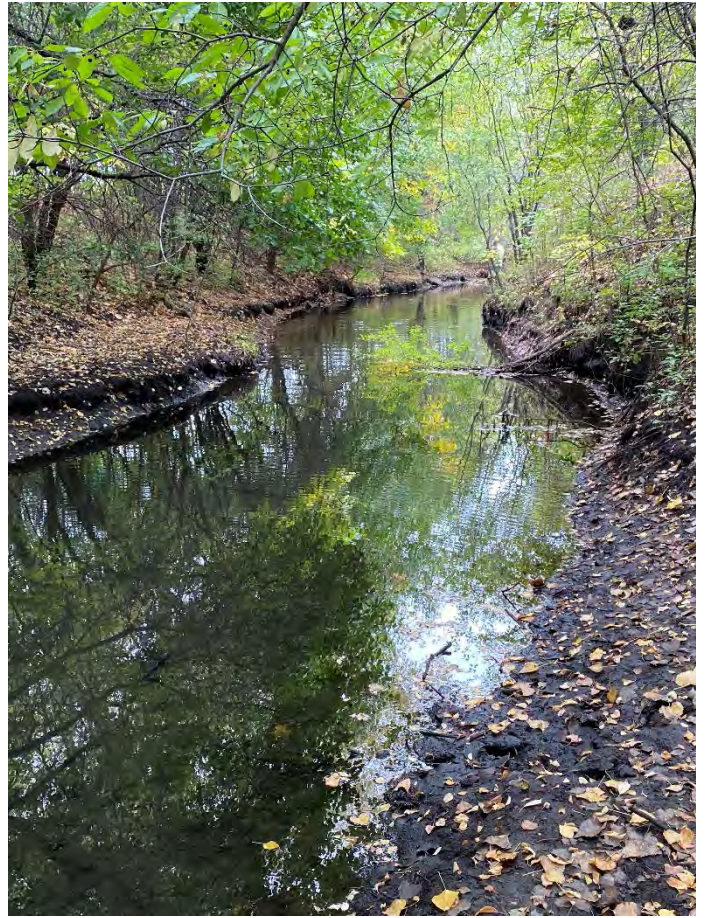
Reach 18 begins at the east edge of the wetland complex south of I-494 and extends downstream approximately 460 feet. The stream channel in this reach occurs in a highly altered and ditched corridor with a very narrow floodplain. The stream channel is wide and straight with substrates comprised of silt and sand. Riffle and pool features are diminished and affected by poor sediment transport and high composition of fine bed material. Stream type: F, Pfankuch Condition: Moderately Unstable.

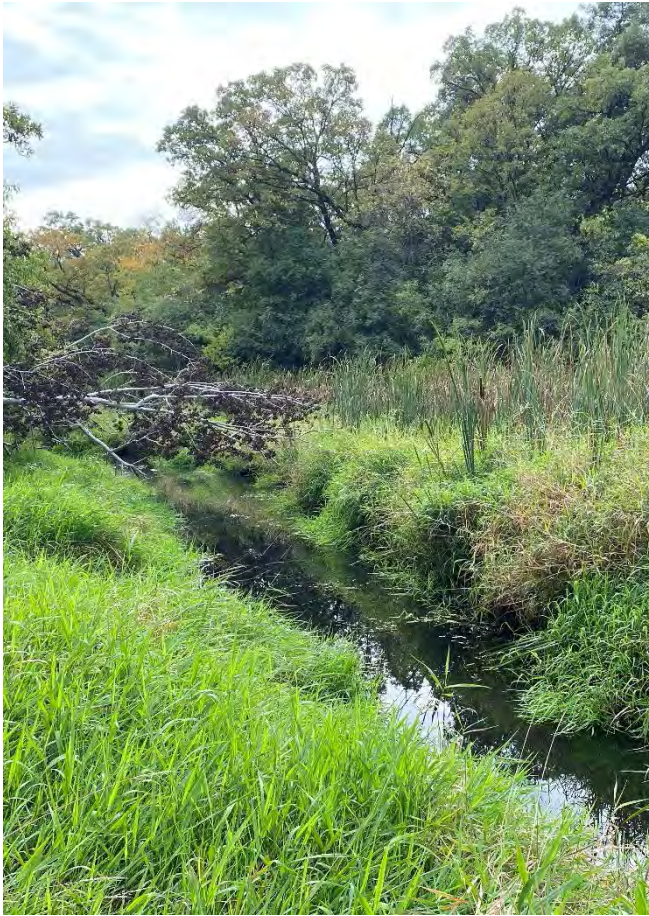
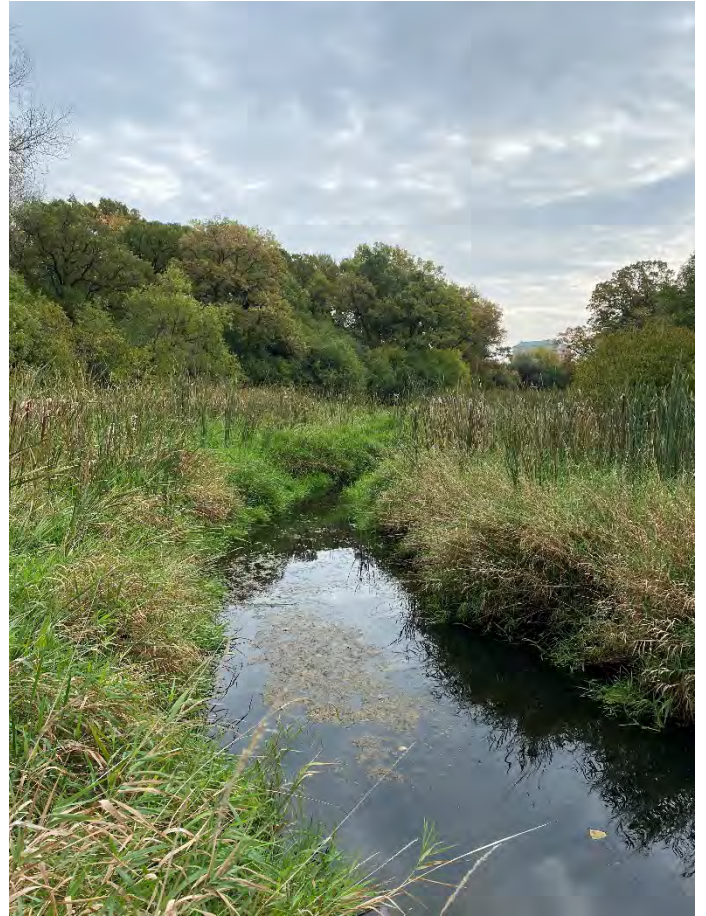
Reach 19 begins at the downstream terminus of Reach 18 and extends to East Bush Lake Road. The stream channel transitions into a wetland meadow dominated by reed canary grass and narrowleaf cattail. The stream channel is mostly connected to the floodplain and has limited bank erosion. Stream gradient in this reach is low with channel substrates comprised of silt and sand that support abundant macrophyte growth. Stream type: C, Pfankuch Condition: Fairly Stable.
