Lake Cornelia and Lake Edina Water Quality Study

*Use Attainability Analysis for Lake Cornelia (updated from 2010)
and Lake Edina (first version)*

Prepared for
Nine Mile Creek Watershed District

May 2019

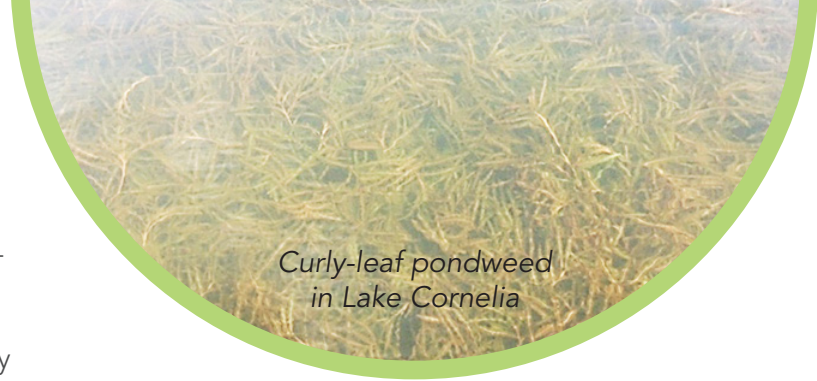
Curly-leaf pondweed in Lake Cornelia

Curly-leaf pondweed — The invasive (i.e., non-native) aquatic plant grows under the ice during the winter and gets an early start in the spring, often crowding out native species. It dies back in late-June and early-July, much earlier than native species. As the plants decay, phosphorus is released into the water column, fueling algal production and causing oxygen depletion.

Curly-leaf pondweed treatments in Lake Cornelia — Continued city-led spring herbicide treatments in Lake Cornelia are recommended to reduce the presence of curly-leaf pondweed and promote a healthy native aquatic plant population.

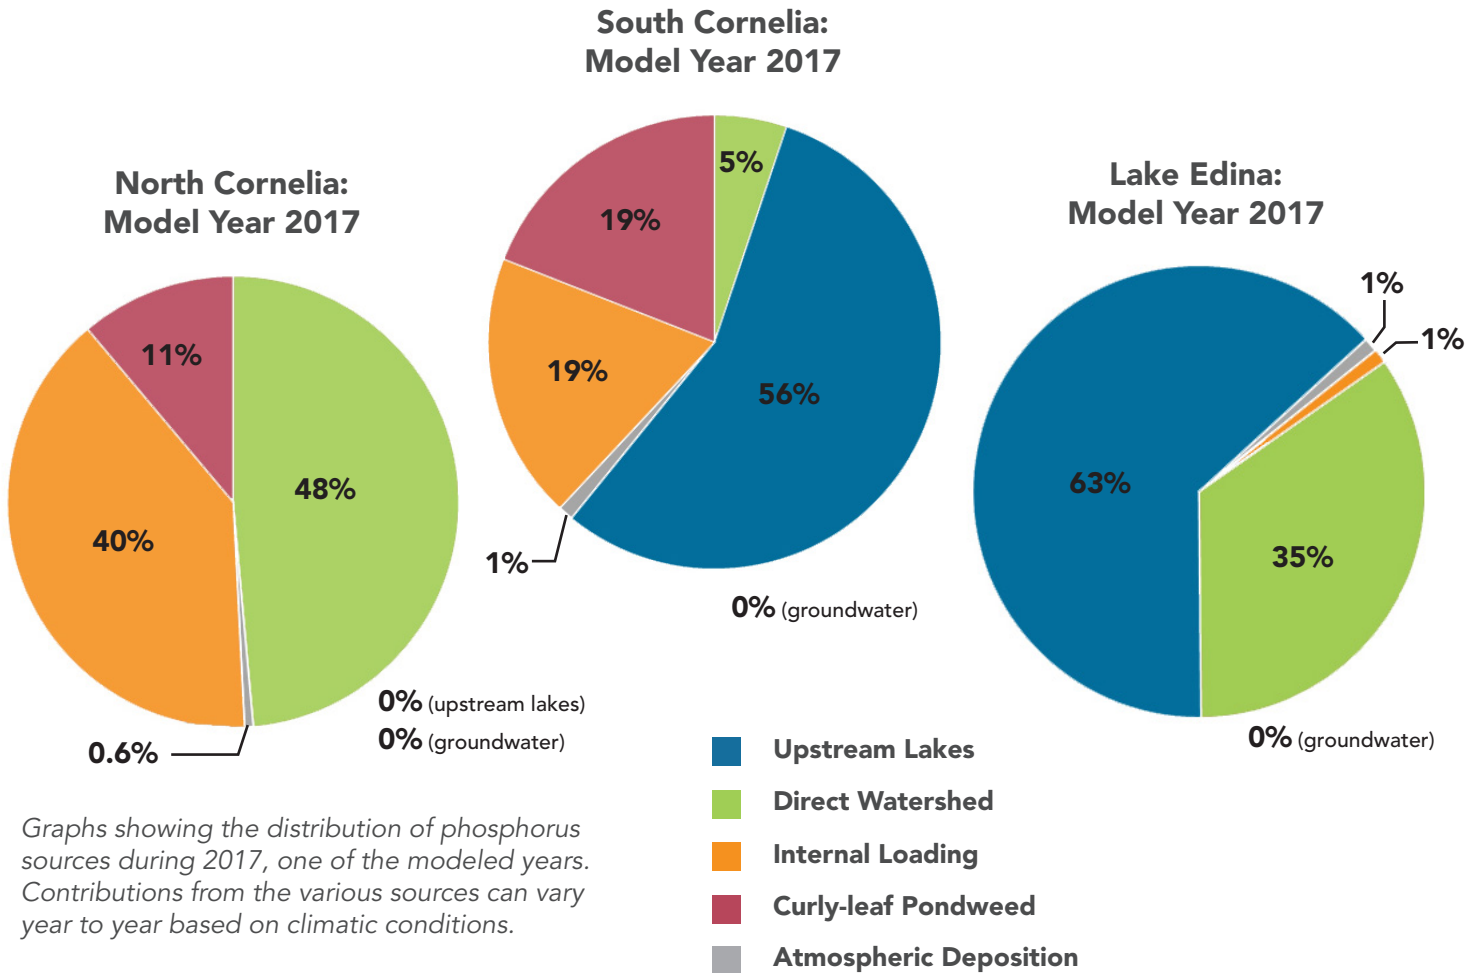
Graphs showing the distribution of phosphorus sources during 2017, one of the modeled years. Contributions from the various sources can vary year to year based on climatic conditions.

Water quality in Lake Edina is poor, with summer-average total phosphorus and chlorophyll a concentrations generally not meeting the state standard for shallow lakes. The poor water quality is primarily due to excess phosphorus in the lake, which fuels algal production and decreases water clarity. Phosphorus in Lake Edina comes from several primary sources, including stormwater runoff from the watershed (external sources) and flows from upstream Lake Cornelia (see pie charts below).

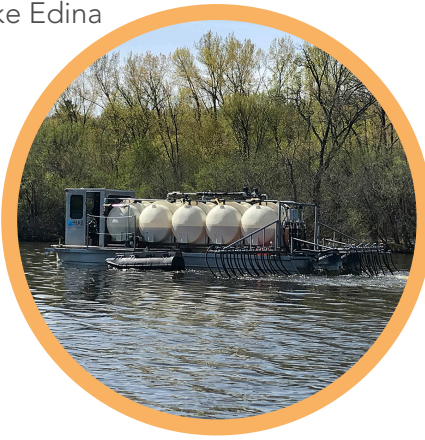
Alum treatment barge

Alum treatment in Lake Cornelia — A whole-lake alum treatment in North and South Lake Cornelia is recommended to bind (or immobilize) the phosphorus in lake bottom sediments and prevent release into the water column.

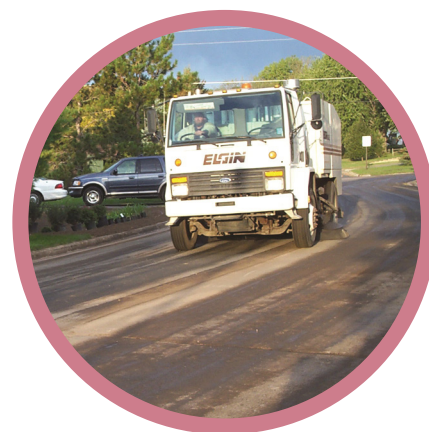
Street sweeping can help reduce the amount of pollutants that reach the lakes from stormwater runoff.

Another potential watershed management practice for consideration is an expanded **street sweeping program**. Study results show that a weekly street sweeping program can result in reliable and consistent reductions in phosphorus removal from stormwater runoff. However, this nonstructural BMP only showed moderate improvements in lake water quality, similar to other watershed management practices. An expanded street sweeping program to target residential streets or streets and/or commercial parking lots not already treated by BMPs could be considered further.

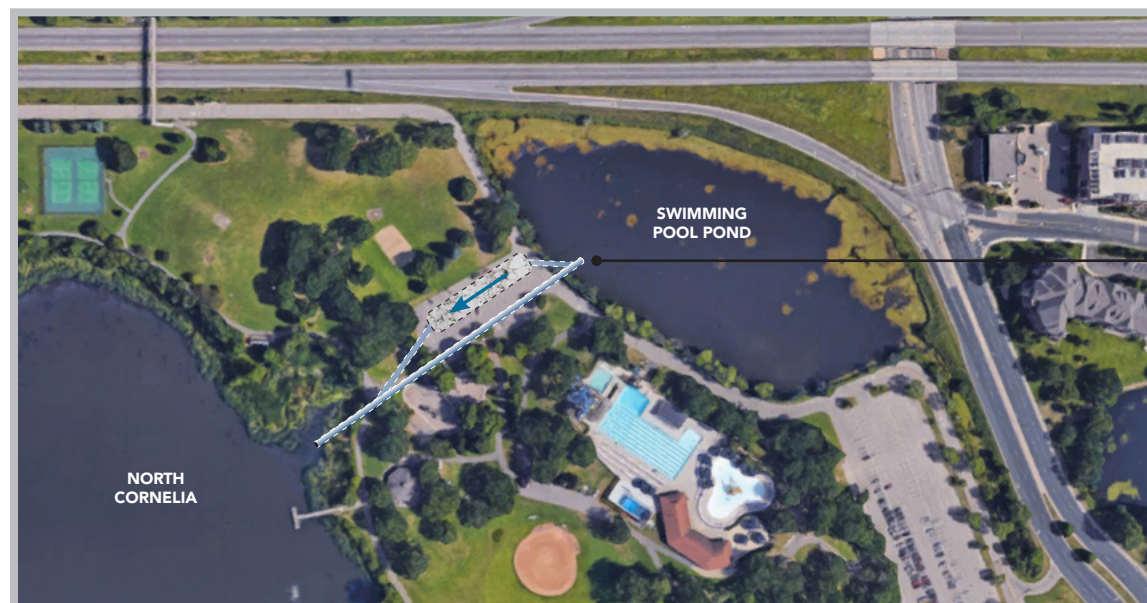
Water moves through the spent lime filtration chamber to remove phosphorus before discharge to Lake Cornelia.

Study results indicate that the greatest source of phosphorus to Lake Cornelia and Lake Edina is stormwater runoff. Because the watersheds are fully-developed, significantly reducing the phosphorus inputs from watershed runoff is logistically challenging and expensive. One BMP that is recommended is installation of a **spent lime/CC17 treatment chamber** under the parking lot in Rosland Park (see image at right). The innovative spent lime/CC17 treatment chamber would serve as a "polishing" step, diverting a portion of the discharge from Swimming Pool Pond through the

spent lime filtration chamber to remove dissolved phosphorus before discharge to Lake Cornelia. Figure 2 shows the predicted improvements in summer-average phosphorus concentrations in all three lakes as a result of the spent lime/CC17 treatment chamber, in combination with the alum and curly-leaf pondweed treatments. While the incremental improvement resulting from the watershed BMP is not significant, reducing the external phosphorus loading will also increase the longevity of the alum treatment (and therefore the frequency of repeat treatments) and reduce future build-up of phosphorus in lake bottom sediments.
