Anderson Lakes Protection Strategy

Northwest Anderson, Southwest Anderson, & Southeast Anderson Lakes

Prepared for
Nine Mile Creek Watershed District

Prepared by
Barr Engineering Co.

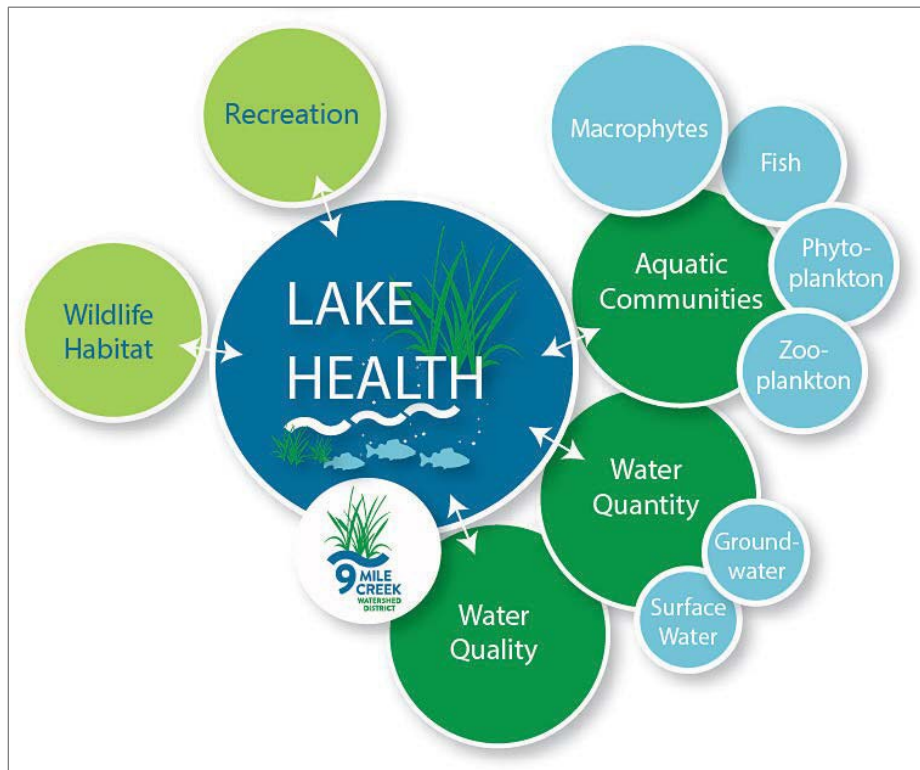
Figure 3-1 NMCWD holistic lake health assessment factors (NMCWD, 2017, amended 2023)

The NMCWD’s approach to evaluating, improving, and protecting lake health includes numerous health assessment factors, as illustrated in Figure 3-1. The primary factors identified as affecting lake ecological health include chemical water quality (e.g., nutrient concentrations), aquatic communities (e.g., plants, fish, algae, and zooplankton), and water quantity (groundwater and surface water). The effects of recreation and wildlife habitat on overall lake health are also considered.

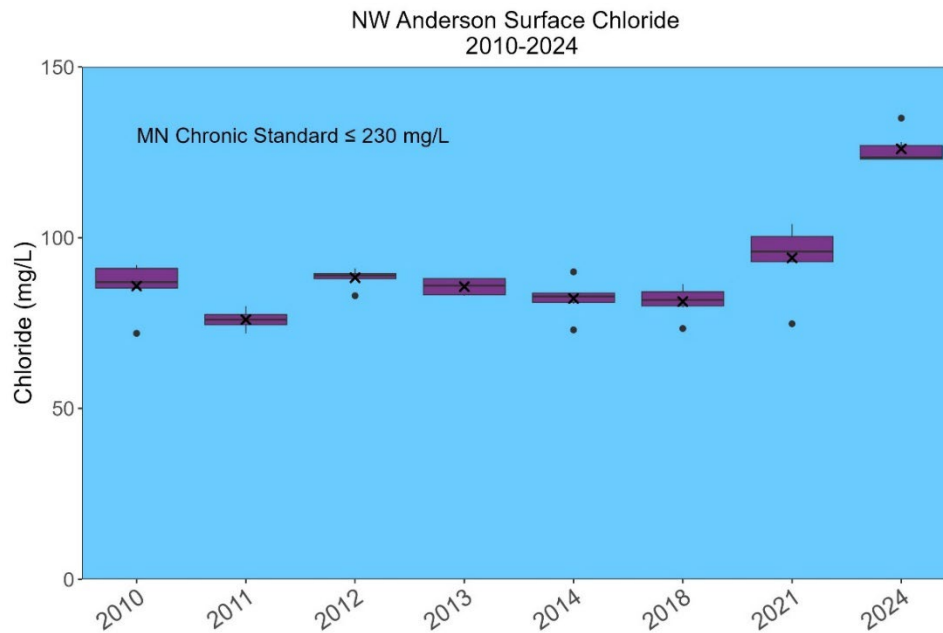
Figure 5-4 Surface chloride concentrations in Northwest Anderson Lake

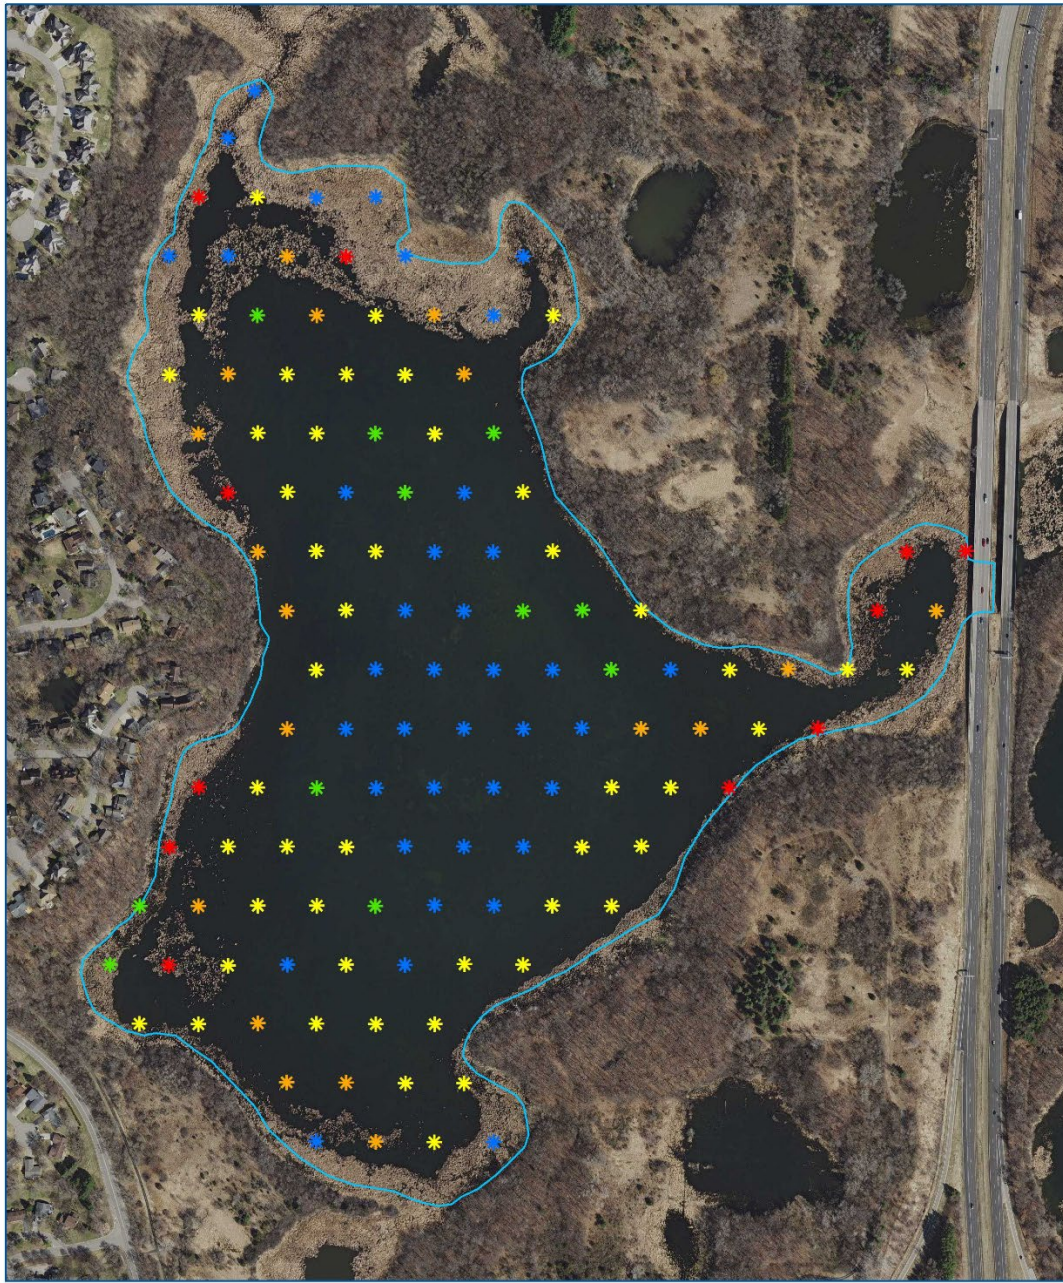
- # of Native Species**
- × None Found
 - ★ 1
 - ★ 2
 - ★ 3 - 4
 - ★ 5 - 6
 - ★ 7

The plant species and their percent occurrence during the most recent PI surveys (June and August 2024) are summarized in Table 5-1. Figure 5-13 through Figure 5-15 show the number of native species found at each survey point during the August 2024 survey. Below are noteworthy observations on the native plant species for each lake:

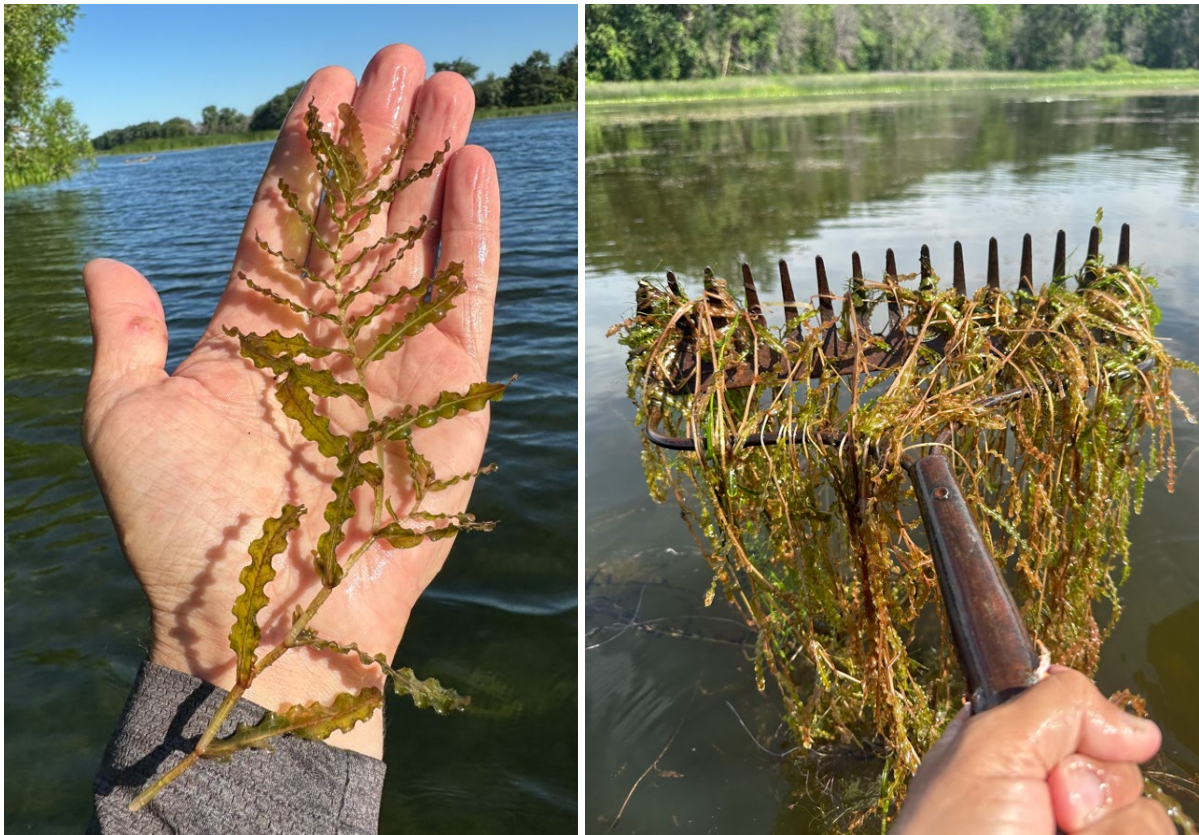
Figure 5-16 While curly-leaf pondweed was found in Northwest Anderson (left photo) and Southwest Anderson Lakes in 2024, it was found at only a few locations and low densities. Curly-leaf pondweed was widespread throughout Southeast Anderson Lake in 2024. The right photo shows a dense curly-leaf pondweed rake that was observed at one of the sample locations.

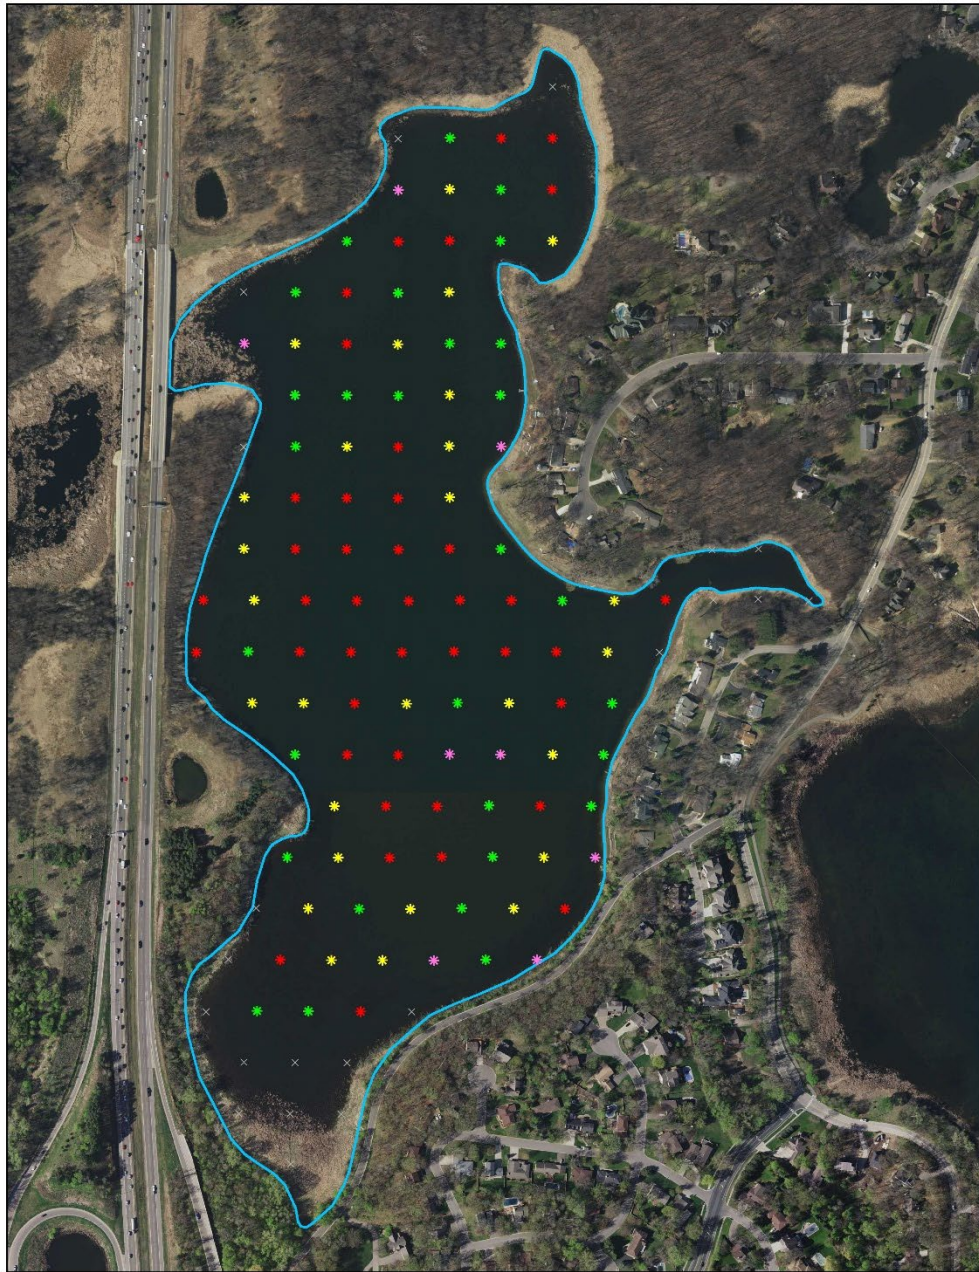
Figure 5-17 Abundance of Eurasian watermilfoil observed during the June 2024 point-intercept survey in Southeast Anderson

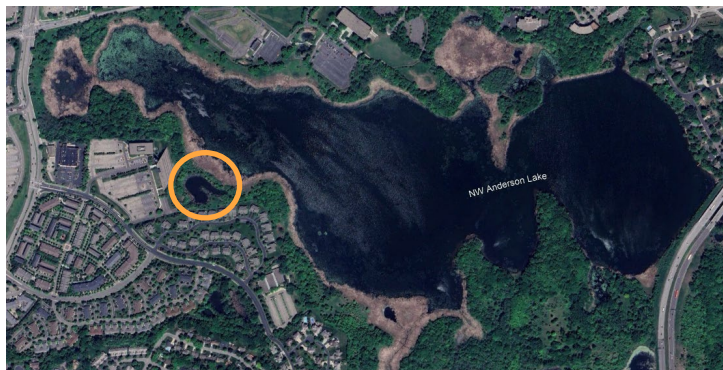
Figure 6-1 Stormwater pond NW-AL-12 west of Northwest Anderson Lake

Watershed Area (acres)	Impervious Area (acres)	NURP Permanent Pool Volume (ac-ft ¹)	Existing Permanent Pool Volume (ac-ft ¹)	Retrofitted Permanent Pool Volume (ac-ft ¹)	Downstream Waterbody
67.8	43.4	11.7	3.09	3.94	Northwest Anderson

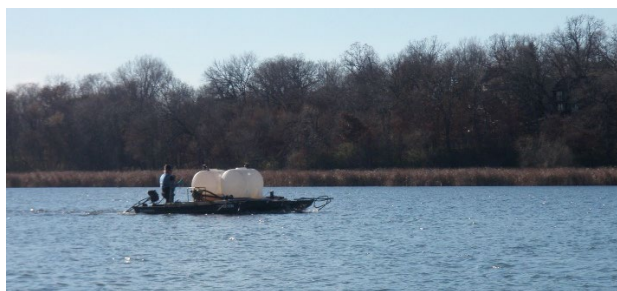
Figure 6-5 Alum sediment treatment on Southwest Anderson in fall 2012

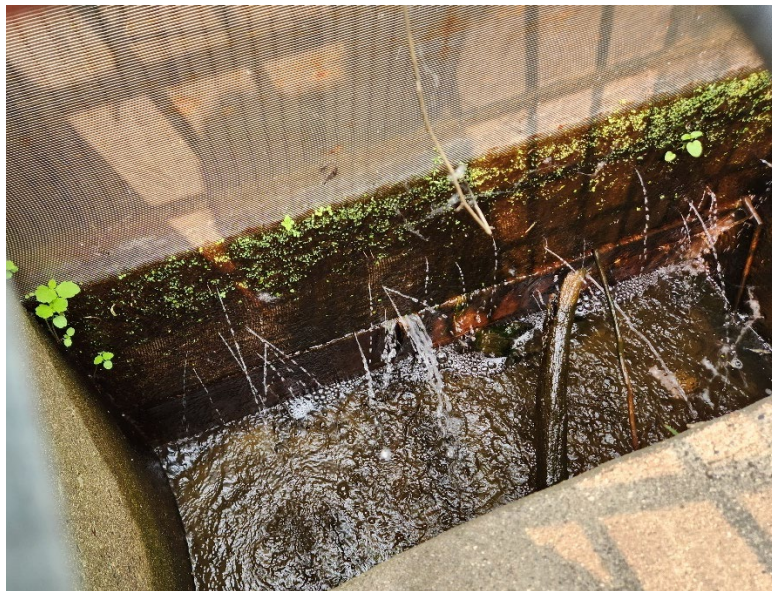
Given the small, slotted openings of the macrophyte screen, the screen plugs rapidly and regularly, significantly restricting flow from Southwest Anderson to Southeast Anderson under typical storm events (Figure 8-8). Additionally, since the control structure was installed, U.S. Highway 169 has been re-constructed, creating more difficult access conditions for maintenance of the structure. As such, regular macrophyte screen cleaning and maintenance has been a challenge for the City of Bloomington, resulting in prolonged screen-plugging conditions.

Figure 8-8 Photo of plugged Southeast Anderson macrophyte screen on top of stop logs (May 2025)

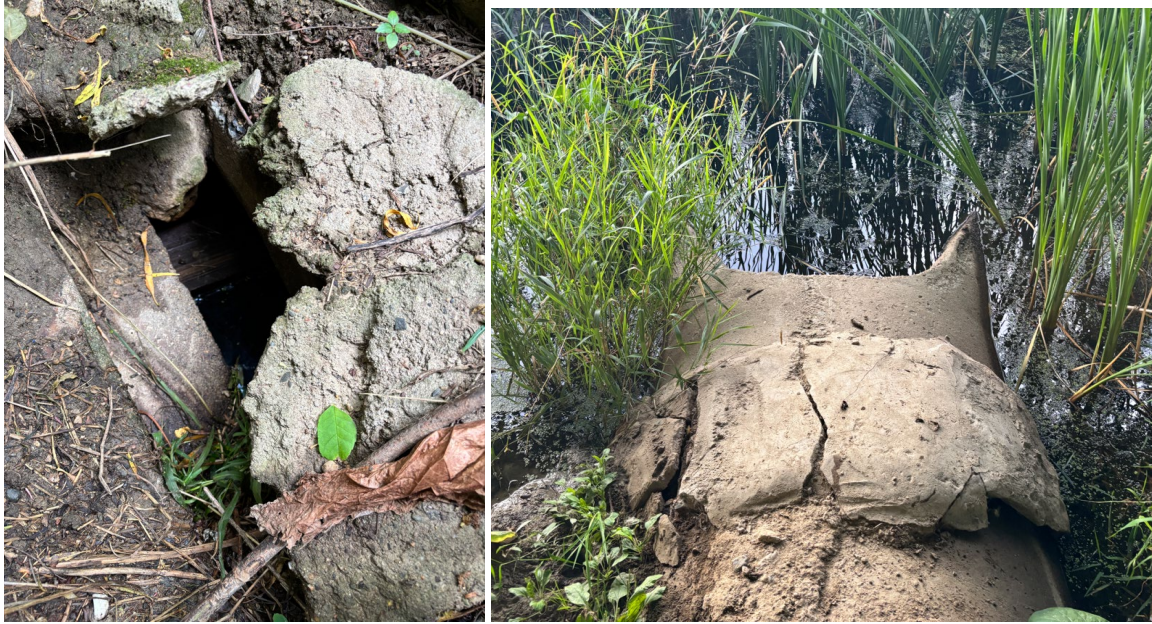
Figure 8-9 Degrading Southeast Anderson storm sewer infrastructure (September 2025)

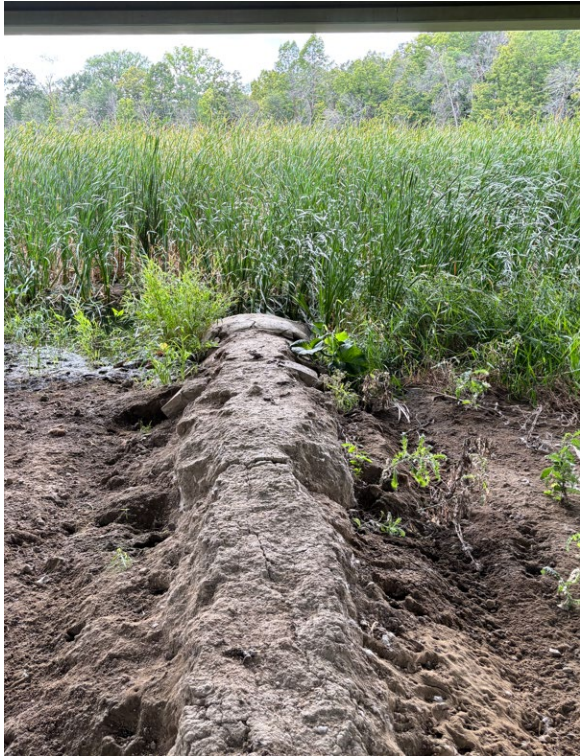
Figure 8-10 Settling and/or soil erosion around Southeast Anderson culvert (September 2025)

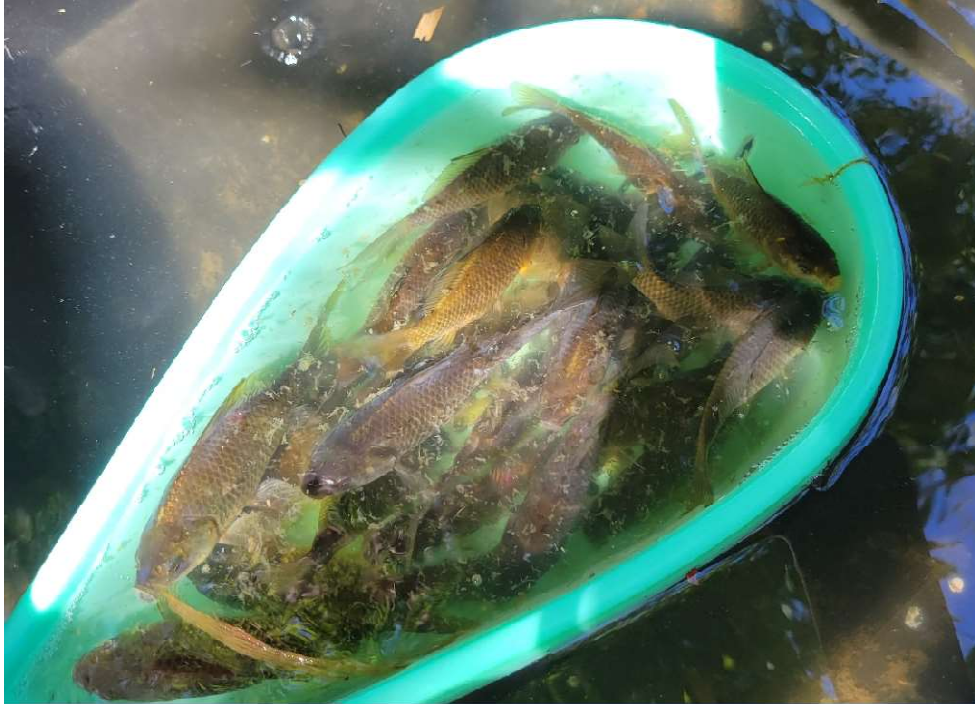
Figure 2. Goldfish sampled in Adelman Pond, September 4, 2024.

In total, 136 carp and goldfish were tagged with uniquely numbered PIT tags on September 4, 2024. Of these 108 were goldfish, 27 were carp, and 1 was a hybrid carp/goldfish. All goldfish, carp, and hybrid carp/goldfish were checked for tags in the October 18th survey and none were recaptured. A record of PIT tagged fish collected in this survey period is included in Appendix A.

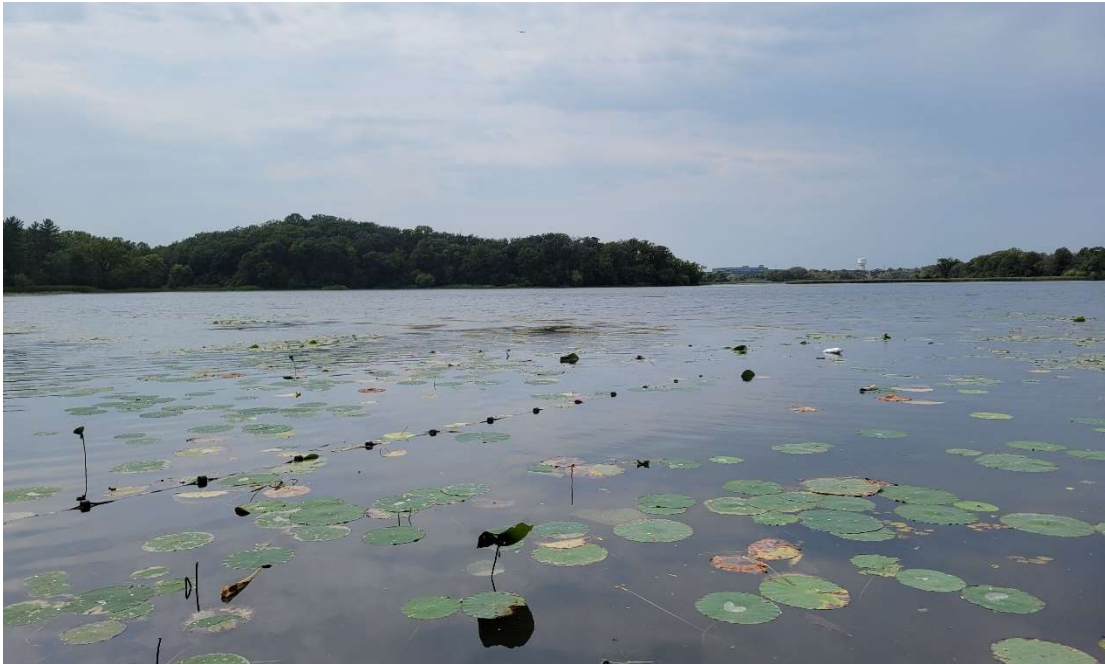
Figure 8. Trap net set in North Anderson Lake.

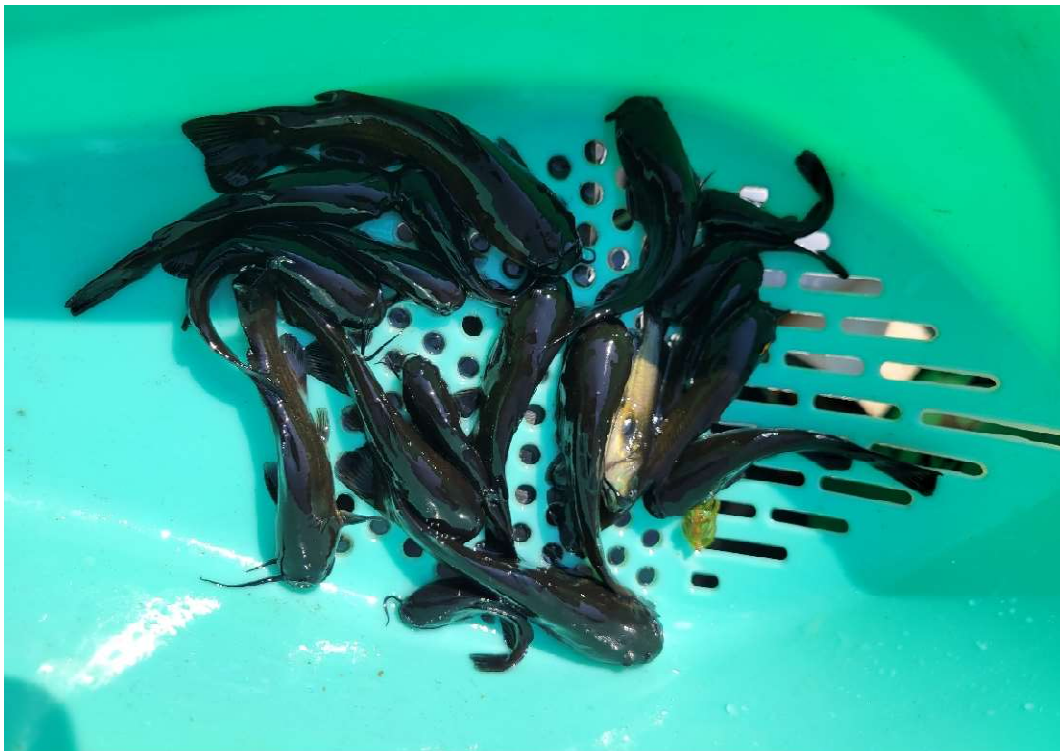
Figure 9. Bullheads captured in Southeast Anderson Lake 2024 survey.
