## Nine Mile Creek Watershed District 2016 Annual Water Quality Monitoring Report

# Summary of 2016 Water Quality Monitoring Programs

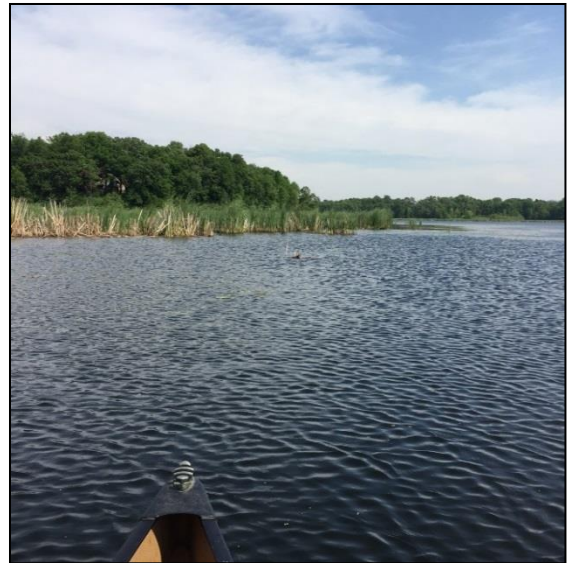
**Figure 1** The District completed a water quality improvement project of Southwest Anderson Lake, pictured above, during 2008 through 2012 that substantially improved its water quality.

Southwest Anderson Lake during 2008 through 2012 to reduce phosphorus loading to the lake from internal sources. A partial lake drawdown in 2008 followed by herbicide treatments in the lake's center during the spring of 2010 and 2011 reduced internal phosphorus loading from curly-leaf pondweed. An alum treatment in the fall of 2012 further reduced internal phosphorus loading from lake sediment. The lake's water quality was substantially improved by the project (Figure 1 and Figure 3).

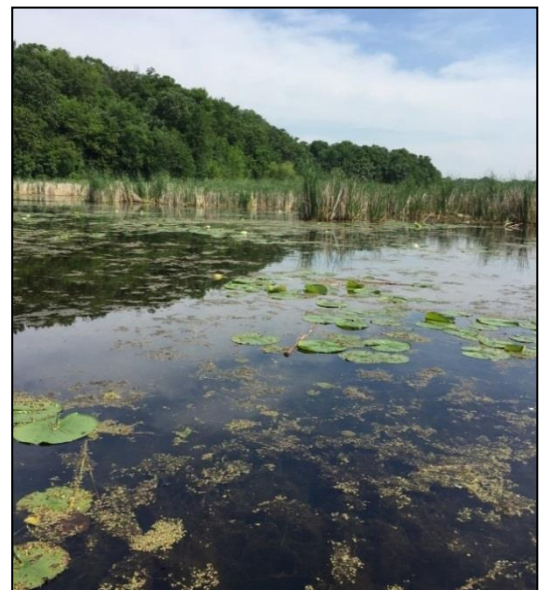
**Figure 2** The plant community of Southwest Anderson Lake, pictured above, has improved since the onset of the water quality improvement project.

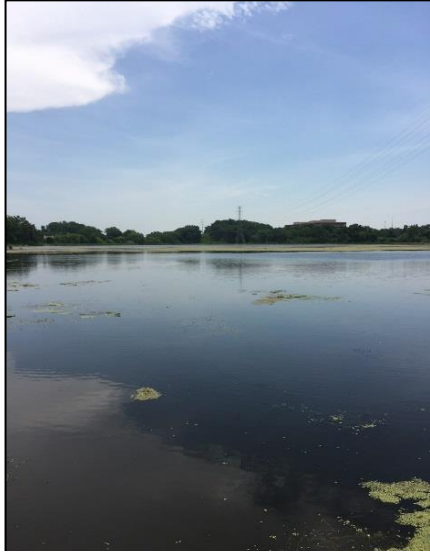
**Figure 7** In 2016, Smetana Lake, pictured above, had good water quality.

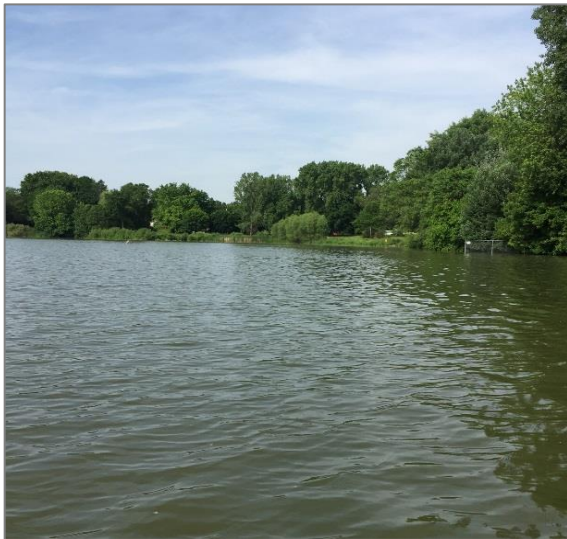
**Figure 10** In 2016, blue-green algae numbers in Penn Lake, pictured above, were within the low-risk of adverse health effects category.

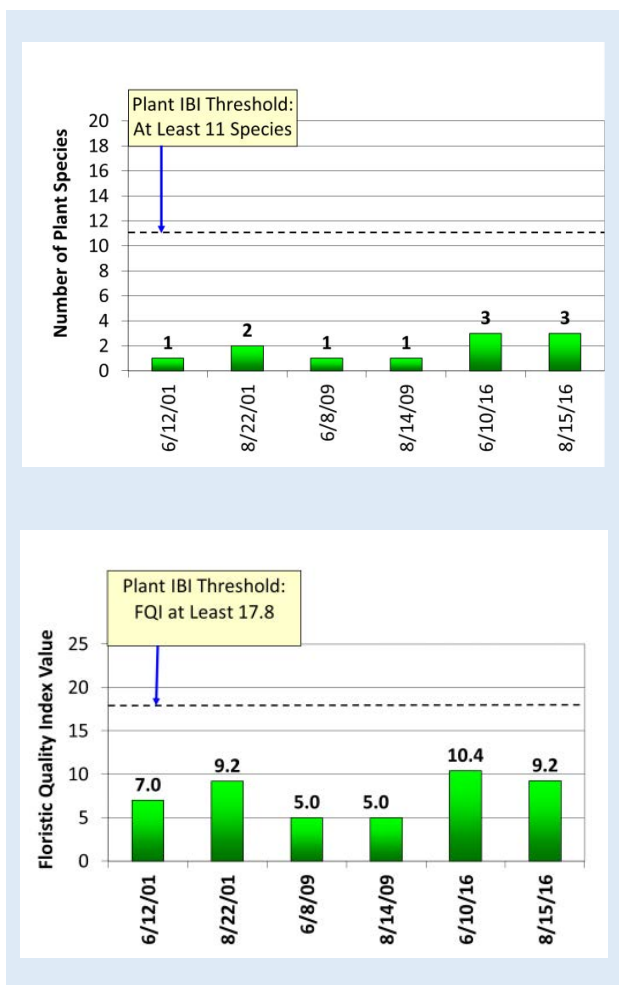
**Figure 11 2001-2016 Penn Lake Plant Index of Biotic Integrity (IBI) Threshold Values compared with MDNR Plant IBI Threshold Goals: Number of Plant Species (top) and Floristic Quality Index (FQI) Values (bottom).**

impairment thresholds for the entire period of record, Penn Lake would be considered impaired for plants. As mentioned previously, the plant IBI has not yet been used by the MPCA/MDNR to determine impairment. However, it is expected to eventually be used to determine biological impairment. There were no invasive species known to be present in Penn Lake during 2016.

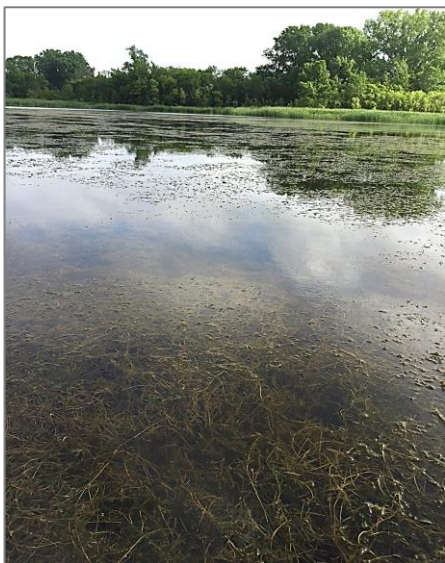
**Figure 13** Dense curly-leaf pondweed in North Lake Cornelia, pictured above, in June of 2016.

The lake's 2016 water quality was heavily influenced by the lake's severe curly-leaf pondweed infestation. The June plant survey documented dense curly-leaf pondweed growth throughout the entire lake (Figure 13). The 2016 curly-leaf pondweed growth was much denser than in 2015. The dense curly-leaf pondweed growth in June

Curly-leaf pondweed naturally dies at the end of June and then decays, adding a pulse of phosphorus to the lake. When the lake's 2016 dense growth of curly-leaf pondweed (Figure 13) senesced, the lake's phosphorus concentrations rapidly increased, fueling a severe algal bloom. As shown on Figure 14, high numbers of blue-green algae were present during the lake's early August algal bloom. A similar scenario occurred in 2015. The 2016 curly-leaf pondweed infestation was more severe than 2015 and the resultant blue-green algae bloom was more severe in 2016 than 2015 (Figure 14).

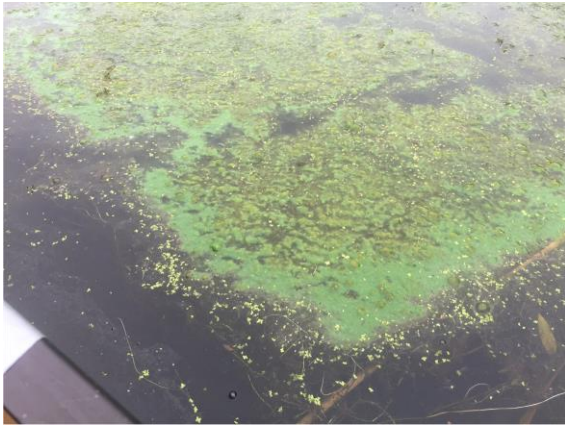
**Figure 16** On September 7, 2016, near shore algal scum was observed in North Lake Cornelia, pictured above. Algal toxin samples were collected from the algal scum.

toxins could still be present in the lake and pose health risks for lake users. Hence, the District collected algal toxin samples from the lake on September 7. Blue-green numbers at the mid-lake sample location were relatively low on September 7 (Figure 14), but near shore algal scum was observed (Figure 15). Algal toxin samples were collected from the mid-lake sample location and from the near shore algal scum.

WHO guidelines indicate users of North Lake Cornelia in early August of 2016 had a moderate risk of adverse health effects from exposure to the blue-greens in the lake (Figure 14). The City of Edina performed a chemical treatment of the lake with algaecide on August 8 to manage the lake's algal bloom. Although the numbers of blue-green algae were reduced by the treatment, the District and City were concerned that algal

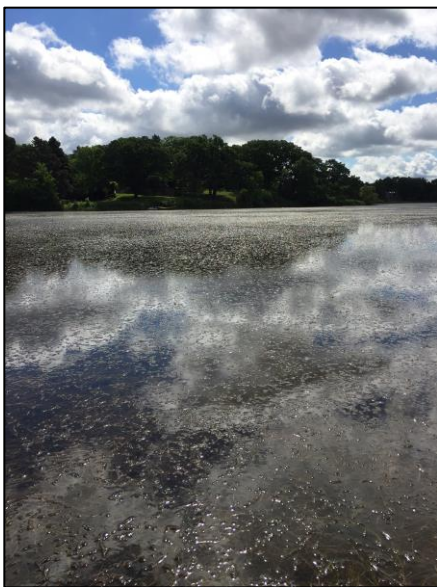
In 2016, South Lake Cornelia water quality, like North Lake Cornelia water quality, was heavily influenced by the lake's severe curly-leaf pondweed infestation. The June plant survey documented dense curly-leaf pondweed growth throughout the entire lake (Figure 19). As with

**Figure 19** Dense curly-leaf pondweed in South Lake Cornelia in June of 2016.

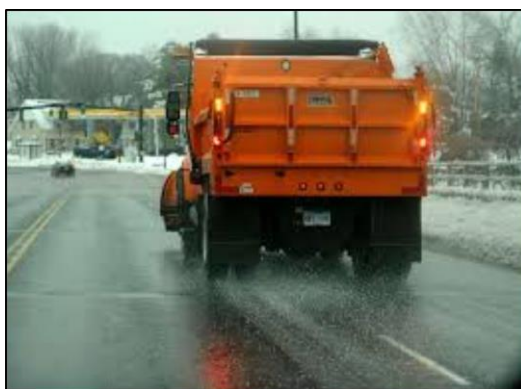
**Figure 23** Chloride present in deicing chemicals applied to streets in the South Lake Cornelia watershed is conveyed to the lake by snowmelt and rainfall runoff.

Chloride present in deicing chemicals applied to streets in the South Lake Cornelia watershed (Figure 23) is conveyed to the lake by snowmelt and rainfall runoff. In 2016, chloride concentrations in South Lake Cornelia ranged from a high of 194 mg/L in June to a low of 82 mg/L in September. All 2016 chloride concentrations met the MPCA chronic exposure standard of 230 mg/L.

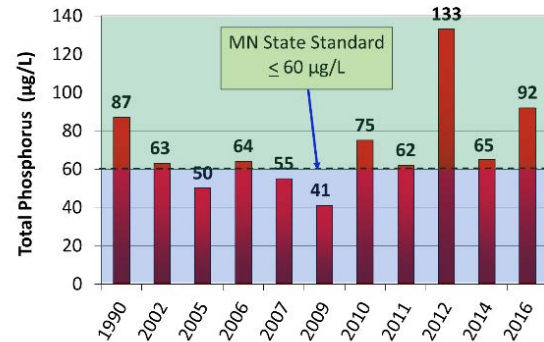
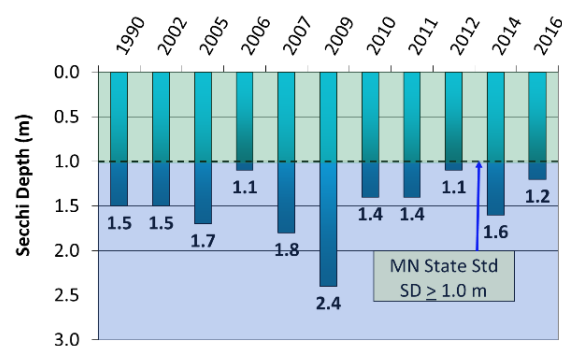
**Figure 25** Normandale Lake summer average total phosphorus, chlorophyll *a*, and Secchi disc values during 2003-2016.

In 2016, as in previous years, chlorophyll *a* concentration and Secchi disc transparency both met the Minnesota State water quality standard for shallow lakes in the North Central Hardwood Forest Ecoregion, but total phosphorus concentration did not meet the State Standard. The lake's summer average total phosphorus concentration was 92 µg/L, which failed to meet the Minnesota State Standard of 60 µg/L or less. The lake's summer average chlorophyll *a* concentration was 17 µg/L, which met the Minnesota State Standard of 20 µg/L or less. The lake's summer average Secchi disc depth was 1.2 meters which met the Minnesota State Standard of at least 1.0 meter (Figure 25).

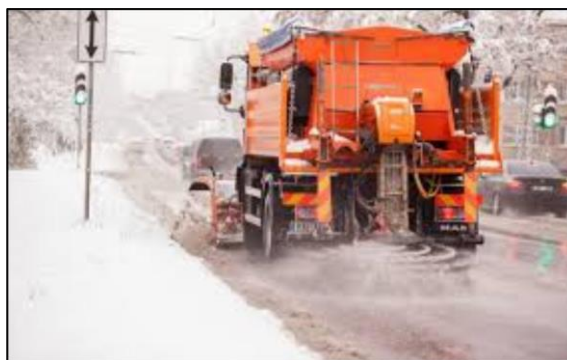
**Figure 26** Chloride from deicing chemicals applied to streets in the Normandale Lake watershed was conveyed to the lake, resulting in a high chloride concentration in April of 2016 that failed to meet the MPCA chronic exposure standard. All other 2016 concentrations met the MPCA standard.

(Figure 26) is conveyed to the lake by snowmelt and rainfall runoff. As expected, the highest

2016 chloride concentration in Normandale Lake was observed in April. Chloride concentrations consistently declined from April to September when the lowest concentration of 55 mg/L was observed. The April concentration of 235 mg/L failed to meet the MPCA chronic exposure standard of 230 mg/L, but all other 2016 concentrations met the MPCA standard.

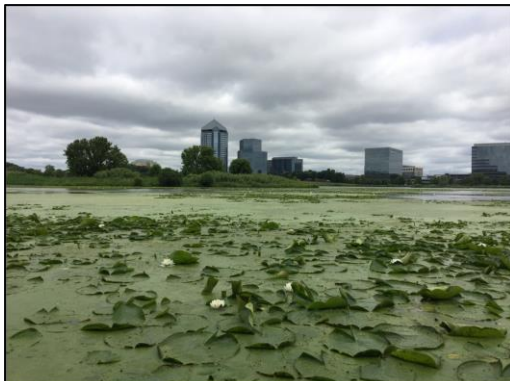
In 2016, a reduction in vegetation occurred in Normandale Lake between June and August. A statistical comparison of June and August vegetation data documented a statistically significant decline in frequency for filamentous algae, large duckweed (*Spirodela polyrhiza*), common waterweed (*Elodea canadensis*), and curly-leaf pondweed (*Potamogeton crispus*). The decline in curly-leaf pondweed was due to natural die-off. A statistical comparison of June and August plant density documented a statistically significant decline in coontail (*Ceratophyllum demersum*) density. The reduction in Normandale Lake vegetation between June and August is pictured on Figure 27 and Figure 28.

**Figure 28** June plant growth in Normandale Lake, picture above, was dense.

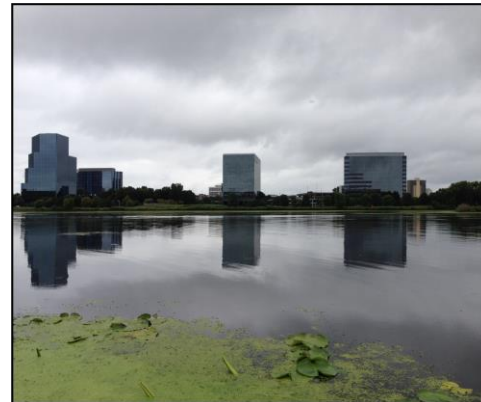
**Figure 27** August vegetation in Normandale Lake, pictured above, was reduced from June.

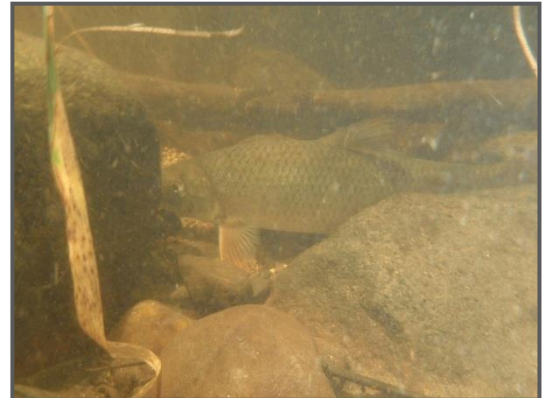
**Figure 30** The primary use of Nine Mile Creek is a place for fish and aquatic life to live, such as the shorthead redhorse fish swimming in the Main Stem of Nine Mile Creek at Station ECU-7C, pictured above

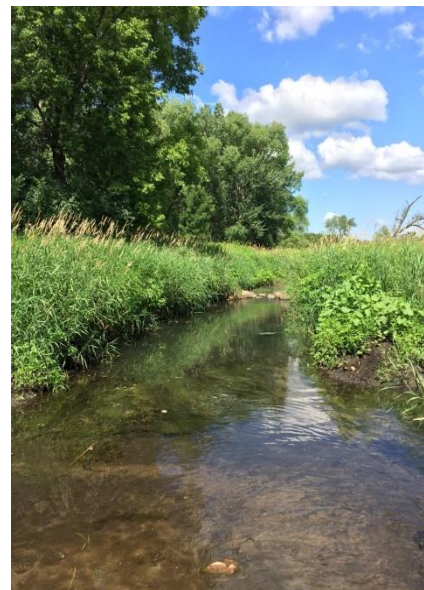
**Figure 32** In 2016, a tolerant forage fish assemblage, an indicator of average to poor water quality, was observed at the most upstream North Fork location, ECU-1A/1A-1, pictured above.

Ecological use is a term used to describe the fish assemblage/aquatic life use that the stream has the capacity to support per the stream's flow, water quality, and habitat characteristics. The 2016 fish data indicate Nine Mile Creek is currently supporting the ecological use determined from assessments completed during 1997 and 2003. In 2016, a tolerant forage fish assemblage (e.g., creek chub—an indicator of average to poorer water quality) was found at the majority of sample locations—ECU-1A/1A-1 (Figure 32) and ECU-2 on the North Fork, ECU-3A and ECU-5A on the South Fork, and

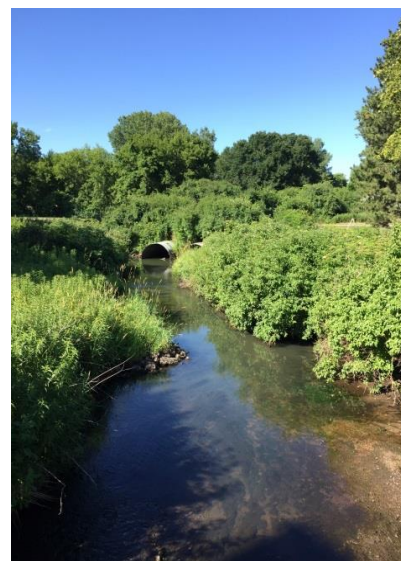
**Figure 33** In 2016, an intolerant forage fish assemblage, an indicator of better water quality, was observed at the most downstream North Fork location, ECU-2A, pictured above

the most upstream Main Stem location, ECU-7A/N1 (Figure 35). An intolerant forage fish assemblage (e.g., western blacknose dace – an indicator of better water quality) was found at the most downstream North Fork location, ECU-2A (Figure 33), and the middle Main Stem location, ECU-7B. A warm water sport fish assemblage (e.g., green sunfish, largemouth bass) was found at the most downstream Main Stem location, ECU-7C (Figure 34).

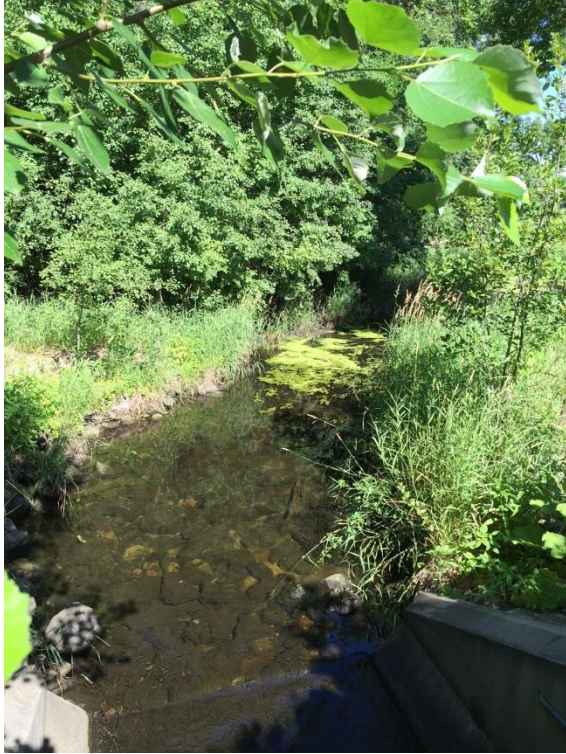
**Figure 36** During 2003 through 2016, the most downstream South Fork location, ECU-5A, pictured above, met the Fish IBI standard 29 percent of the time.

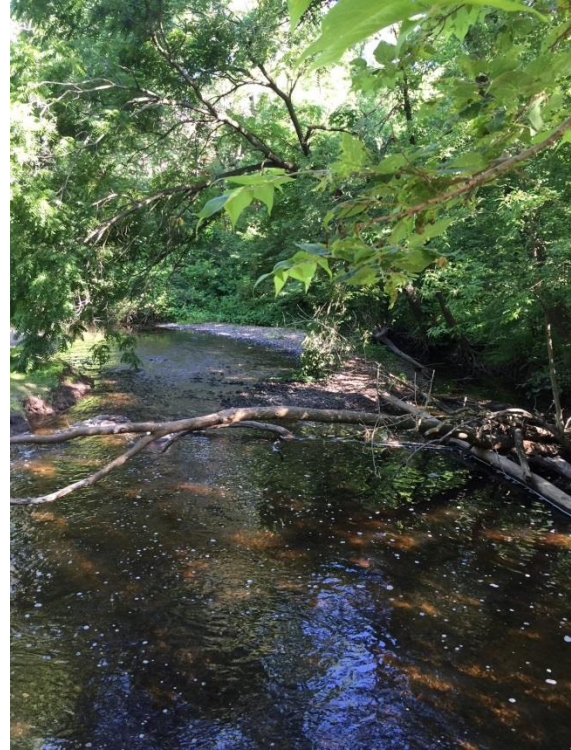
A comparison of 2016 data with historical data indicates the current fish assemblage is generally similar to or better than the stream's average long-term fish assemblage. Main Stem monitoring locations ECU-7B (Figure 37) and ECU-7C (Figure 34) observed a higher quality fish assemblage in 2016 than had, on average, been observed at these locations historically. A tolerant forage fish community has historically been observed at ECU-7B compared to an intolerant forage fish community observed in 2016. An intolerant forage fish community has historically been observed at ECU-7C compared to a warm water sport fish community observed in 2016.

**Figure 37** During 2003 through 2016, the middle Main Stem location, ECU-7B, pictured above, met the Fish IBI standard 50 percent of the time.

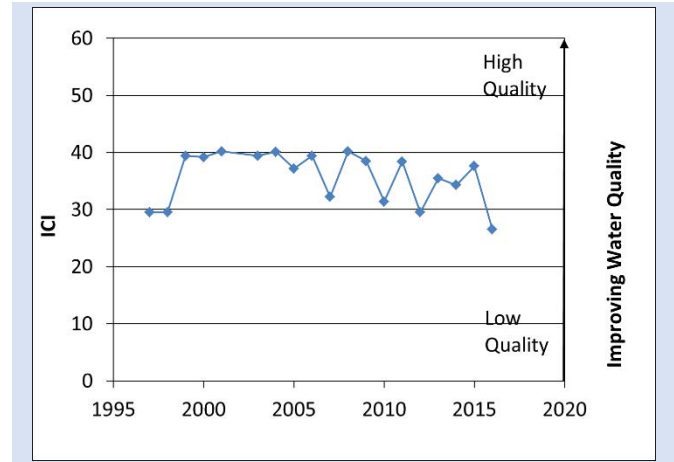
**Figure 42** 1997-2016 Nine Mile Creek ICI: Main Stem Station ECU-7A/N1

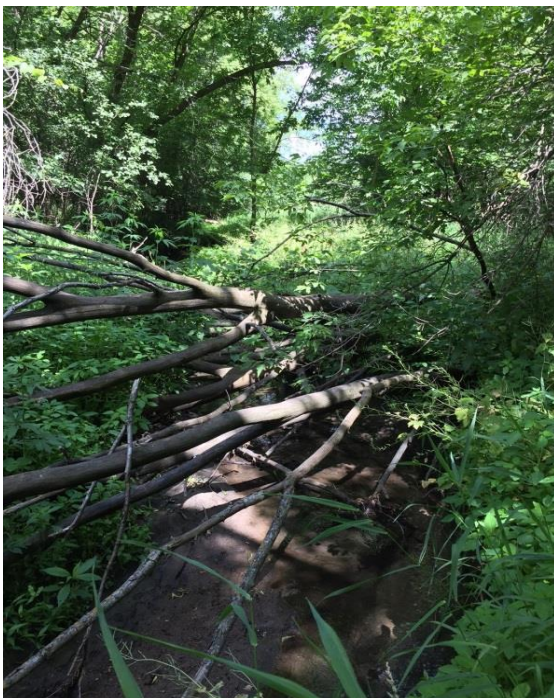
**Figure 43** In 2016, ECU-3A, pictured above, continued a trend toward improving HBI values and fish IBI scores. The ICI score also

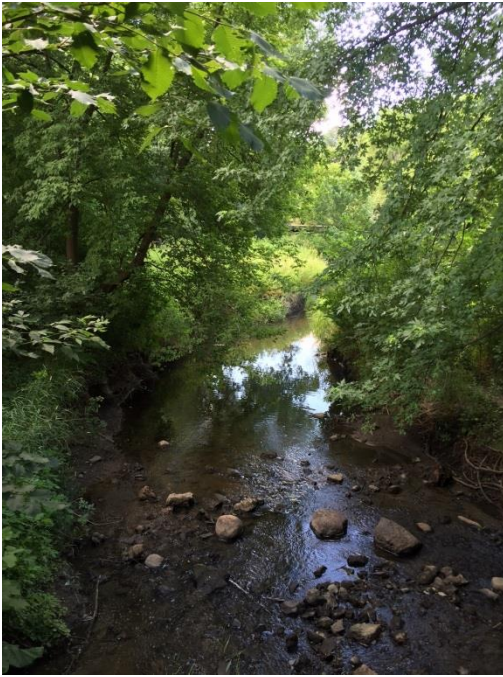
**Figure 45** In 2016, North Fork location ECU-2, pictured above, and ECU-2A continued a trend toward improving water quality and oxygen conditions.
