Nine Mile Creek Watershed District Summary of 2018 Water Quality Monitoring Program

Prepared for
Nine Mile Creek Watershed District

April 2019

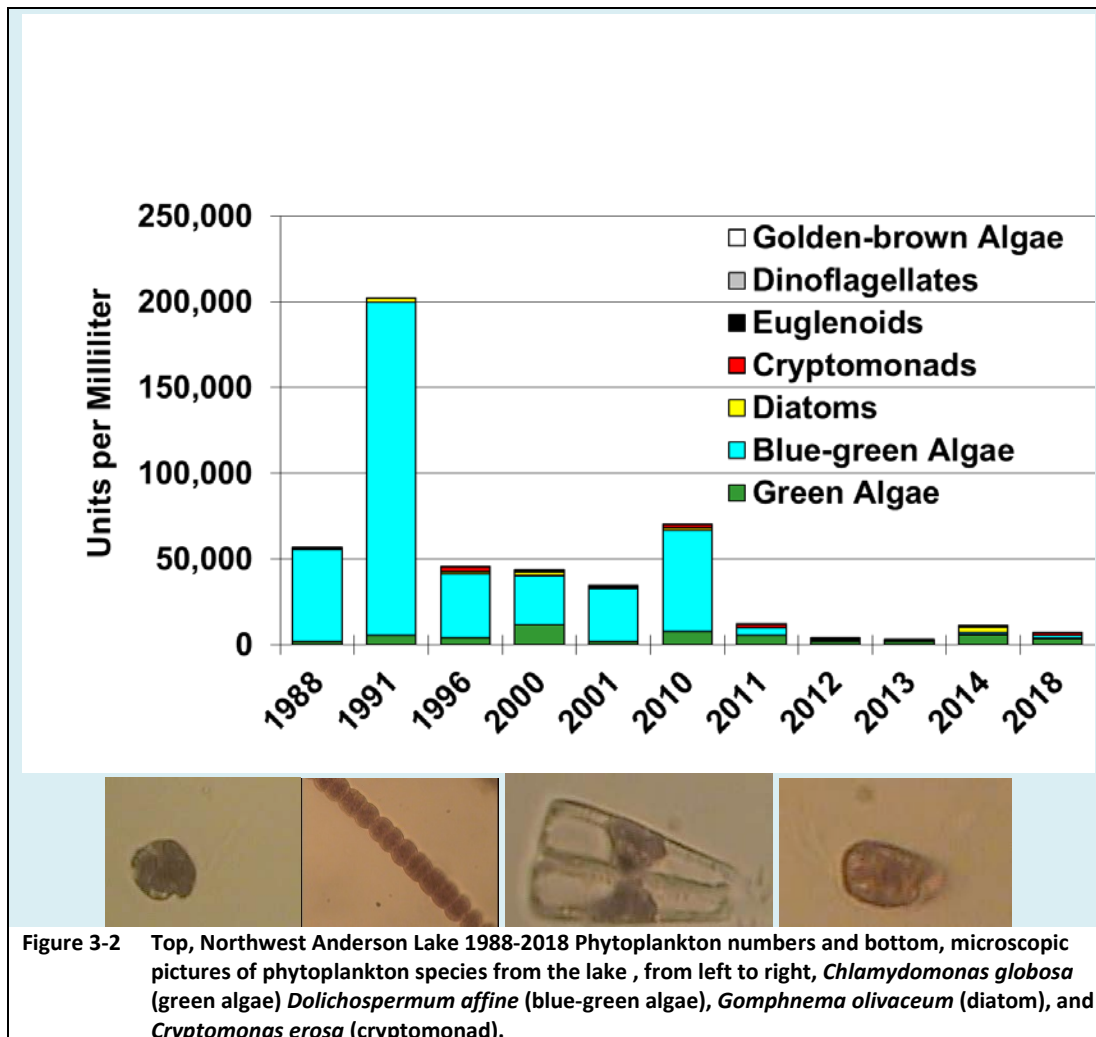
Phytoplankton numbers during the monitored period 1988 through 2018 followed a pattern similar to chlorophyll, both reflecting the substantial improvement in water quality resulting from the Northwest Anderson Lake water quality improvement project. For the period prior to the start of the lake's water quality improvement projects (1988-2007), the average summer phytoplankton number was 76,363 per milliliter (Figure 3-2) and the average summer chlorophyll concentration was 53 µg/L (Figure 3-1). For the period after the completion of the water quality improvement project (2014-2018), the average summer phytoplankton number was 9,011 per milliliter (Figure 3-2) and the average summer chlorophyll concentration was 7 µg/L (Figure 3-1). Blue-green algae numbers were much lower after the completion of the water quality improvement projects – pre-project average blue-green numbers were 68,937 units per milliliter compared with post-project average blue-green numbers of 1,660 units per milliliter (Figure 3-2).

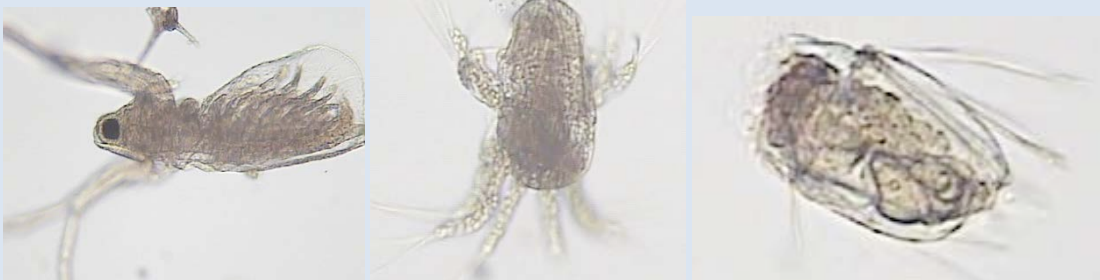
The composition of the 2018 zooplankton community was consistent with recent years, with all three groups of zooplankton (rotifers, copepods, and cladocerans) represented (Figure 3-3). Higher numbers of rotifers were observed in 2018 than previous years, primarily due to higher numbers of *Polyarthra vulgaris* (Figure 3-3). Although the reason for the increase in numbers is unknown, because *Polyarthra vulgaris* is a favorite food for yellow perch and bluegills, both present in the lake, the increased numbers in 2018 are considered a favorable change. During the period of record, small rotifers and copepods have generally dominated the community. The low numbers of cladocerans are an indication of fish predation which is typical of shallow lakes. Because small rotifers and copepods do not graze as heavily on algae as the larger cladocerans, they generally have limited impact on the lake's water quality. This suggests that future Northwest Anderson Lake water quality management efforts should focus on management of phosphorus, a nutrient that contributes to algae growth.

Figure 3-3 Top, 1988-2018 Northwest Anderson Lake zooplankton numbers and bottom, microscopic pictures of zooplankton species from the lake, from left to right, *Diaphanosoma leuchtenbergianum* (cladoceran), nauplii (baby copepod), and *Polyarthra vulgaris* (rotifer).

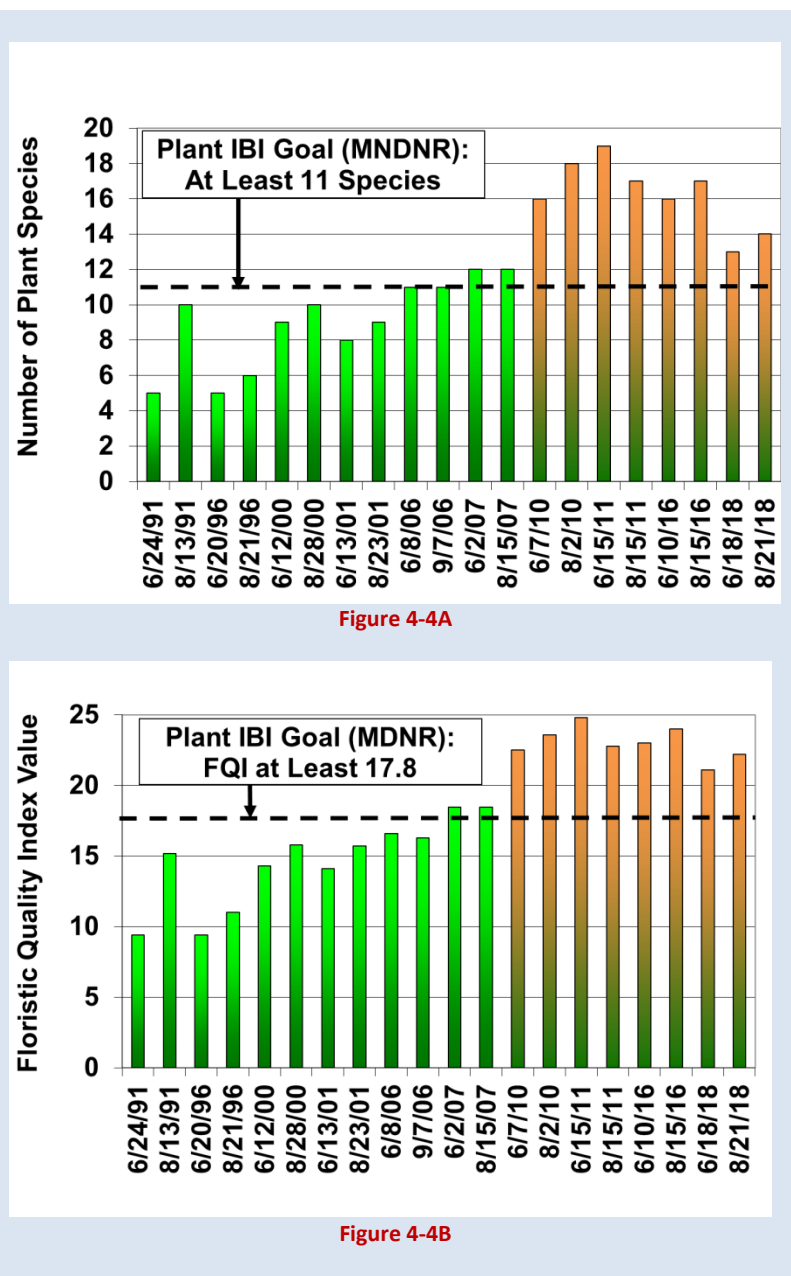
Figure 4-4 1991-2018 Southwest Anderson Lake Plant Index of Biotic Integrity (IBI) Threshold Values compared with Plant IBI Thresholds: Number of Plant Species (top) and Floristic Quality Index (FQI) Values (bottom).

numbers of species were observed from 2010 through 2018 than 1991 through 2007 (Figure 4-4A). The increase in species numbers is a positive result of the lake's water quality improvement projects.

- **FQI values (quality of species):** The impairment threshold for shallow lakes, as measured by FQI, is a minimum value of 17.8. During the period examined, FQI values ranged from 9.4 to 27.8 bettering the threshold since 2007 (Figure 4-4B). Higher FQI values were observed from 2010 through 2018 than 1991 through 2007 (Figure 4-4A). The increase in FQI values is a positive result of the lake's water quality improvement projects.
- **2018 results:** Both the number of species in the lake and FQI values were better than the minimum IBI thresholds that define impairment. As such, the waters would not be considered impaired for aquatic plants.

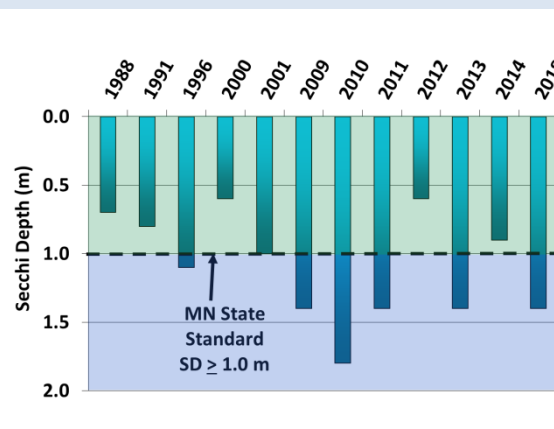
In 2018, the lake's summer average total phosphorus concentration and summer average Secchi disc transparency both met the State Standard. During the past 20 years, average summer total phosphorus concentrations and Secchi disc transparency measurements have failed to meet the State Standard 33 percent and 42 percent of the time, respectively(Figure 5-1).

Figure 5-1 Southeast Anderson Lake summer average total phosphorus (top) , chlorophyll *a* (middle), and Secchi disc (bottom) values during 1988-2018.

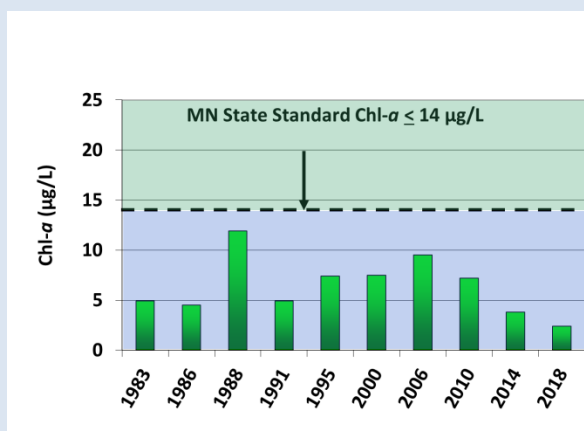
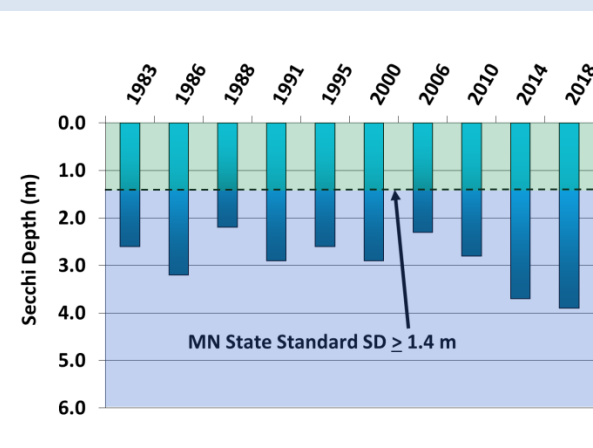
Figure 6-1 Bush Lake summer average total phosphorus (top), chlorophyll *a* (middle), and Secchi disc (bottom) values during 1983-2018.

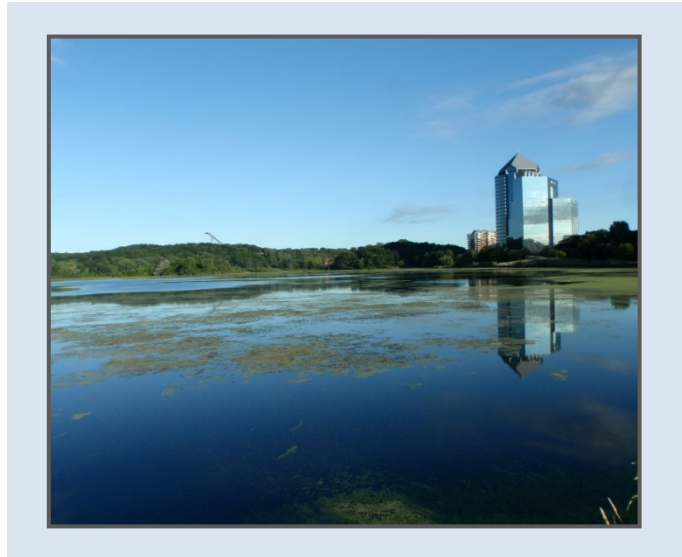
The lake is shallow enough for aquatic plants (i.e., macrophytes) to grow over the entire lake bed. The water level in the lake is controlled mainly by weather conditions (snowmelt, rainfall, and evaporation) and by the elevation of the outlet structure located at the east side of Normandale Lake.

Figure 8-1 Normandale Lake, pictured above, is a shallow lake created as a flood control project

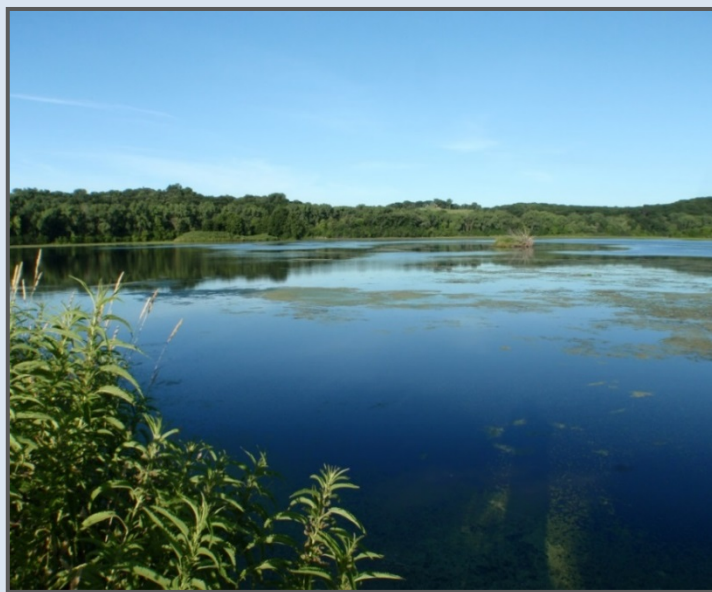
In 2016, the last year monitored by NMCWD, chloride concentrations in Normandale Lake ranged from a high of 235 mg/L, measured in April, to a low of 55 mg/L, measured in September. The April concentration exceeded the MPCA standard of 230 mg/L or less.

Figure 8-2 In 2018, chloride concentrations exceeded the MPCA standard of 230 mg/L on two occasions, May 14 (253 mg/L) and June 12 (258 mg/L), in Normandale Lake, pictured above.

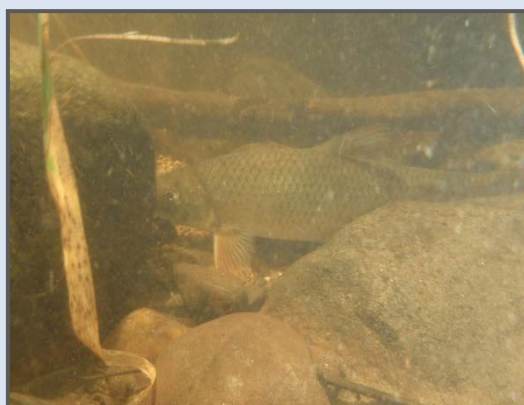
Figure 9-1 The primary use of Nine Mile Creek is a place for fish and aquatic life to live, such as the shorthead redhorse fish swimming in the Main Stem of Nine Mile Creek at Station ECU-7C, pictured above.

Because the primary use of Nine Mile Creek is ecological – a place for fish and aquatic life to live – the focus of the Nine Mile Creek monitoring program is evaluation of the stream’s fish and aquatic life community as well as the ecosystem components essential for the survival of fish and aquatic life (Figure 9-1). The 2018 Nine Mile Creek monitoring program included:

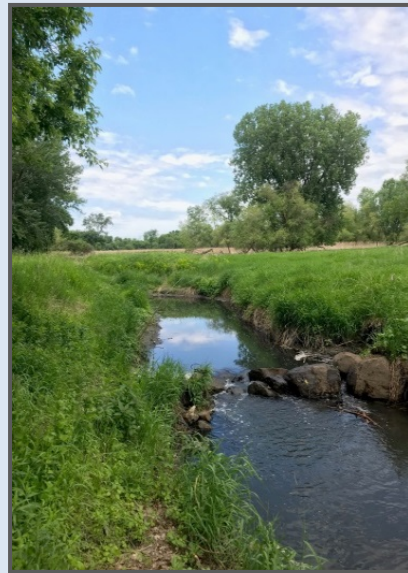
Figure 9-2 Pictured above, the North Fork location ECU-1A-1 on June 4, 2018.

A precipitation event on July 1, 2018 increased discharge in the headwaters reaches of the North Fork (ECU-1A-1) and South Fork (ECU-3A), influencing the 2018 averages at these locations such that the 2018 discharge averages were the highest to date. Additionally, the July 1 precipitation event greatly increased turbidity at North Fork locations ECU-1A-1, ECU-2, and N2 such that the 2018 averages were the highest to date. Pictures of (ECU-1A-1) before and after the July 1 precipitation event are shown in Figure 9-2 and Figure 9-3.

have improved MRAP Fish IBI scores at North Fork location ECU-1A/1A-1 (Figure 9-2, Figure 9-3, and Figure 9-8). The pre-project MRAP Fish IBI score from ECU-1A/1A-1 was 26.4, which did not meet the

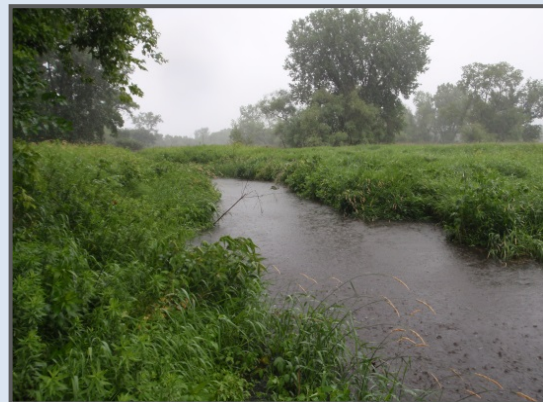
Figure 9-3 Pictured above, the North Fork location ECU-1A-1 on July 1, 2018 after a precipitation event increased discharge and turbidity.

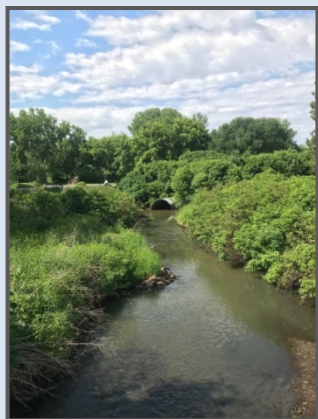
Figure 9-7 In 2018, improvements in the fish and macroinvertebrate communities were observed at North Fork location ECU-2A, pictured above. The improvements may be a result of the Edina stream stabilization project completed during 2017 through 2018.

In 2018, the fish community at the most downstream North Fork location, ECU-2A was intolerant forage fish, which is better than the designated ecological use for this location (tolerant forage fish) and of higher quality than the fish communities observed in recent years (Figure 9-6) and (Figure 9-7). The improved fish community in 2018 may be a result of the Edina stream stabilization project completed during 2017 through 2018.

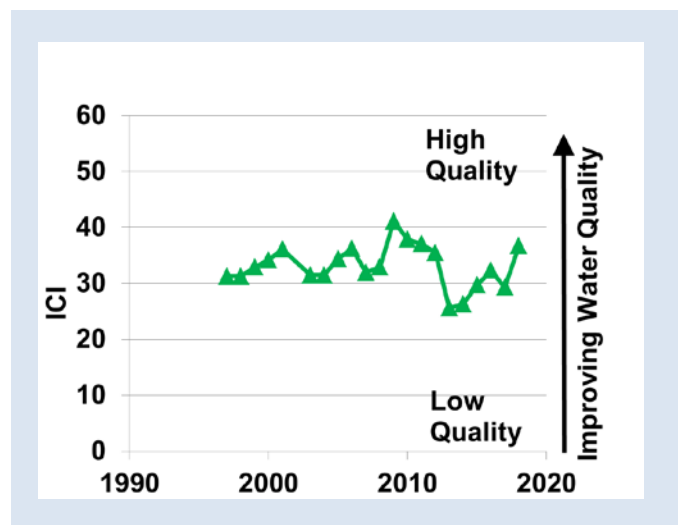
Figure 9-11 1997 2018 Nine Mile Creek ICI: Most Downstream North Fork Location, ECU-2A

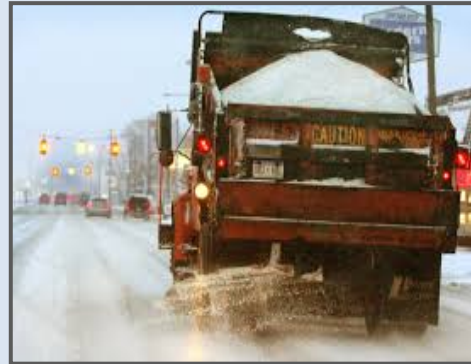
Figure 9-14 Deicing chemicals applied to roads and parking lots within the Nine Mile Creek watershed have been conveyed to the stream and resulted in high chloride concentrations in the stream. In 2018, 55 percent of chloride measurements failed to meet the MPCA standard.
