Nine Mile Creek Watershed District

Summary of 2021 Water Monitoring Program

May 2022

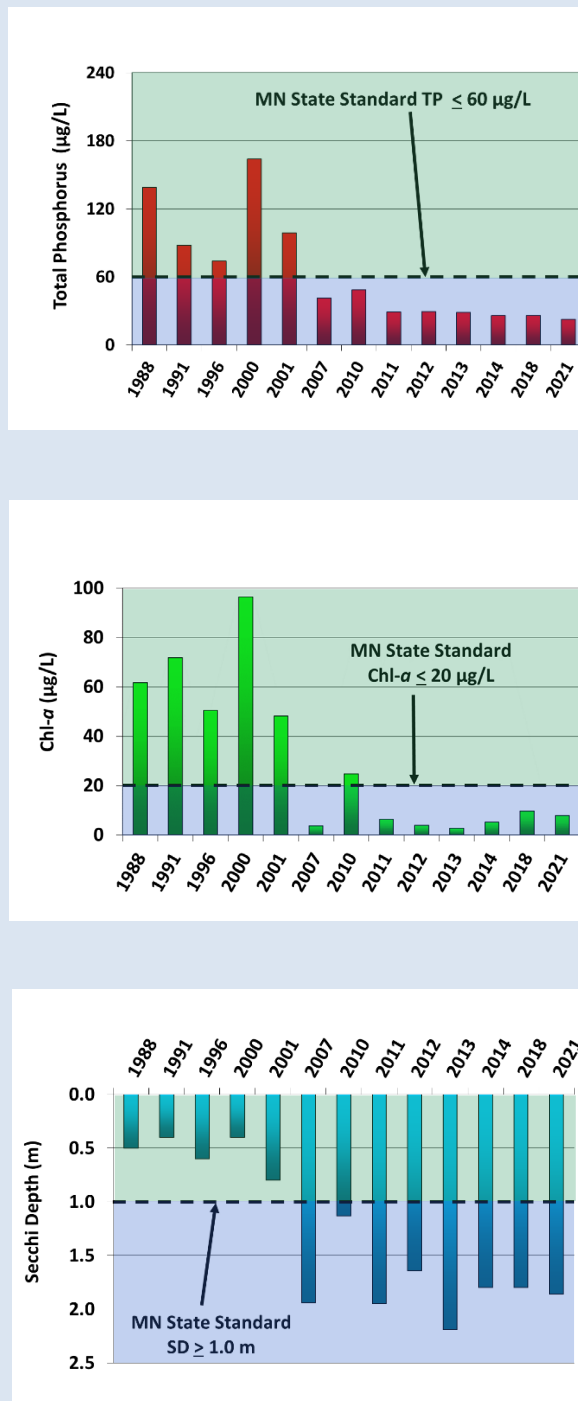
Figure 3-2 Northwest Anderson Lake historical summer average values
total phosphorus (top), chlorophyll *a* (middle), and Secchi disc (bottom)

Monitoring data indicate that the management activities completed as part of the Eden Prairie Lakes Water Quality Improvement Project have improved the lake's water quality. For the monitored period prior to the start of the water quality improvement project (1988-2007), the average summer total phosphorus and chlorophyll *a*

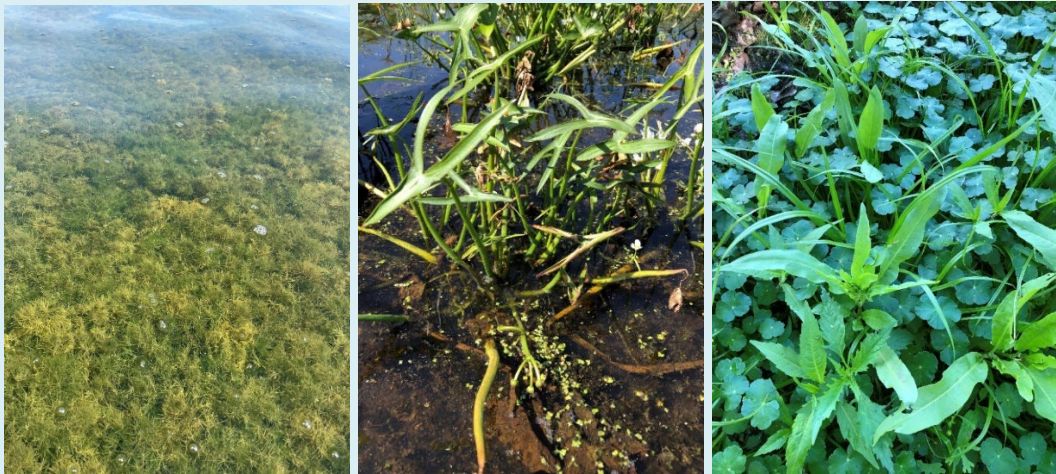
Figure 3-5 Left, bearded stonewort, middle, hooded arrowhead, and right, floating pennywort

In 2021, bearded stonewort (*Lychnothamnus barbatus*) was first observed in Northwest Anderson Lake (Figure 3-5). Bearded stonewort is in the family Characeae, an algae that resembles rooted aquatic plants and obtains all of its nutrients from the water. This nutrient absorber can reduce phosphorus concentrations and improve water quality. Although first observed in 2021, bearded stonewort was the dominant plant species in the lake, observed at 88 locations in June (68 percent of sample locations) and had an average rake density of 2.6 (high density) (Appendix F). Bearded stonewort expanded to 93 locations by August (72 percent of sample locations) and increased its density to an average rake density of 2.7 (high density).

A second species observed for the first time in 2021 was hooded arrowhead (*Sagittaria calycina*), a rare species in Minnesota listed by the MNDNR as threatened (Figure 3-5). This species is drought tolerant, thriving on large, exposed mud flats and preferring soft mud (silt) to firm substrates. The dry conditions in 2021 provided favorable conditions for hooded arrowhead, which was observed at two locations in the far northwest corner of the lake in June at low density (average rake density of 1.0). In August, hooded arrowhead was found at two locations in the far northwest corner of the lake, one location on the south side of the lake, and at one location near the canoe landing in the southeast corner at low to moderate density (average rake density of 1.5).

A third species observed for the first time in 2021 was floating pennywort (*Hydrocotyle ranunculoides*), observed at one location near the canoe landing in the southeast corner in June (Figure 3-5).

Both the number of aquatic plant species in the lake and FQI values were better than the MNDNR Plant IBI thresholds. Both number of species and FQI increased in 2018 and 2021 and, in 2021, the plant community had the highest number of species and FQI score on record. Three species were observed for the first time in 2021 – bearded stonewort, hooded arrowhead, a rare, drought-tolerant species in Minnesota listed by the MNDNR as threatened, and floating pennywort. Although first observed in 2021, bearded stonewort was the dominant plant species in the lake. Continued monitoring of the aquatic plant community is recommended to track changes and evaluate potential impacts of bearded stonewort on other plant species.

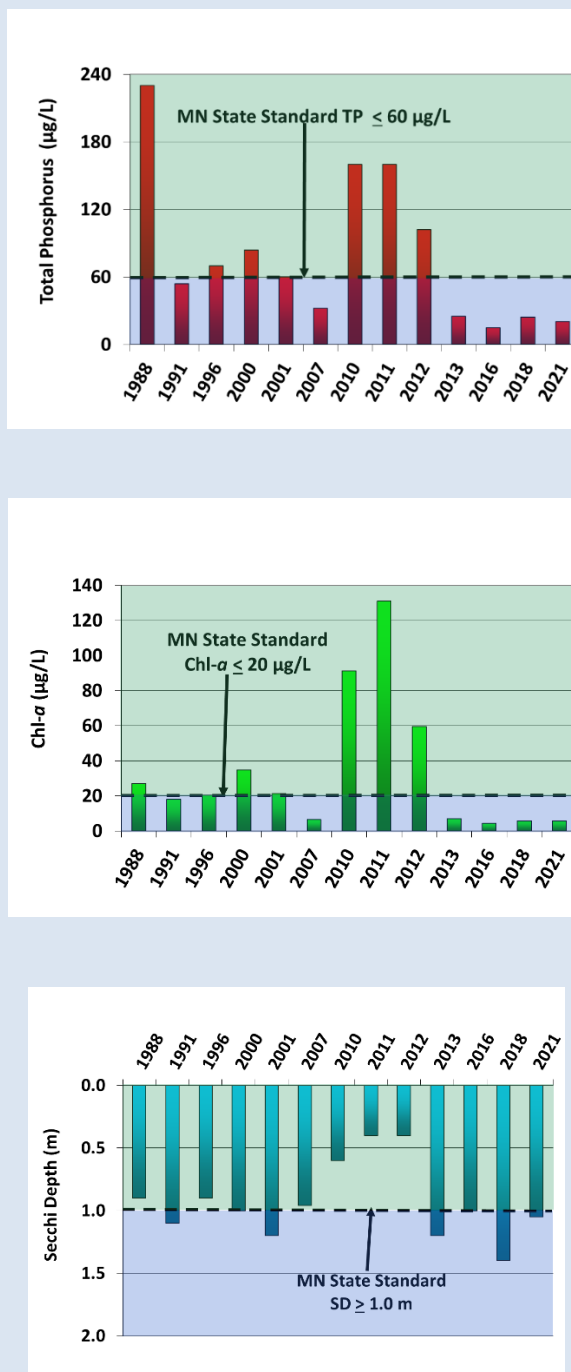
Figure 4-2 Southwest Anderson Lake historical summer average values
total phosphorus (top), chlorophyll *a* (middle), and Secchi disc (bottom)

Monitoring data indicate that the management activities completed as part of the Eden Prairie Lakes Water Quality Improvement Project have substantially improved the lake's water quality. For the monitored period prior to the start of the water quality improvement project (1988-2007), the average summer total phosphorus and chlorophyll *a*

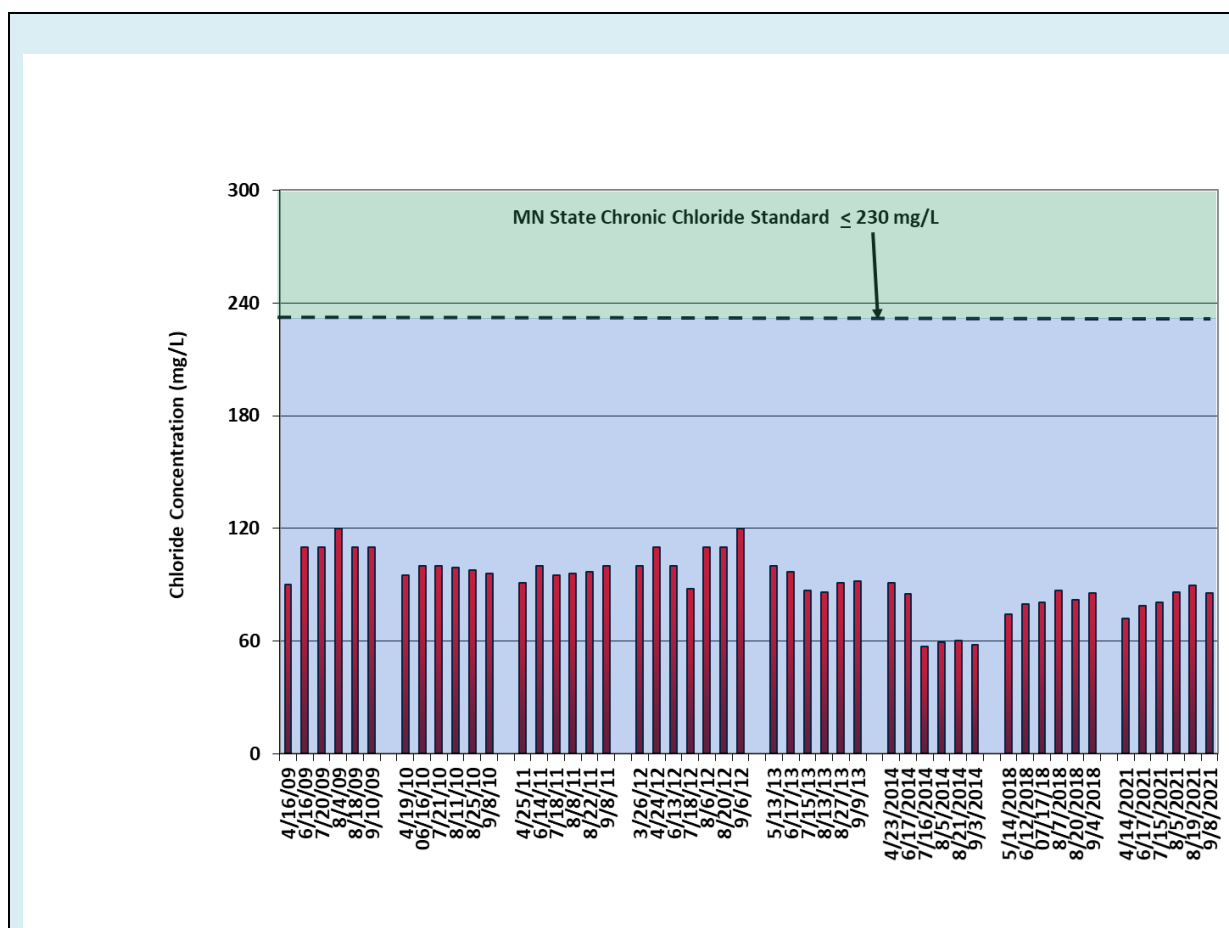
Figure 5-3 Southeast Anderson Lake historical chloride concentrations

Chloride concentrations in Southeast Anderson Lake were measured in 2009, 2010, 2011, 2012, 2013, 2014, 2018, and 2021, generally between April and September. Figure 5-3 shows the observed chloride concentrations from 2009 through 2021. Because high concentrations of chloride can harm fish and plant life, MPCA has established acute and chronic exposure chloride standards. A lake is considered impaired if two or more exceedances of chronic criterion (230 mg/L or less) occur within a three-year period or one exceedance of acute criterion (860 mg/L) is measured. All chloride measurements were below the acute and chronic MPCA criteria. 2021 data are summarized in Appendix A.

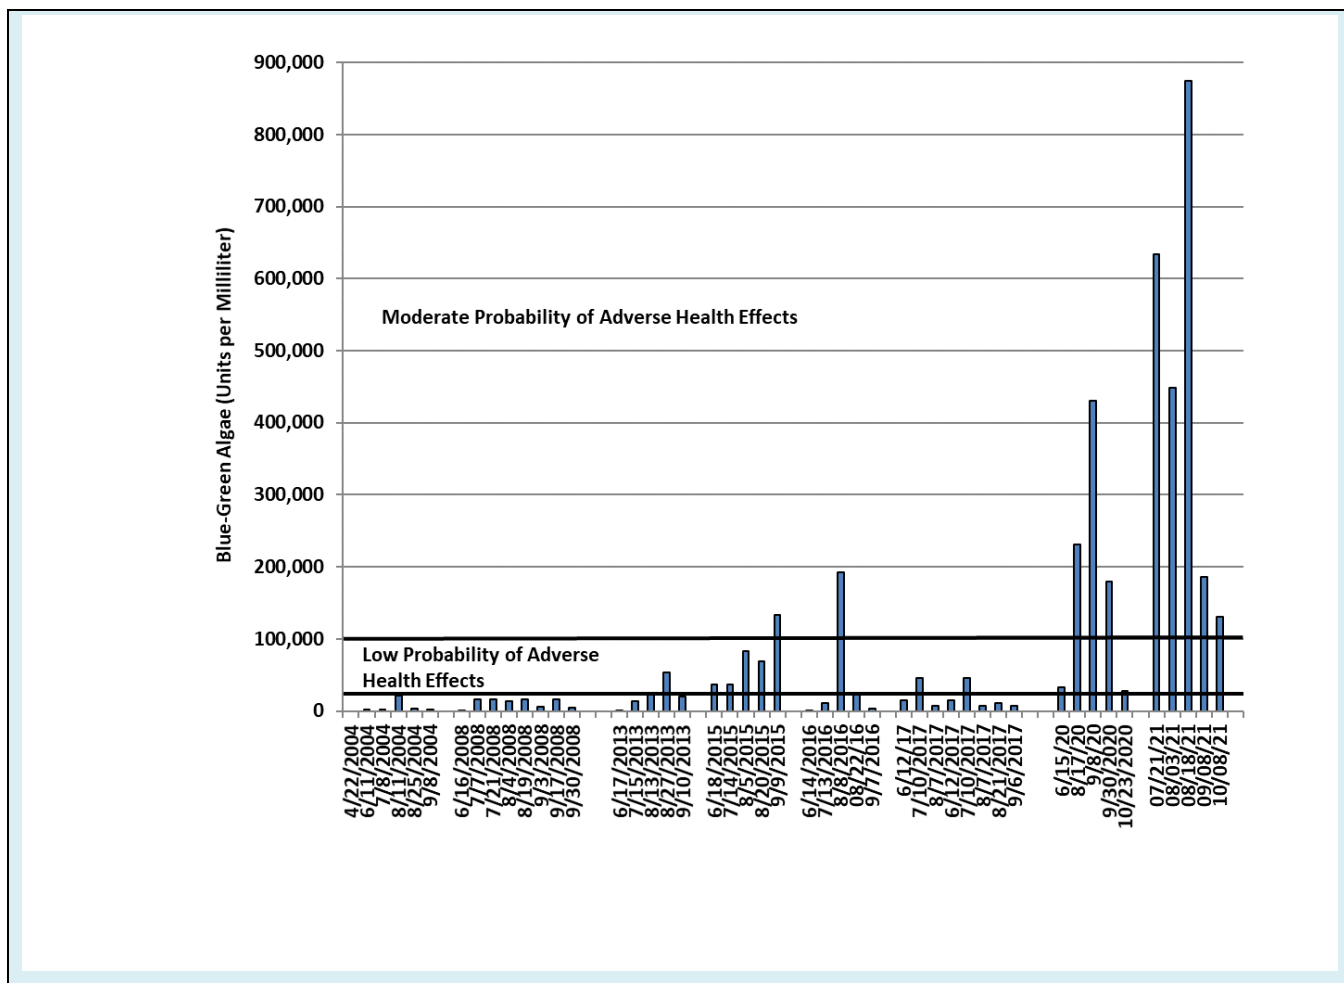
Figure 6-5 Lake Cornelia – North Basin blue-green algae compared with World Health Organization (WHO) thresholds for adverse health effects

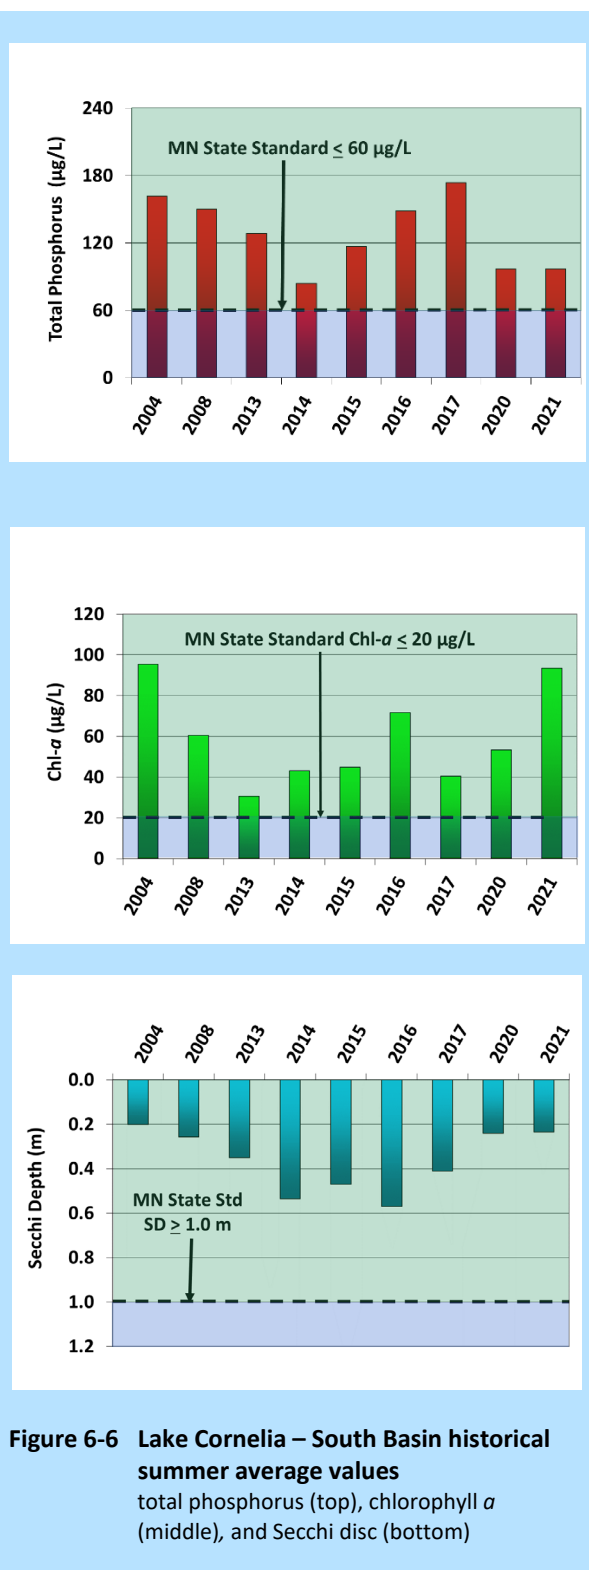
Figure 6-6 Lake Cornelia – South Basin historical summer average values
total phosphorus (top), chlorophyll *a* (middle), and Secchi disc (bottom)

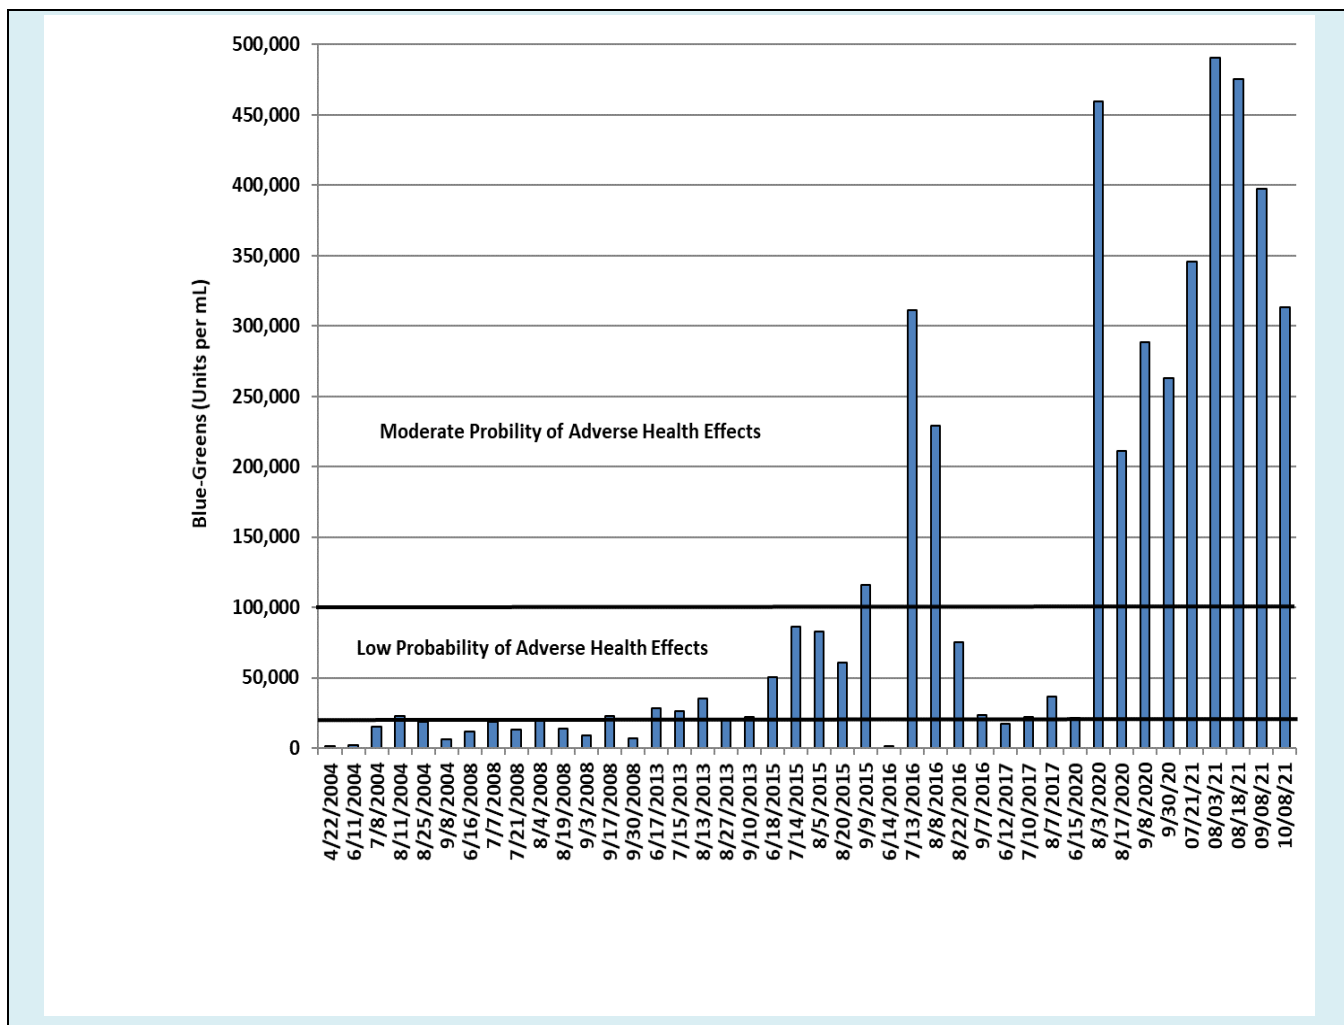
Figure 6-9 Lake Cornelia – South Basin blue-green algae compared with World Health Organization (WHO) thresholds for adverse health effects

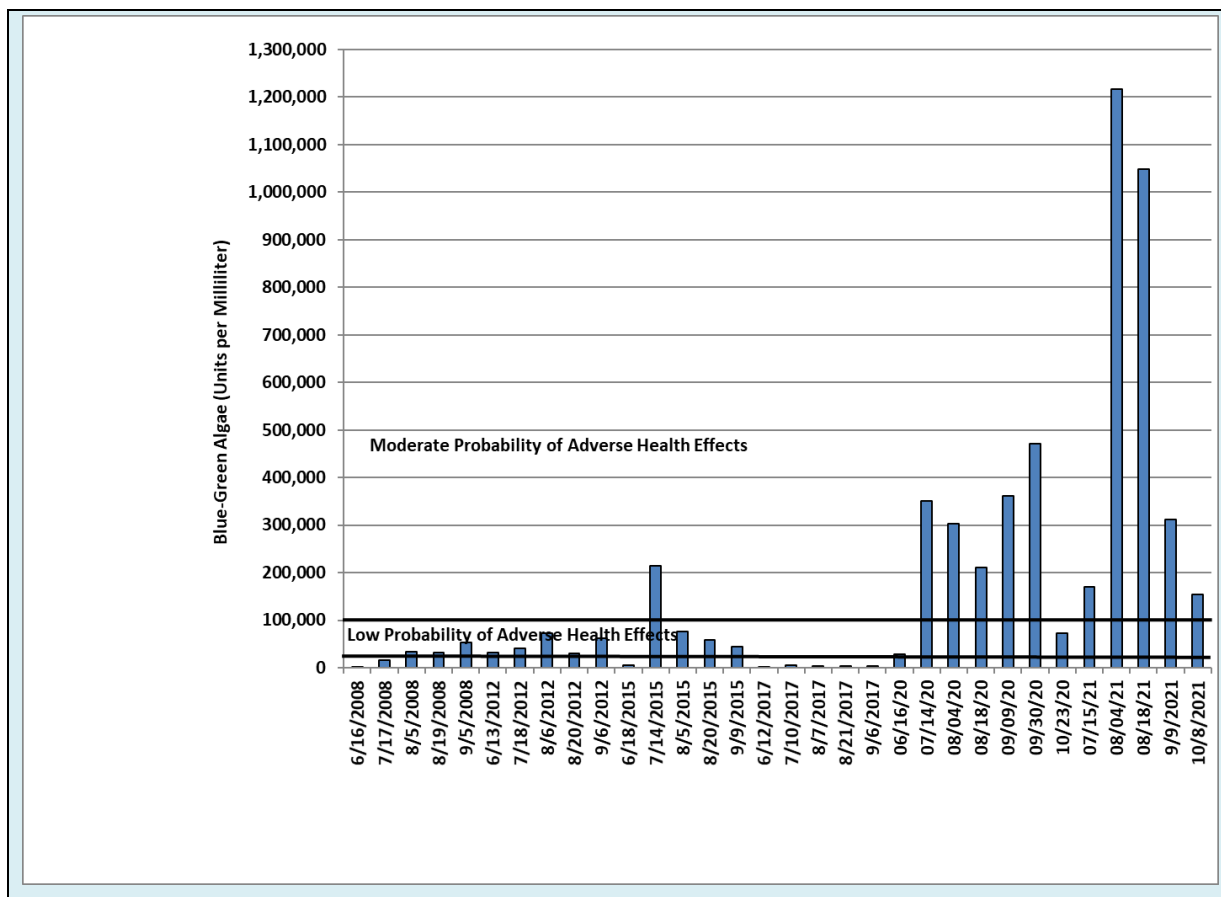
Figure 7-5 Lake Edina blue-green algae compared with World Health Organization (WHO) thresholds for adverse health effects

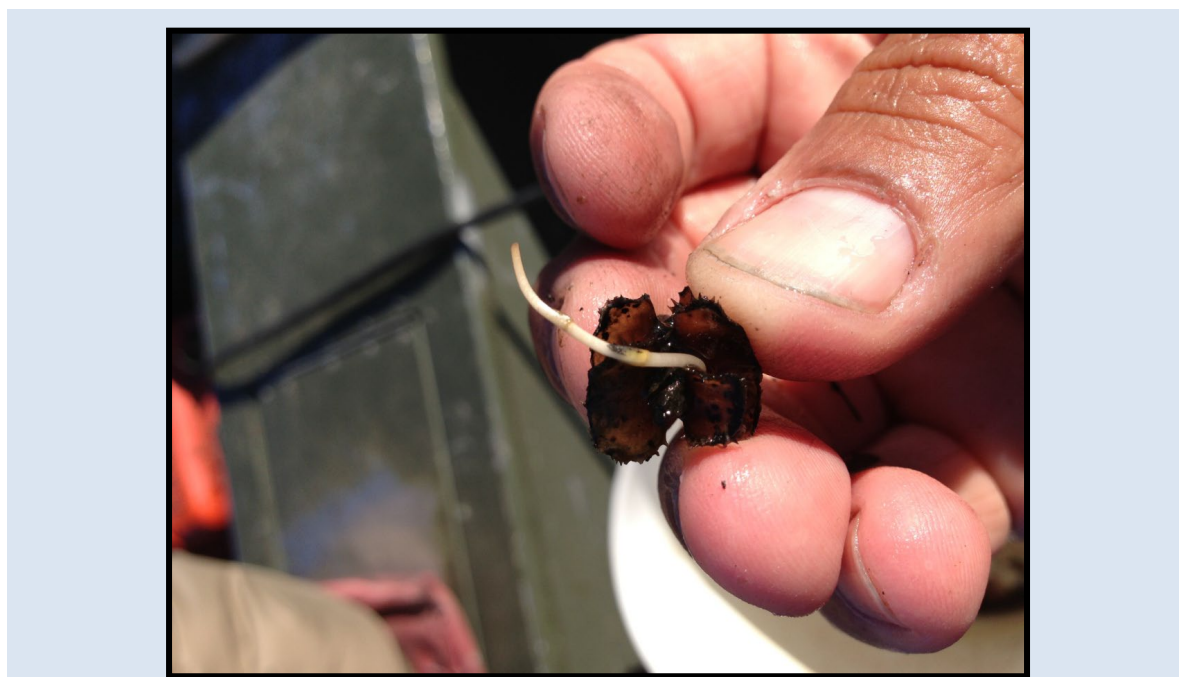
Figure 9-15 A germinating curly-leaf pondweed turion (Photo Credit: Endangered Resource Services, LLC)

The 2019 survey found some turions remaining in the lake sediment following the drawdown that occurred in the winter of 2018-2019, although generally in low or very low densities. Turions were generally found along the stream channel that remained unfrozen and flowing throughout the winter of the drawdown. A patch of turions was also found in the northeastern portion of the lake.

During 2019, live turions were found at 19 of the 50 sample points (38 percent) compared with live turions found at 14 sample points in 2020 (28 percent) and 17 sample points in 2021 (34 percent) (Figure 9-16). During 2019, a total of 36 live turions were collected from all 50 sample points compared with 21 live turions collected in 2020 and 27 live turions collected in 2021 (Figure 9-17). While results from the 2020 and 2021 turion monitoring showed fewer locations with turions and fewer turions than 2019, the year-over-year differences were not statistically significant.

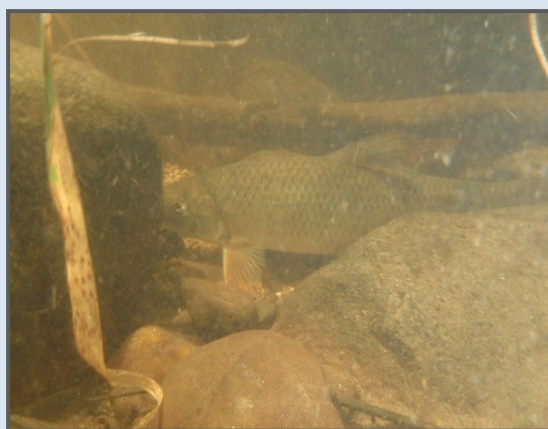
Figure 10-1 Downstream Main Stem Location ECU-7C (Shorthead Redhorse Fish)

The primary use of Nine Mile Creek is a place for fish and aquatic life to live, such as the shorthead redhorse fish swimming in downstream Main Stem Location ECU-7C, pictured above.

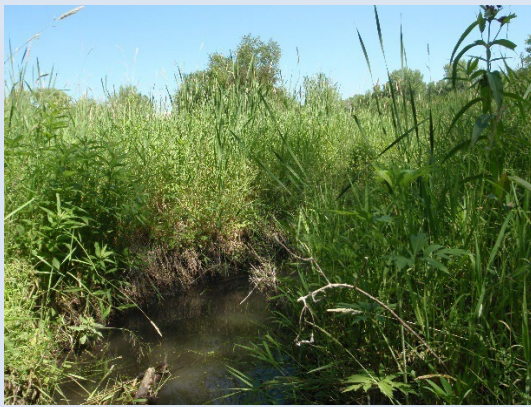
Figure 10-2 Upstream South Fork Location ECU-3A
In 2021, 89% of South Fork conductance, dissolved oxygen, pH, and temperature values met the MPCA standards. At the South Fork upstream location, ECU-3A pictured above, these levels met the MPCA standards 100 percent of the time.

- FIBI values from the upstream South Fork location, ECU-3A, met the FIBI standard during 2018 and 2020, but not during 2017, 2019, and 2021, although the 2017 and 2019 values were within the standard's confidence limits indicating the values were fairly close to the standard (Figure 10-15 and Figure 10-2). The lower score in 2021 was likely influenced by lower flows in 2021 than previous years. Observed flows on the day of fish surveys completed during 2017 through 2021 are shown in Figure 10-19. The flow during the 2021 fish survey of 0.1 cfs compares with flows ranging from 0.4 to 2.6 cfs during the 2017 through 2020 fish surveys.

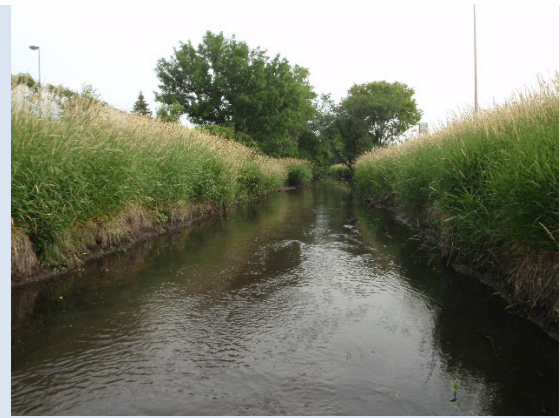
Figure 10-3 Downstream North Fork Location ECU-2A
In 2021, the North Fork met the specific conductance standard less frequently than other locations. Pictured above is downstream North Fork location ECU-2A.

FIBI values from the South Fork downstream location, ECU-5A, met the FIBI standard during 2017 through 2019 and in 2021, but not during 2020 (Figure 10-15 and Figure 10-16). FIBI scores from the downstream North Fork location, ECU-2A, met the FIBI standard during 2018, 2019, 2020, and 2021, but not during 2017, although the value was within the standard's confidence limits indicating it was fairly close to the standard (Figure 10-15 and Figure 10-3).

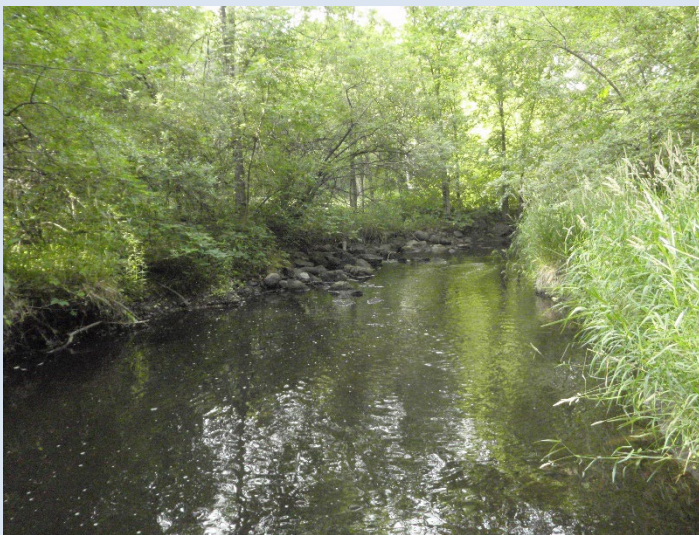
Figure 10-14 Middle Main Stem Location ECU-7B

The 2021 FIBI value at the middle Main Stem Location ECU-7B, pictured above, did not meet the FIBI standard.

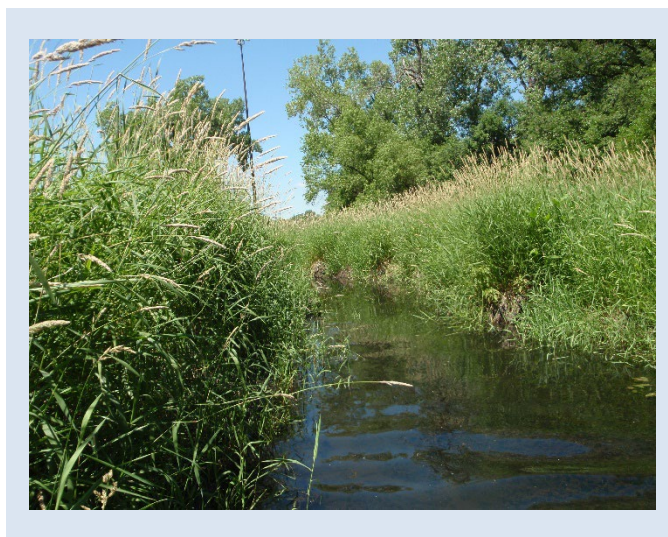
Figure 10-16 South Fork Downstream Location ECU-5A

The 2021 FIBI value at the downstream South Fork location, ECU- 5A, pictured above, met the FIBI standard.

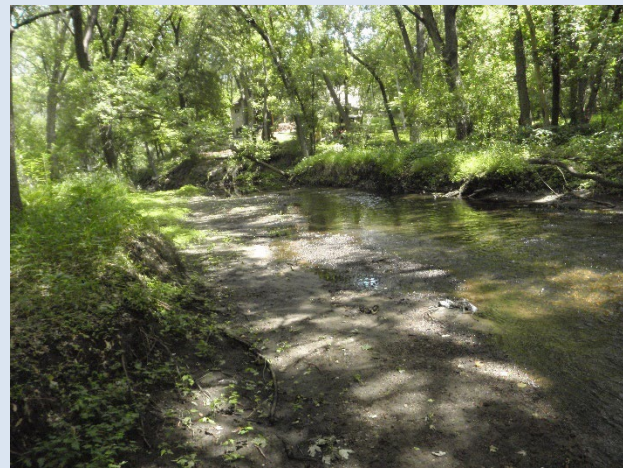
Figure 10-17 Main Stem Upstream Location ECU-7A

The 2021 FIBI value at the upstream Main Stem location, ECU- 7A, pictured above, did not meet the FIBI standard, but its score was greater than the lower confidence limit, indicating it was close to the standard.

- FIBI scores from the upstream Main Stem location, ECU-7A, met the FIBI standard during 2018 and 2019, but not during 2017, 2020, and 2021 (Figure 10-15 and Figure 10-17). However, the 2020 and 2021 values were within the standard's confidence limits indicating the scores were relatively close to the standard (Figure 10-15). The 2021 score was higher than the 2017 score, but lower than scores observed in 2018 through 2020. The lower score in 2021 was likely influenced by lower flows in 2021. Observed flows on the day of fish surveys completed during 2017 through 2021 are shown in Figure 10-18. The flow during the 2021 fish survey of 4 cfs compares with flows ranging from 16 to 24 cfs during the 2017 through 2020 fish surveys.

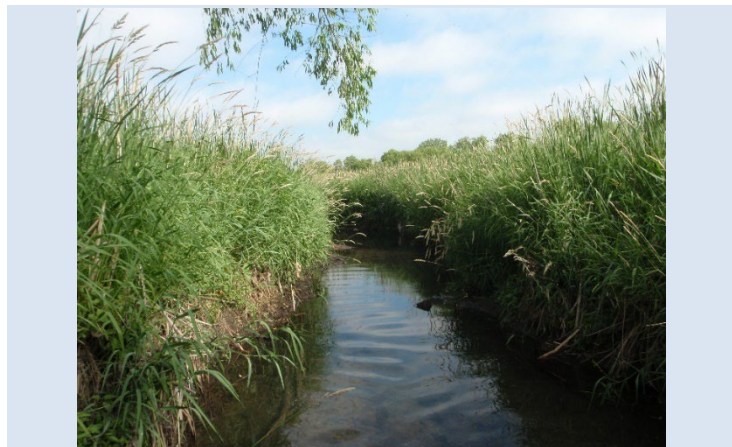
FIBI scores from the two most upstream North Fork locations, ECU-1A-1 (North Fork Just Upstream of the Hopkins/Edina Boundary) and ECU-2 (North Fork near Cahill Road and Brook Drive in Edina), did not meet the FIBI standard during 2017 through 2021 (Figure 10-15, Figure 10-20, and Figure 10-21). The *Nine Mile Creek Biological Stressor Identification* (November 2010) concluded the primary stressors to the North Fork fish community were inadequate dissolved oxygen followed by excess sediment and then ionic strength due to excess chloride in the stream. As noted previously, the 2021 data indicated these same stressors were present in the stream during 2021. Inadequate oxygen was observed at ECU-2 during June, July, September, and October (Appendix A). High turbidity values at all North Fork locations, including ECU-1A-1 and ECU-2 in March indicated excess sediment was present in the stream during that time (Figure 10-10, Figure 10-11, and Figure 10-12). High specific conductance measurements at ECU - 1A- 1 during all 2021 monitoring events (Figure 10-4) and at all other North Fork locations, including ECU-2 (Figure 10-5) in

Figure 10-20 Upstream North Fork Location 1A-1
The 2021 FIBI value at the North Fork upstream location, ECU-1A-1, pictured above, did not meet the FIBI standard during 2017-2021.

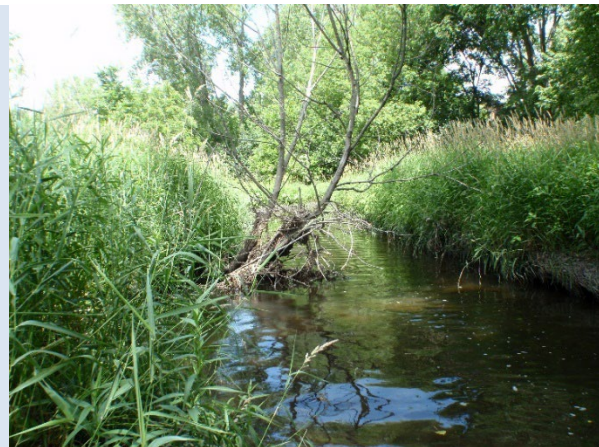
Figure 10-21 North Fork middle location ECU-2
The 2021 FIBI value at the North Fork middle location, ECU-2, pictured above, did not meet the FIBI standard during 2017 through 2021.
