Nine Mile Creek Watershed District

Summary of 2022 Water Monitoring Program

Prepared for
Nine Mile Creek Watershed District

August 2023

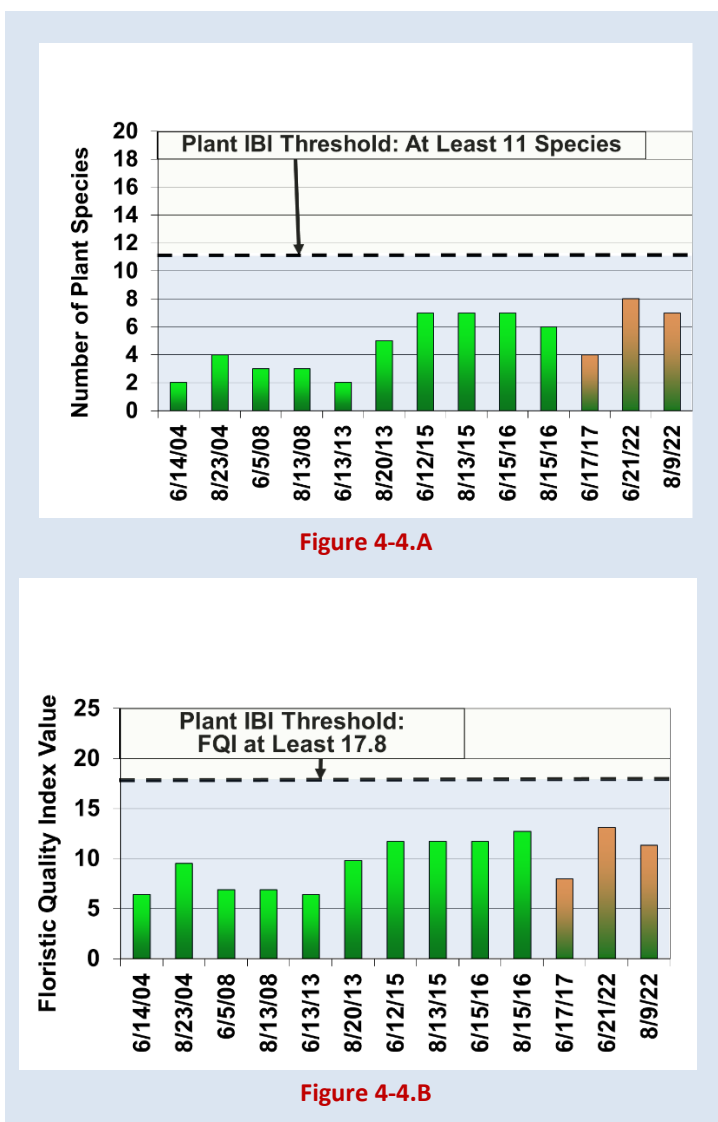
Figure 4-4 Lake Cornelia-North Basin Plant Index of Biotic Integrity (IBI)
Values compared with plant IBI thresholds (MNDNR): Number of Plant Species (top) and Floristic Quality Index (FQI) (bottom). Note: orange bars indicate period following significant infestation of curly-leaf pondweed and completion of spring herbicide treatments (2017-2021) to reduce curly-leaf prevalence.

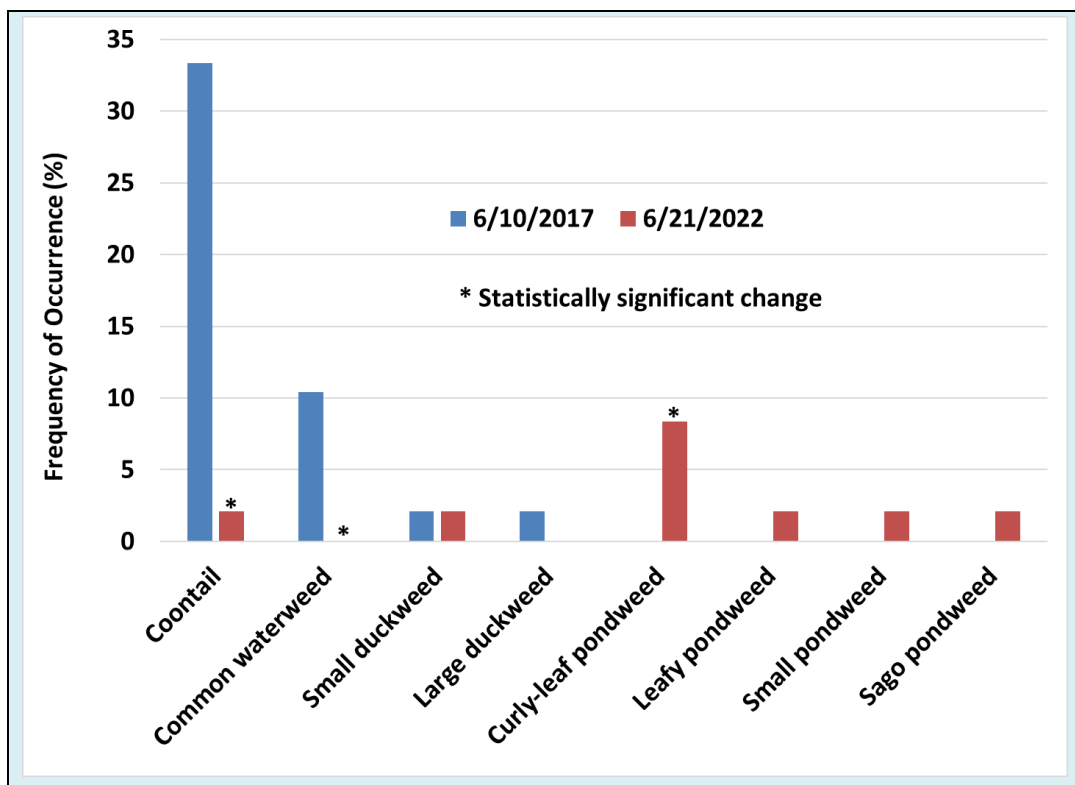
Figure 4-6 2017-2022 Lake Cornelia-North Basin frequency of occurrence and significant change between years. 2017 data collected and provided by the City of Edina. 2022 data collected by Nine Mile Creek Watershed District.

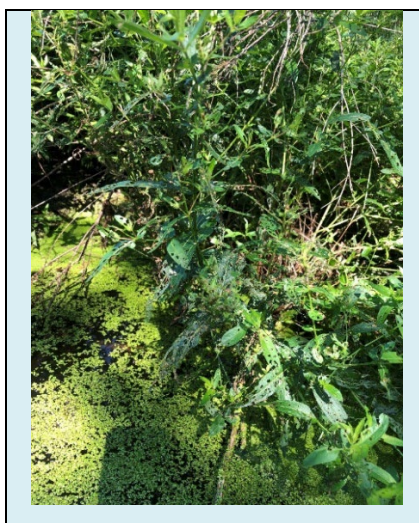
Figure 4-7 Purple loosestrife plants in Lake Cornelia-North Basin covered with *Galerucella* beetles on August 9, 2022

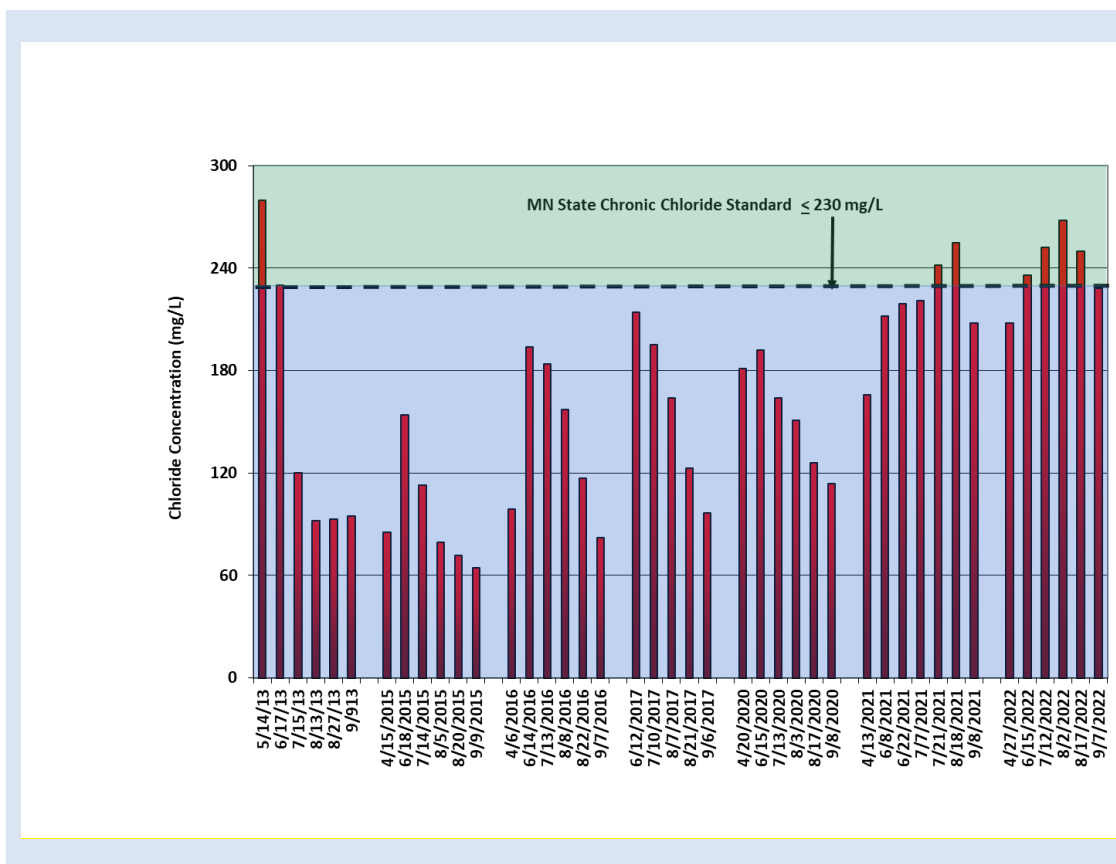
Figure 4-11 Lake Cornelia – South Basin historical chloride concentrations

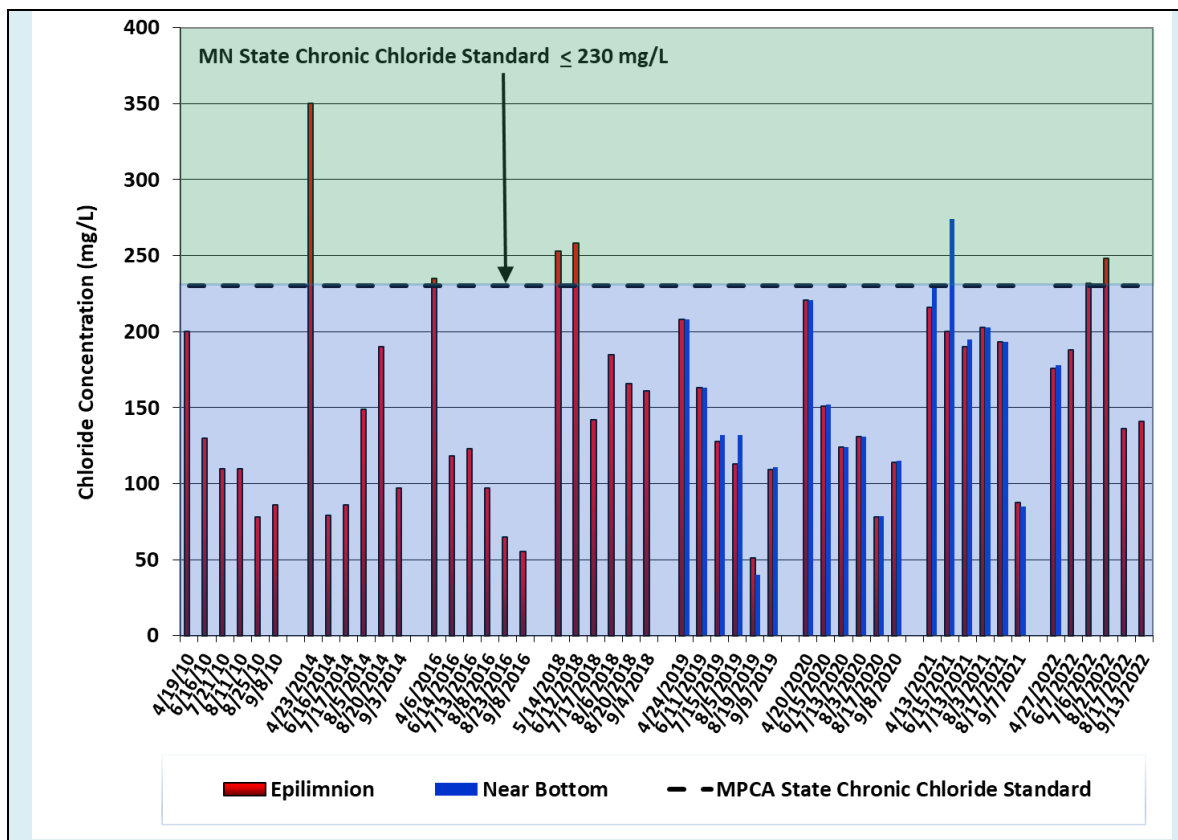
Figure 5-6 Normandale Lake historical chloride concentrations

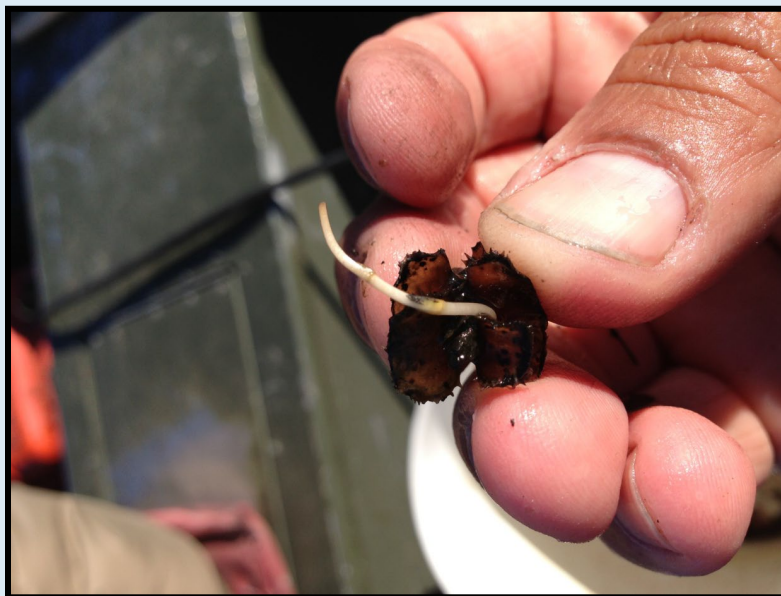
Figure 5-15 A germinating curly-leaf pondweed turion (Photo Credit: Endangered Resource Services, LLC)

Location and density of curly-leaf pondweed turions in Normandale Lake were assessed following the lake drawdown. Turions are the primary reproductive structures of curly-leaf pondweed and are found in the lake bottom. They are brown, typically half-inch in size, and look like sharp small pinecones (Figure 5-15). The objective of the drawdown was to freeze (or kill) as many turions as possible to reduce future curly-leaf pondweed growth in the lake. Turion surveys were conducted during October 2019 through 2022 to determine where turions were found in the lake, their density, and their size. Results of the turion surveys are provided in Appendix F.

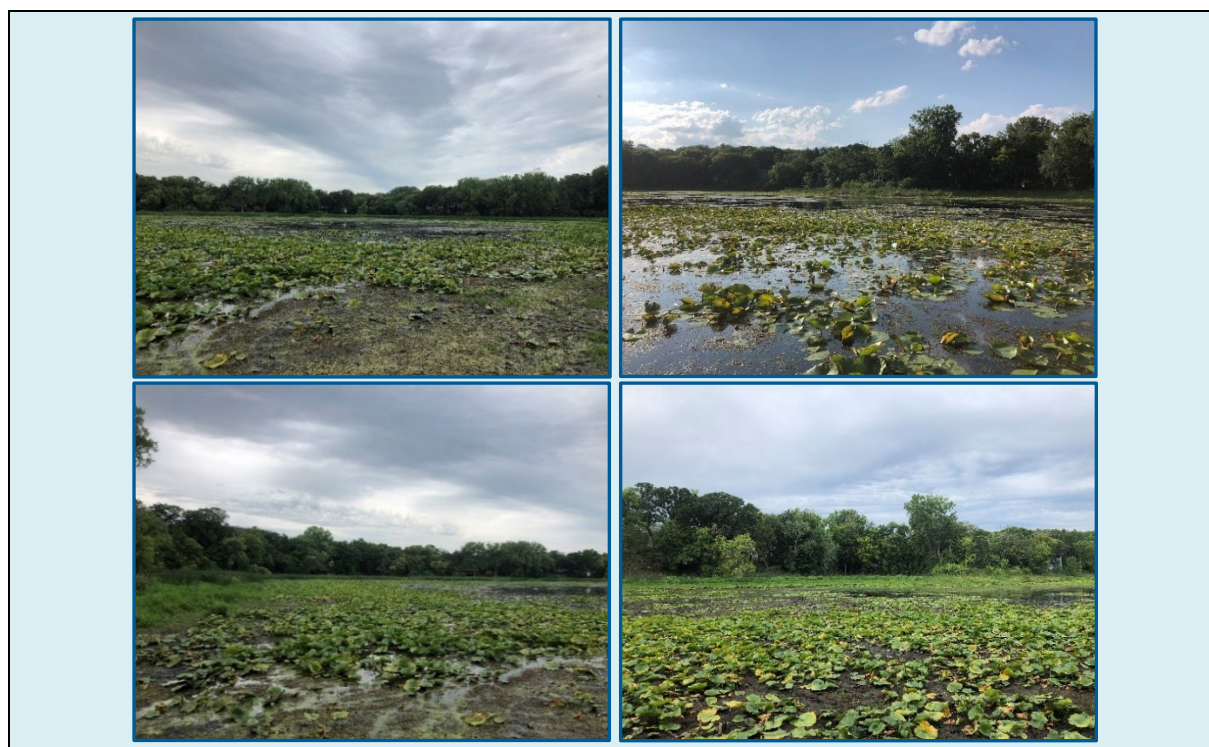
Figure 7-1 Lake Rose on June 27, 2022 - west basin (top left) and east basin (top right) - and on August 11, 2022 – west basin (bottom left) and east basin (bottom right)

In 2022, the District monitored Lake Rose for macrophytes (aquatic plants). Point intercept surveys were completed during June and August. 2022 was a dry year causing the water level in the lake to be very low and causing portions of the lake to be a wet mud flat (Figure 7-1). The plant survey was completed by kayak. Plants found at locations inaccessible by kayak were sampled on foot and plants found at locations inaccessible by kayak or on foot were visually estimated. Monitoring results are discussed in the following paragraphs.

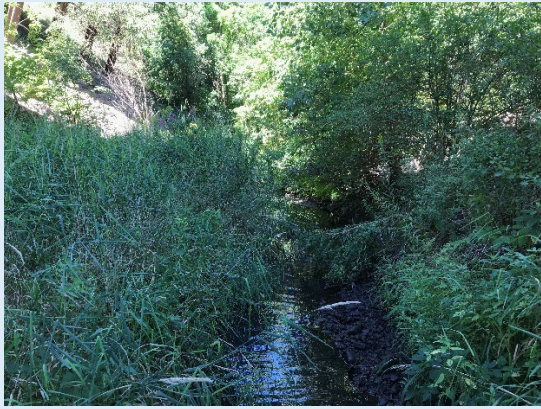
Figure 9-2 Upstream South Fork Location ECU-3A on September 1, 2022

In 2022, 87% of South Fork specific conductance, dissolved oxygen, pH, and temperature values met the MPCA standards. At the South Fork upstream location, ECU-3A pictured above, the levels of these parameters met the MPCA standards 100 percent of the time.

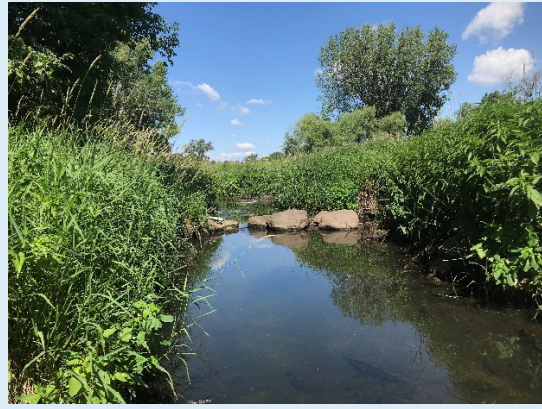
Figure 9-3 Upstream North Fork Location ECU-1A-1 on July 1, 2022

In 2022, the North Fork met the specific conductance standard less frequently than other locations. All 2022 specific conductance measurements from upstream North Fork location ECU-1A-1 failed to meet the specific conductance standard.

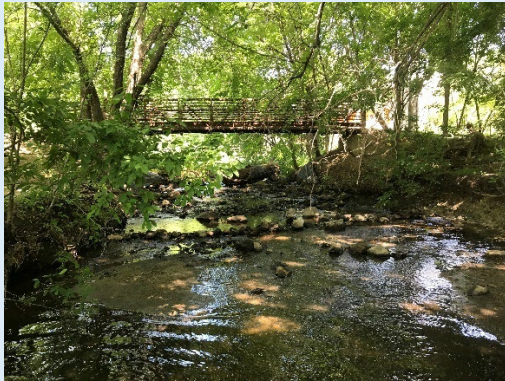
Figure 9-10 North Fork location ECU-2 on July 1, 2022

- ECU-2 (North Fork near Cahill Road and Brook Drive in Edina, Figure 9-10) during July and September;
- N2 (South Fork at West 78th Street in Bloomington, Figure 9-11) during July through October;
- ECU-5A (South Fork in Corridor Park immediately downstream from Interstate 494 in Bloomington and west of East Bush Lake Road, Figure 9-12) during July and September; and
- ECU-7A/N1 (Main Stem of Nine Mile Creek, downstream of Marsh Lake and immediately downstream of 98th Street in Bloomington, Figure 9-13) during July and September.

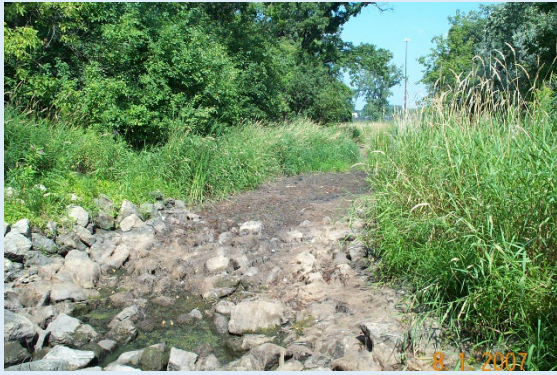
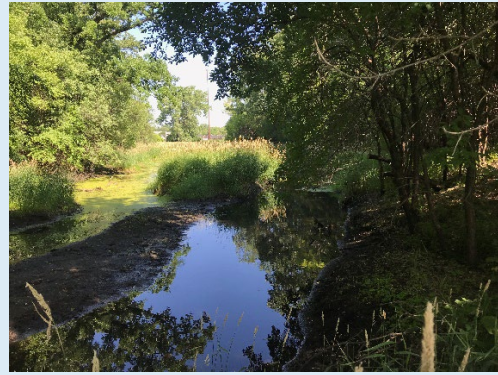
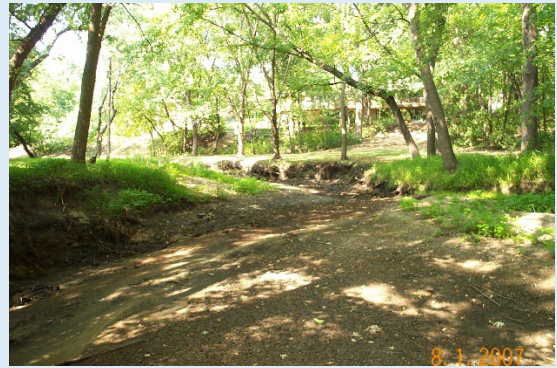
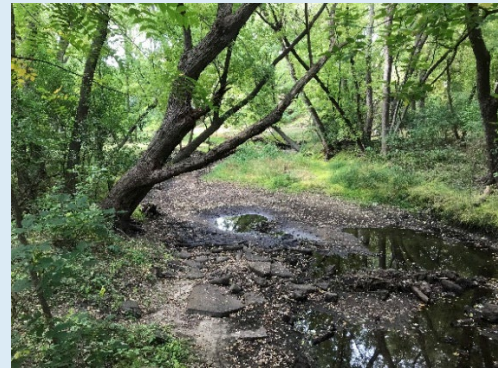
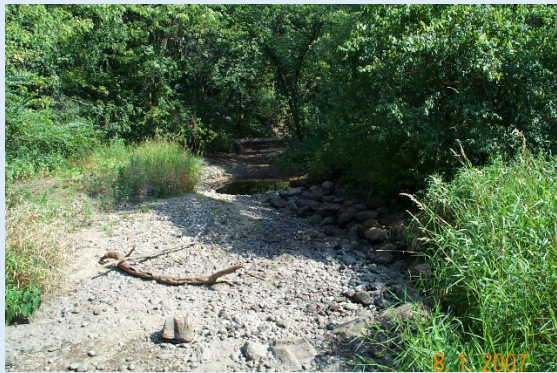
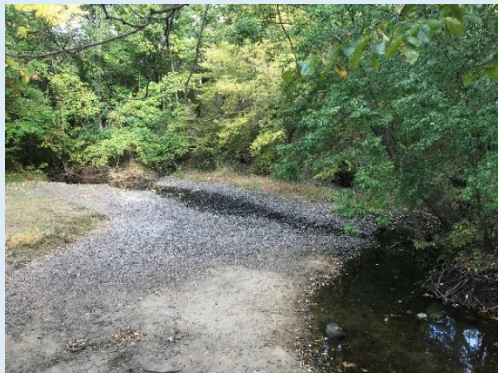
In 2022, all temperature, pH, dissolved oxygen, specific conductance, turbidity, and discharge values were within the range of values measured during the period in which data were collected. The data collection period has included a range of climatic conditions, including very dry years such as occurred in 2022. The pictures shown in Figure 9-18, Figure 9-19, Figure 9-20, Figure 9-21, Figure 9-22, and Figure 9-23 provide a comparison of stations ECU-5A, ECU-7A/N1, and ECU-7B during two very dry years, 2007 and 2022.

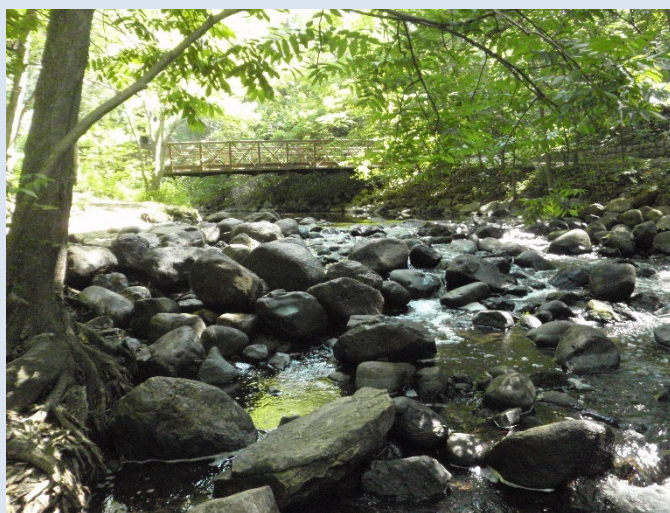
Figure 9-26 Downstream Main Stem location ECU-7C (downstream of 106th Street in Bloomington) on June 27, 2022.
The 2022 FIBI value at ECU-7C, pictured above, met the FIBI standard.

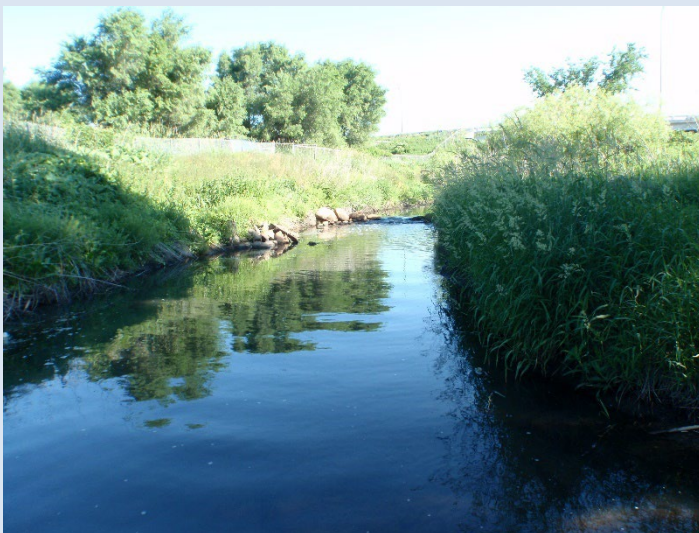
Figure 9-27 Downstream North Fork fish sample location ECU-2A (immediately downstream from West 77th Street / West of Highway 100) on June 22, 2022.
The 2022 FIBI value at ECU-2A, pictured above, met the FIBI standard.

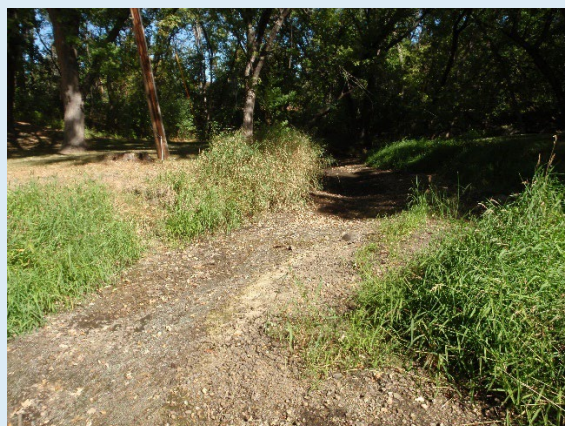
Figure 9-38 Upstream Main Stem macroinvertebrate monitoring location ECU-7A/N1 on October 2, 2022.

Nine Mile Creek macroinvertebrates (bugs that can be seen with the naked eye) were monitored at seven of the eight ecological use monitoring stations (Figure 1-2) during October 1 and 2 and assessed to determine whether the MIBI values met the applicable MPCA MIBI standards for Nine Mile Creek. Samples were not collected from ECU-7A because the stream was dry on October 2 (Figure 9-37 and Figure 9-38).
