## Birch Island Lake Water Quality Study

*January 2024*

Prepared for  
Nine Mile Creek  
Watershed District

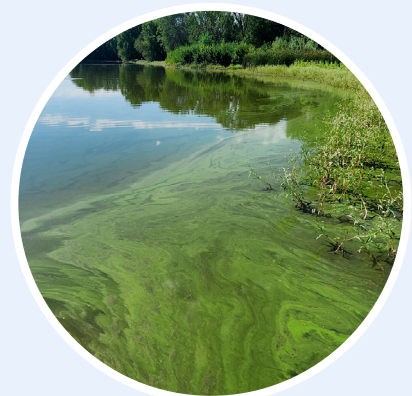
*Example blue-green algae bloom*

Blue-green algae, or cyanobacteria, have historically been found in Birch Island Lake since monitoring began, with a notable increase in abundance in 2015. Blue-green algae are associated with water quality problems and can be a source of health concerns not only for humans that use the lake, but for wildlife.

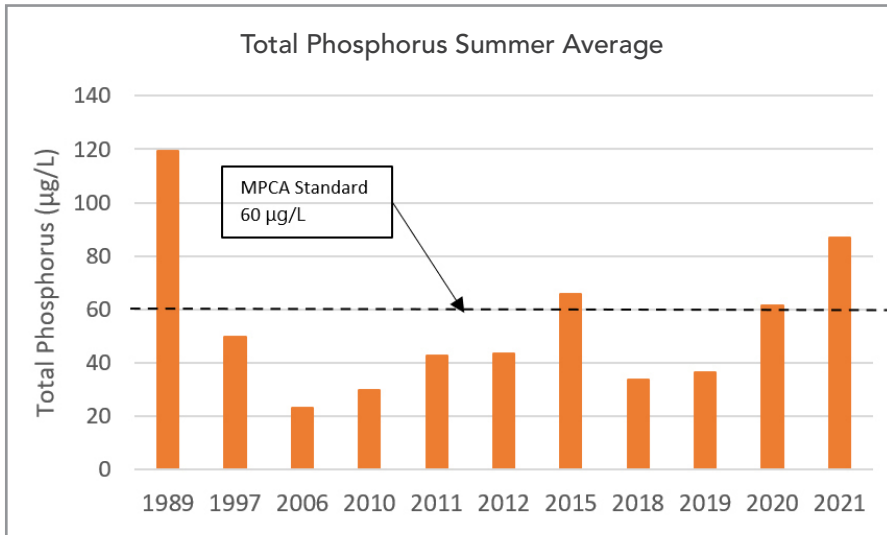
**Figure 2**  
Summer average total phosphorus concentrations measured in Birch Island Lake between 1989 and 2021

- 1) Total Phosphorus, which is a nutrient that can fuel algae and plant growth (Figure 2)
- 2) Chlorophyll-a, which is a measurement of algae growth (Figure 3)
- 3) Secchi disk transparency depth, which is a measurement of lake clarity. (Figure 4)

Recent monitoring data indicate that Birch Island Lake is not meeting Minnesota's water quality standards for shallow lakes in the Twin Cities. The observed summer average (June 1 - Sept 30) total phosphorus and chlorophyll-a concentrations exceeded Minnesota's shallow lake water quality standards (60 µg/L total phosphorus and 20 µg/L chlorophyll-a) in the two most recent monitoring years, 2020 and 2021. Lake water clarity was also poor in 2020 and 2021 with summer average transparency depths below the shallow lake standard of 1 meter. The degrading water quality is primarily due to excess nutrients in the lake, which fuels algal growth and decreases water clarity.

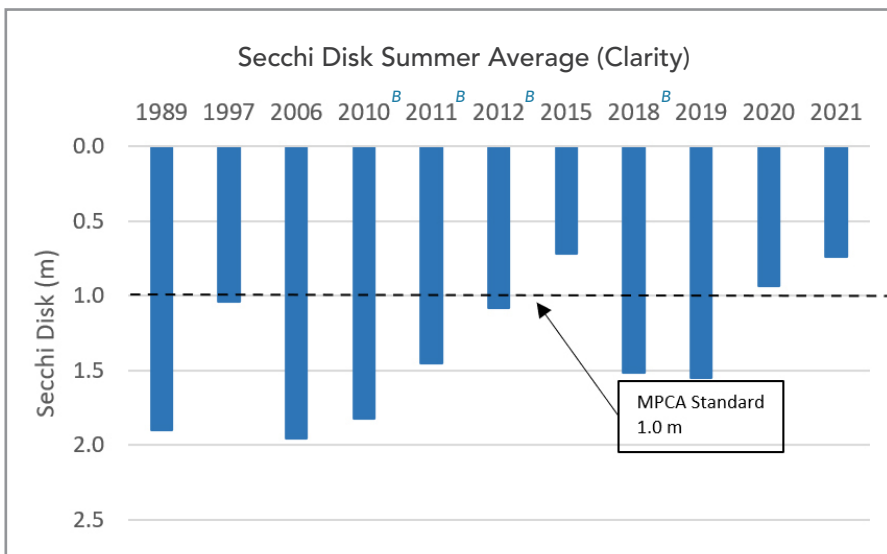
**Figure 4**  
Summer average Secchi disk transparency depths (clarity) measured in Birch Island Lake between 1989 and 2021

*B = Some SD readings measured at lake bottom at sampling location during these monitoring years.*

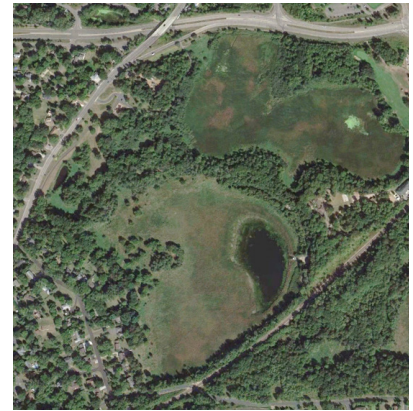
**Figure 6** September 2013 water levels

In the past decade, the difference between the lowest and highest observed water level in Birch Island Lake is approximately 13.3 feet. The lowest observed water level in 2013 corresponds to an open water area of only 3 acres. The highest observed water level in 2019 corresponds to an open water area of almost 44 acres. This substantial difference in open water area, as shown in Figures 6 and 7, can have a notable influence on long-term health of submerged and emergent plants.

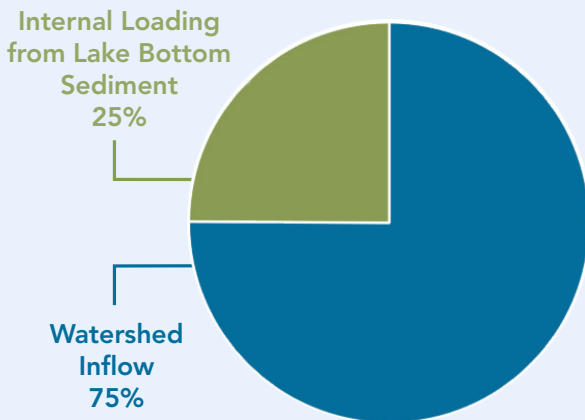
Birch Island Lake 2019  
Total Phosphorus Sources

- **Phosphorus and nitrogen in stormwater runoff from the direct watershed**—Stormwater runoff conveys phosphorus and nitrogen from streets, lawns, driveways and parking lots within the tributary watersheds to Birch Island Lake via a series of drainage channels and storm pipes. This study confirmed that stormwater runoff is a contributor of phosphorus and nitrogen to Birch Island Lake.

- **Nutrient-rich sediment**—Phosphorus builds up over time in lake bottom sediments as a result of sedimentation and die-off of vegetation and algae. When certain environmental conditions are met, such as low oxygen and/or higher temperatures, phosphorus can release back into the water column from the sediment. This study confirmed that phosphorus release from lake bottom sediments, typically termed “internal loading,” is a contributor of phosphorus to Birch Island Lake.

- **Inflow from upstream lakes**—During precipitation and snowmelt events, water levels rise as stormwater runoff discharges from tributary watersheds. When lake levels are high enough, water, along with in-lake nutrients and pollutants, will discharge from upstream lakes and flow towards water bodies further downstream. Three lakes in the City of Minnetonka are upstream of Birch Island Lake (Holiday, Wing, and Rose Lakes). Lake Holiday discharges via pumping to Wing Lake, which then discharges by gravity to Lake Rose. When water levels are high enough, water discharges from Lake Rose via gravity to a stormwater pond located north of County Road 62. If conditions allow, the stormwater pond north of County Road 62 will discharge to the bypass pipe system and ultimately reach Birch Island Lake. Water from Lake Rose has minimally impacted Birch Island Lake in the last two decades because either (1) water levels in Lake Rose have been too low to discharge from the outlet or (2) the bypass pipe has been clogged resulting in flow from Lake Rose entering the wetland north of Birch Island Lake.
