# REPORT SUMMARY

Lake Holiday, Wing  
Lake, and Lake Rose  
Water Quality Study

Prepared for  
Nine Mile Creek  
Watershed District

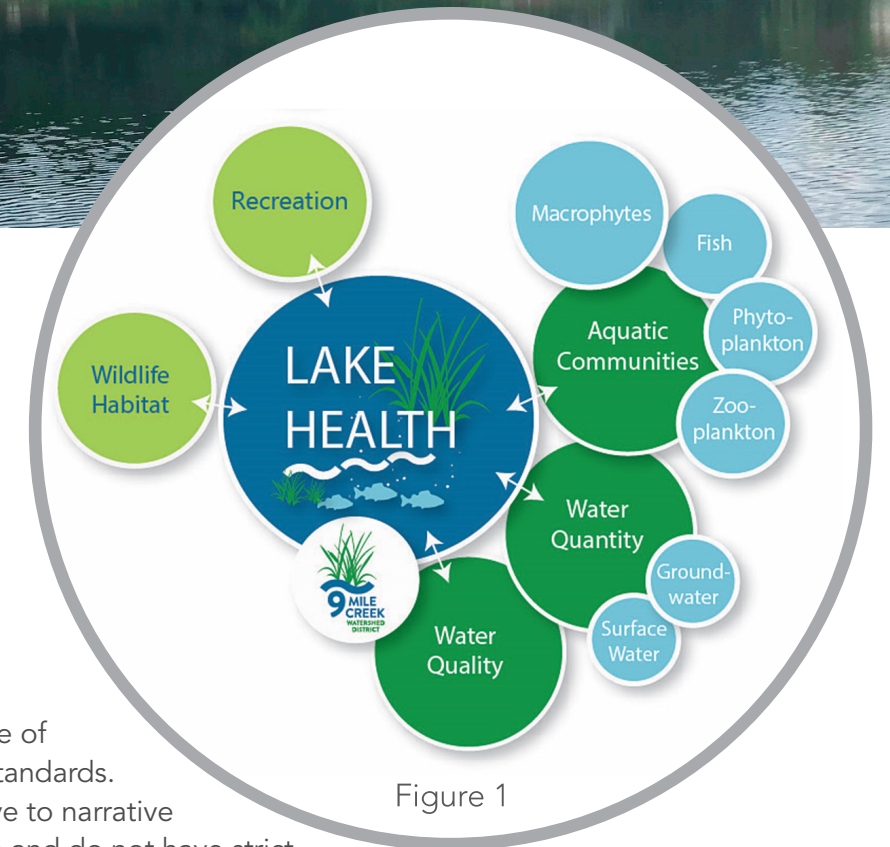
Figure 1

When assessing the ecological health of a lake, it is important to take a holistic approach, considering factors such as in-lake water quality (e.g., phosphorus and nitrogen concentrations), the health and quality of the aquatic communities, and water quantity (see Figure 1). How recreation and wildlife habitat affect and are affected by overall lake health are also considered. Numerical goals exist for some of these factors, such as state water quality standards. However, other factors are assessed relative to narrative criteria that describe the desired condition and do not have strict numerical goals. For this study, the primary goals are to achieve the water quality standards for shallow lakes; attain a diverse, native macrophyte (aquatic plant) population; and support a healthy, balanced aquatic ecosystem.

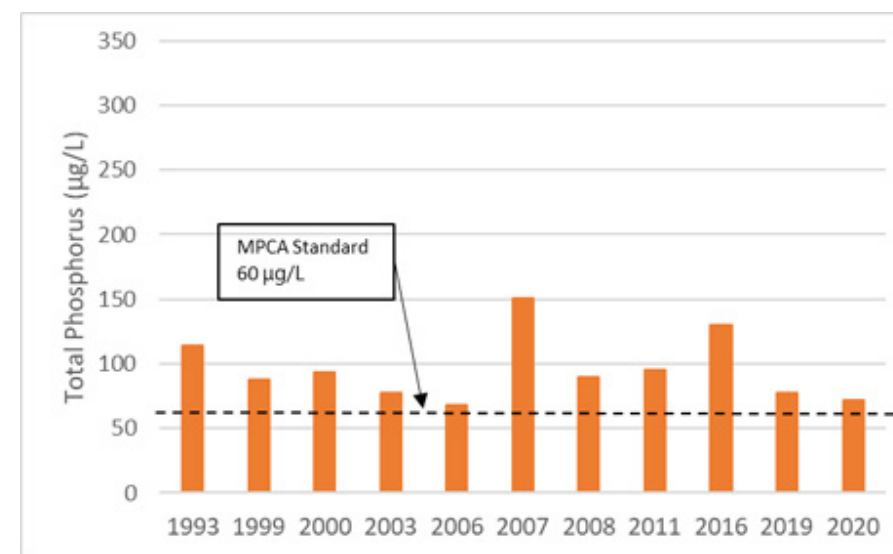
### Lake Rose

Summer average total phosphorus concentrations measured in Lake Rose between 1993 and 2020

Review of historic data indicates that water quality in Lake Rose has generally been improving. The summer average total phosphorus concentrations measured from 1993 through 2020 in Lake Rose were above the shallow lake state standard, although there has generally been a decreasing trend in concentrations since 2007. The Lake Rose summer average chlorophyll-a concentrations measured from 1993 through 2019 were also above the shallow lake state standard, but show a decreasing trend in concentrations since 2007. The summer average chlorophyll-a concentration of 15 µg/L observed in 2020 met the shallow lake standard (<20 µg/L). The phytoplankton (algae) and plant surveys completed in 2020 also show improvement in ecosystem health. Phytoplankton concentrations decreased between 2008 and 2020 and the number of plant species increased from 8 to 12 species, indicating a healthy plant community. While Lake Rose water quality has generally been improving, considerations should still be made to reduce nutrient sources. The phosphorus in Lake Rose comes from several sources, including stormwater runoff from the watershed, inflows from upstream lake, Wing Lake, and internal sources such as nutrient-rich sediments.
