Appendix E

Aquatic Plant Maps: Lake Edina

Aquatic Plant Survey Maps: Lake Edina

Point Intercept Macrophyte Survey
 Lake Edina
 Nine Mile Creek Watershed District
 Hennepin County, MN
 June 26, 2019

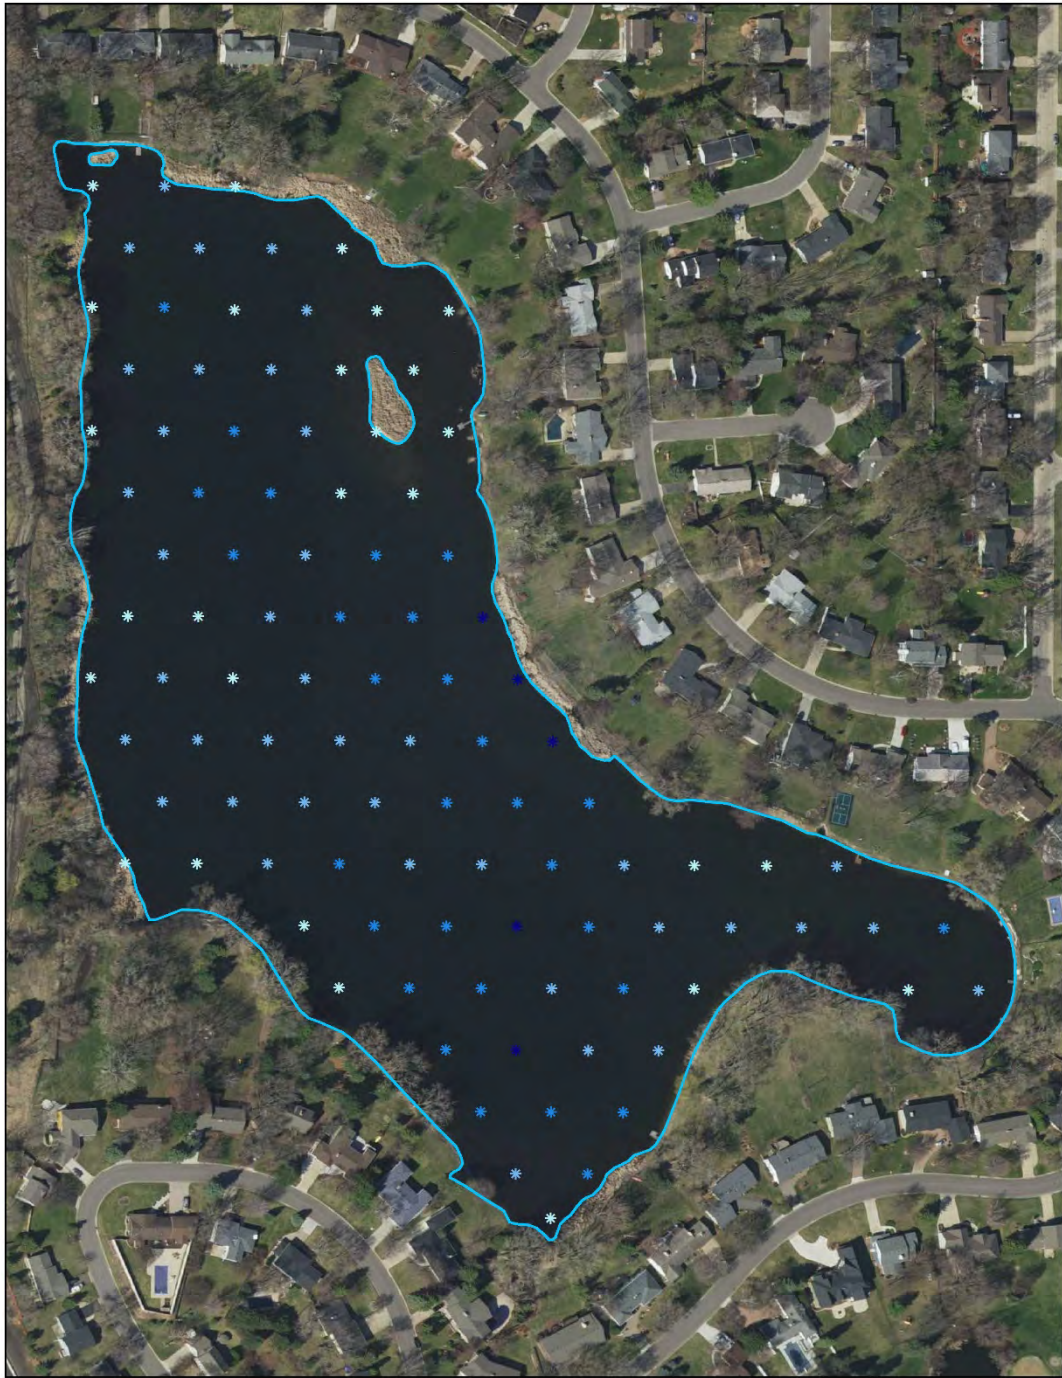
Lake Depth

Depth in ft.

- 1.0 - 2.0
- 2.1 - 2.5
- 2.6 - 3.0
- 3.1 - 4.0

Point Intercept Macrophyte Survey
 Lake Edina
 Nine Mile Creek Watershed District
 Hennepin County, MN
 June 26, 2019

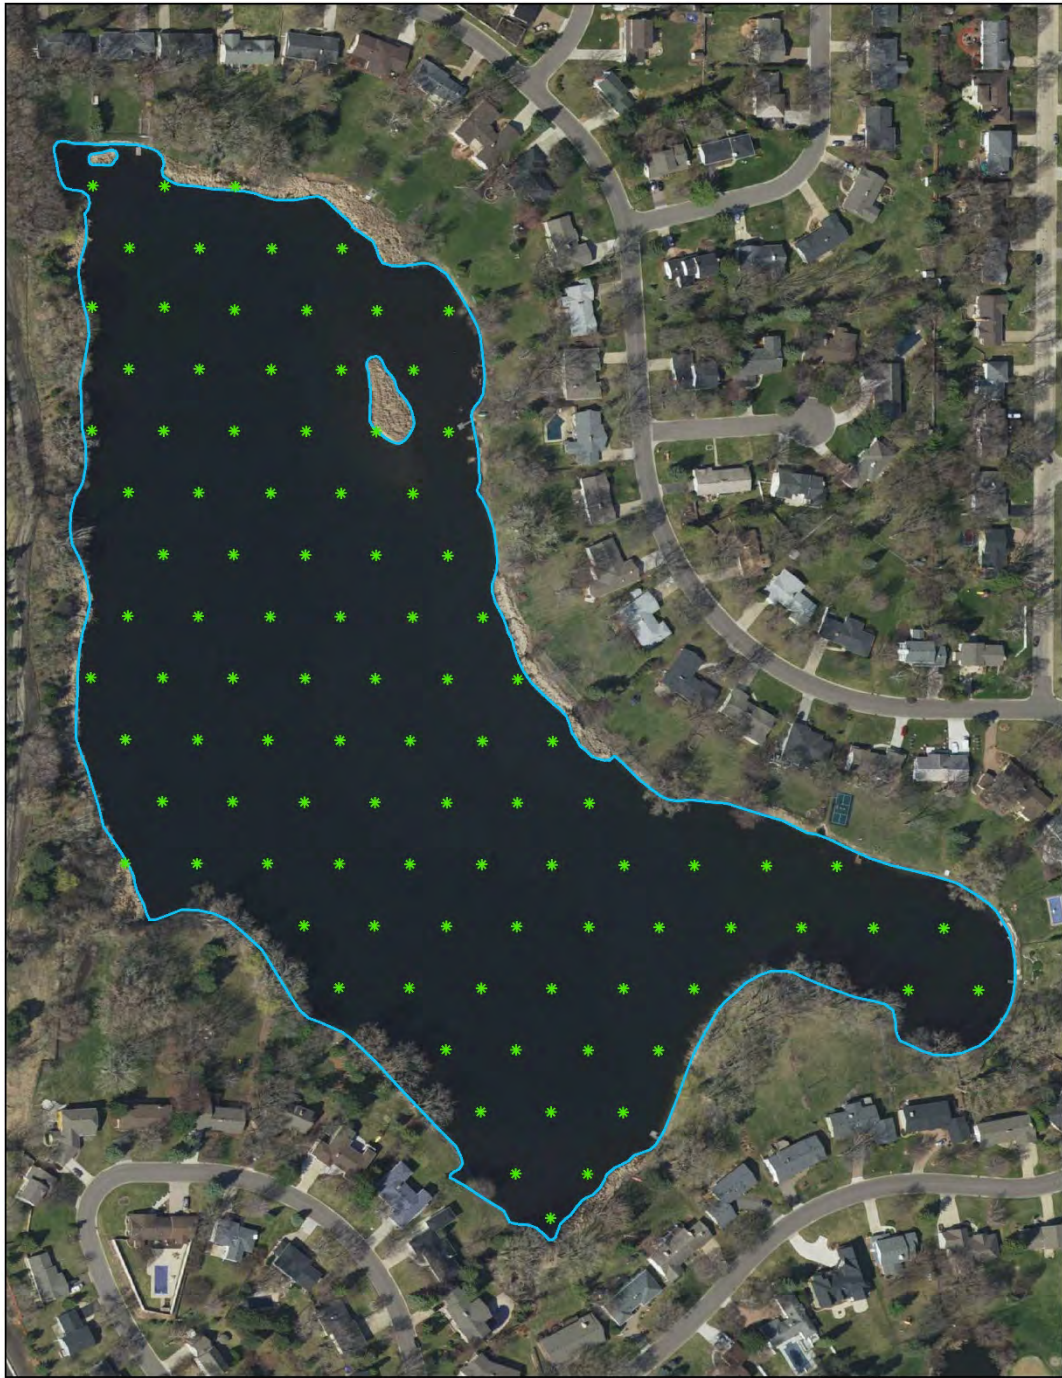
- * Littoral Zone
- * Littoral Zone with Plants

Littoral Zone
 Point Intercept Macrophyte Survey
 Lake Edina
 Nine Mile Creek Watershed District
 Hennepin County, MN
 June 26, 2019

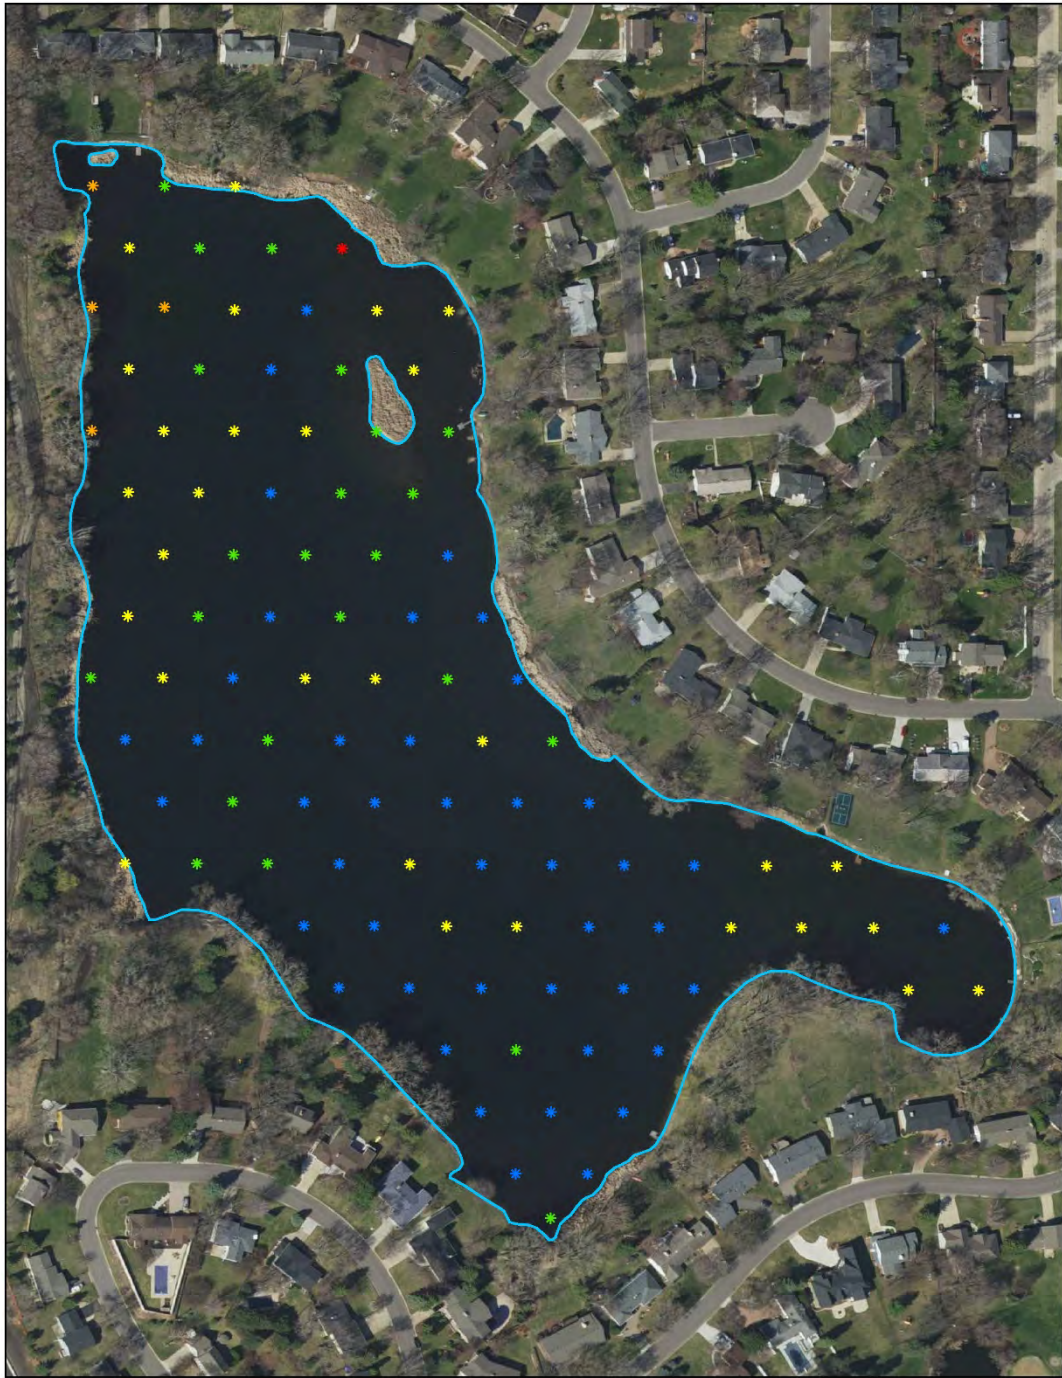
Native Species Richness

of Native Species

- × None Found
- * 1
- * 2
- * 3 - 4
- * 5 - 6
- * 7

Point Intercept Macrophyte Survey
 Lake Edina
 Nine Mile Creek Watershed District
 Hennepin County, MN
 June 26, 2019

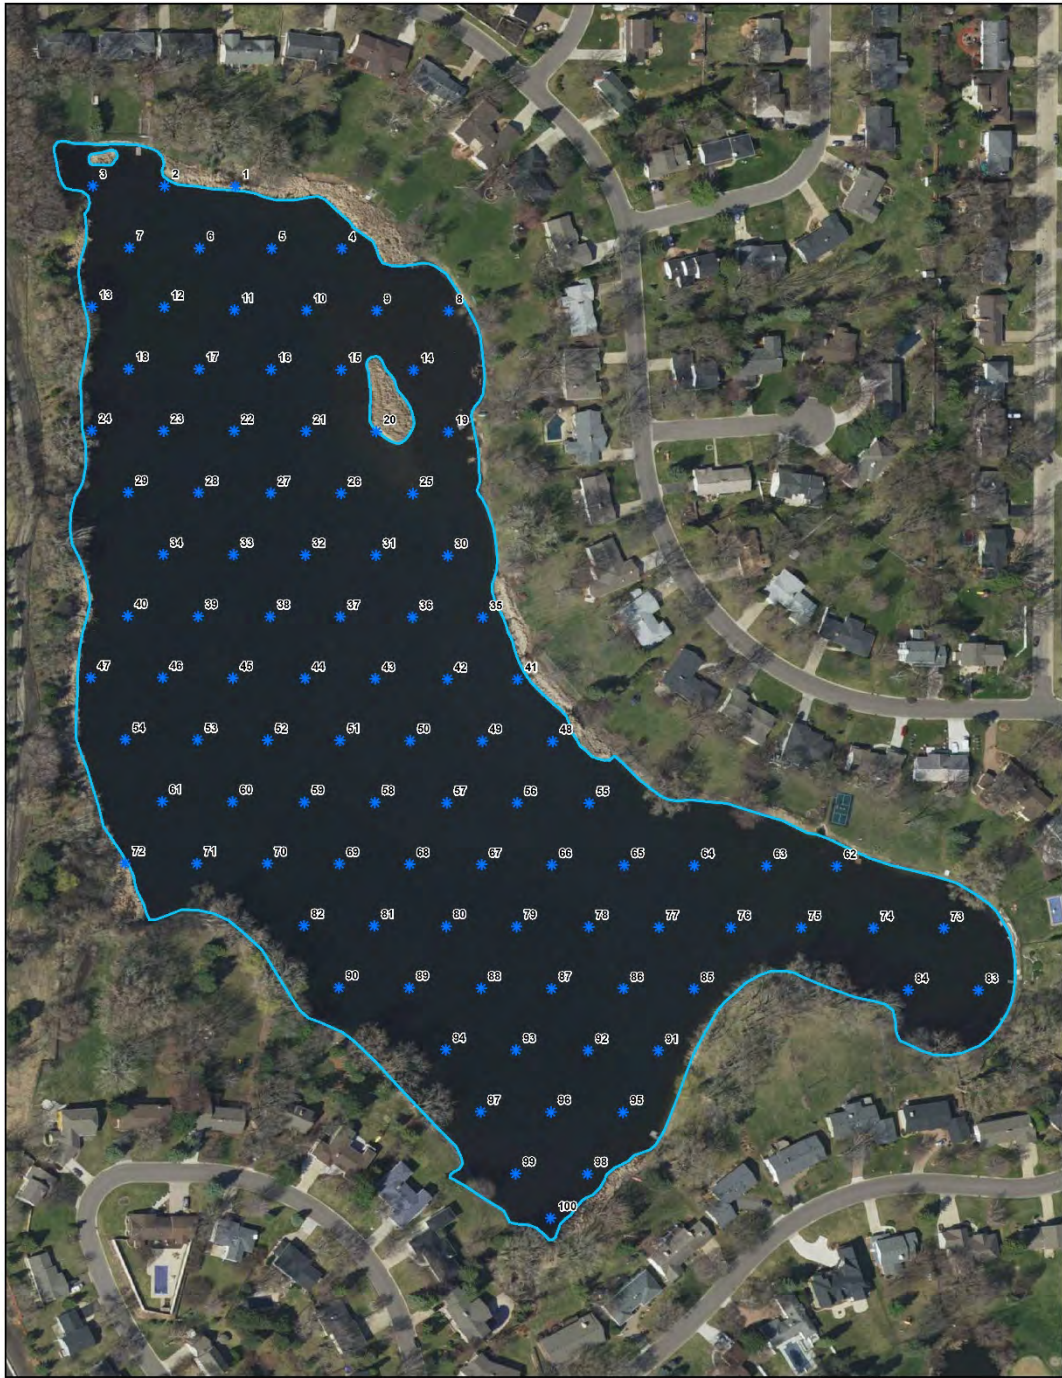
Survey Sample Points

* Sample Point

Point Intercept Macrophyte Survey
 Lake Edina
 Nine Mile Creek Watershed District
 Hennepin County, MN
 June 26, 2019

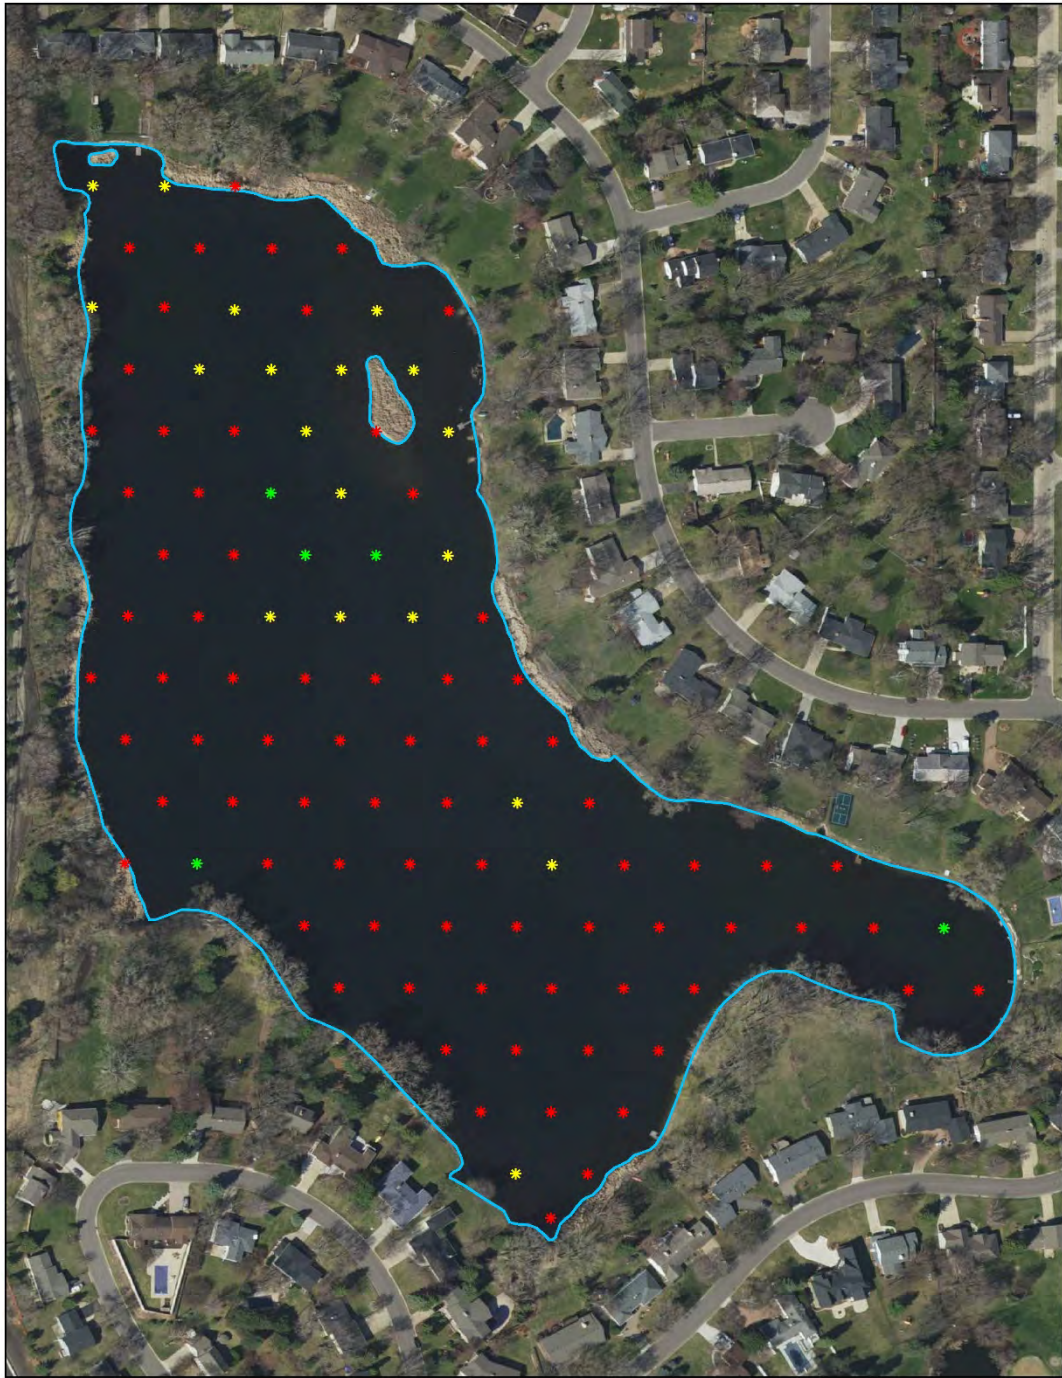
Total Rake Fullness

Rake Fullness Rating

- * 1
- * 2
- * 3
- × None Found

Point Intercept Macrophyte Survey
 Lake Edina
 Nine Mile Creek Watershed District
 Hennepin County, MN
 June 26, 2019

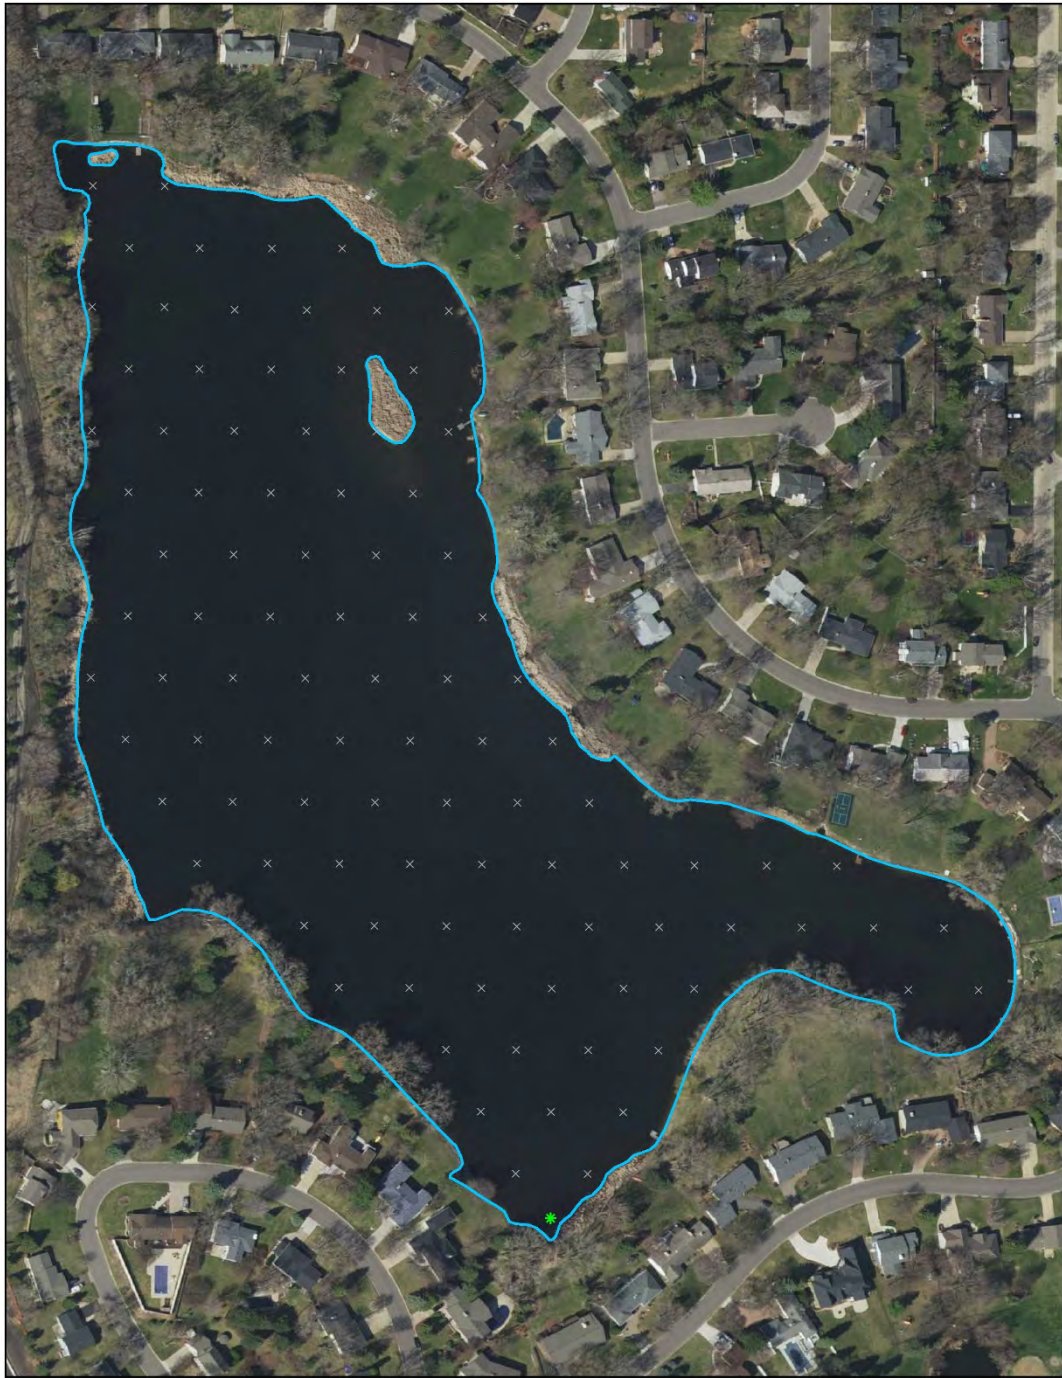
Coontail
(Ceratophyllum demersum)

Rake Fullness Rating

- ✱ Visual
- ★ 1
- ★ 2
- ★ 3
- ✕ None Found

Point Intercept Macrophyte Survey
Lake Edina
Nine Mile Creek Watershed District
Hennepin County, MN
June 26, 2019

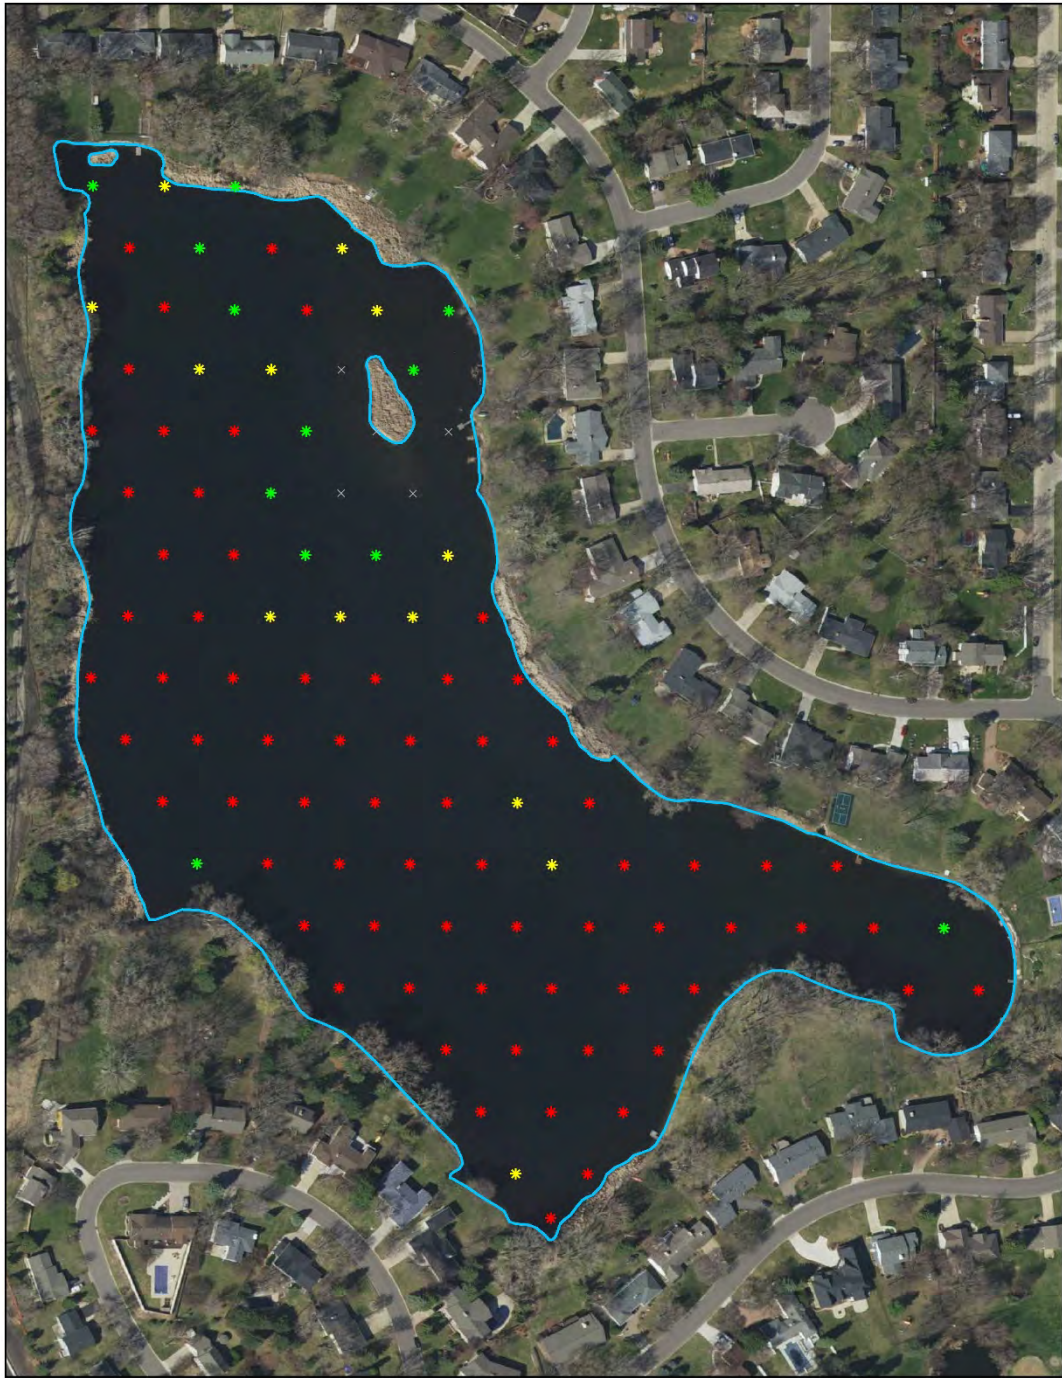
**Common waterweed
(*Elodea canadensis*)**

Rake Fullness Rating

- ✱ Visual
- ✱ 1
- ✱ 2
- ✱ 3
- ✕ None Found

Point Intercept Macrophyte Survey
 Lake Edina
 Nine Mile Creek Watershed District
 Hennepin County, MN
 June 26, 2019

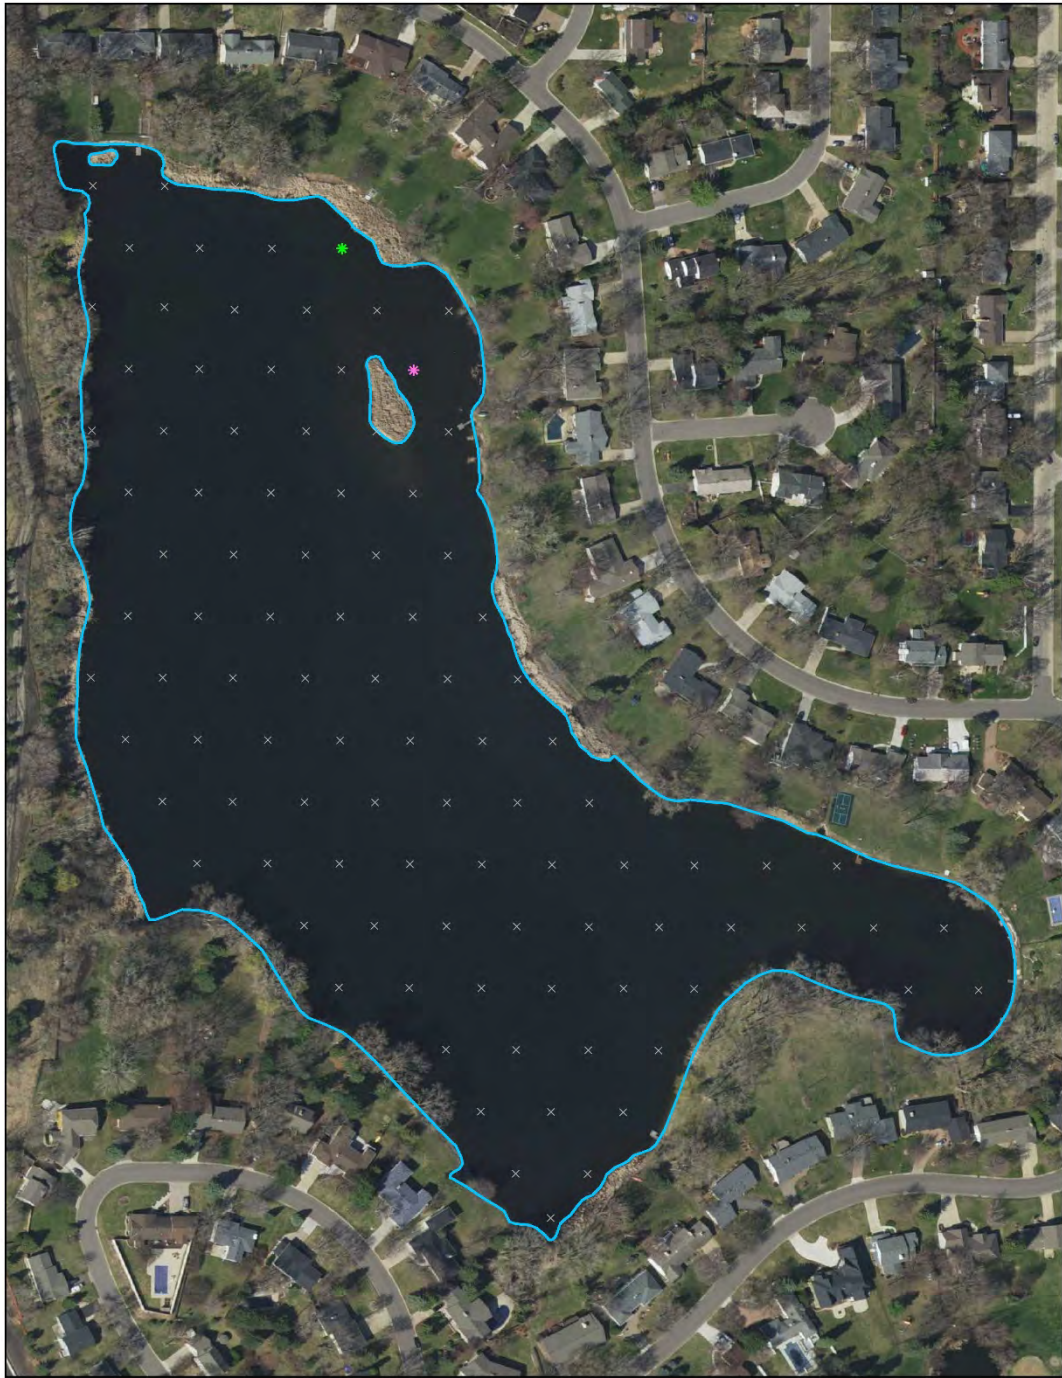
**Slender naiad
(*Najas flexilis*)**

Rake Fullness Rating

- ✱ Visual
- ✱ 1
- ✱ 2
- ✱ 3
- ✕ None Found

Point Intercept Macrophyte Survey
 Lake Edina
 Nine Mile Creek Watershed District
 Hennepin County, MN
 June 26, 2019

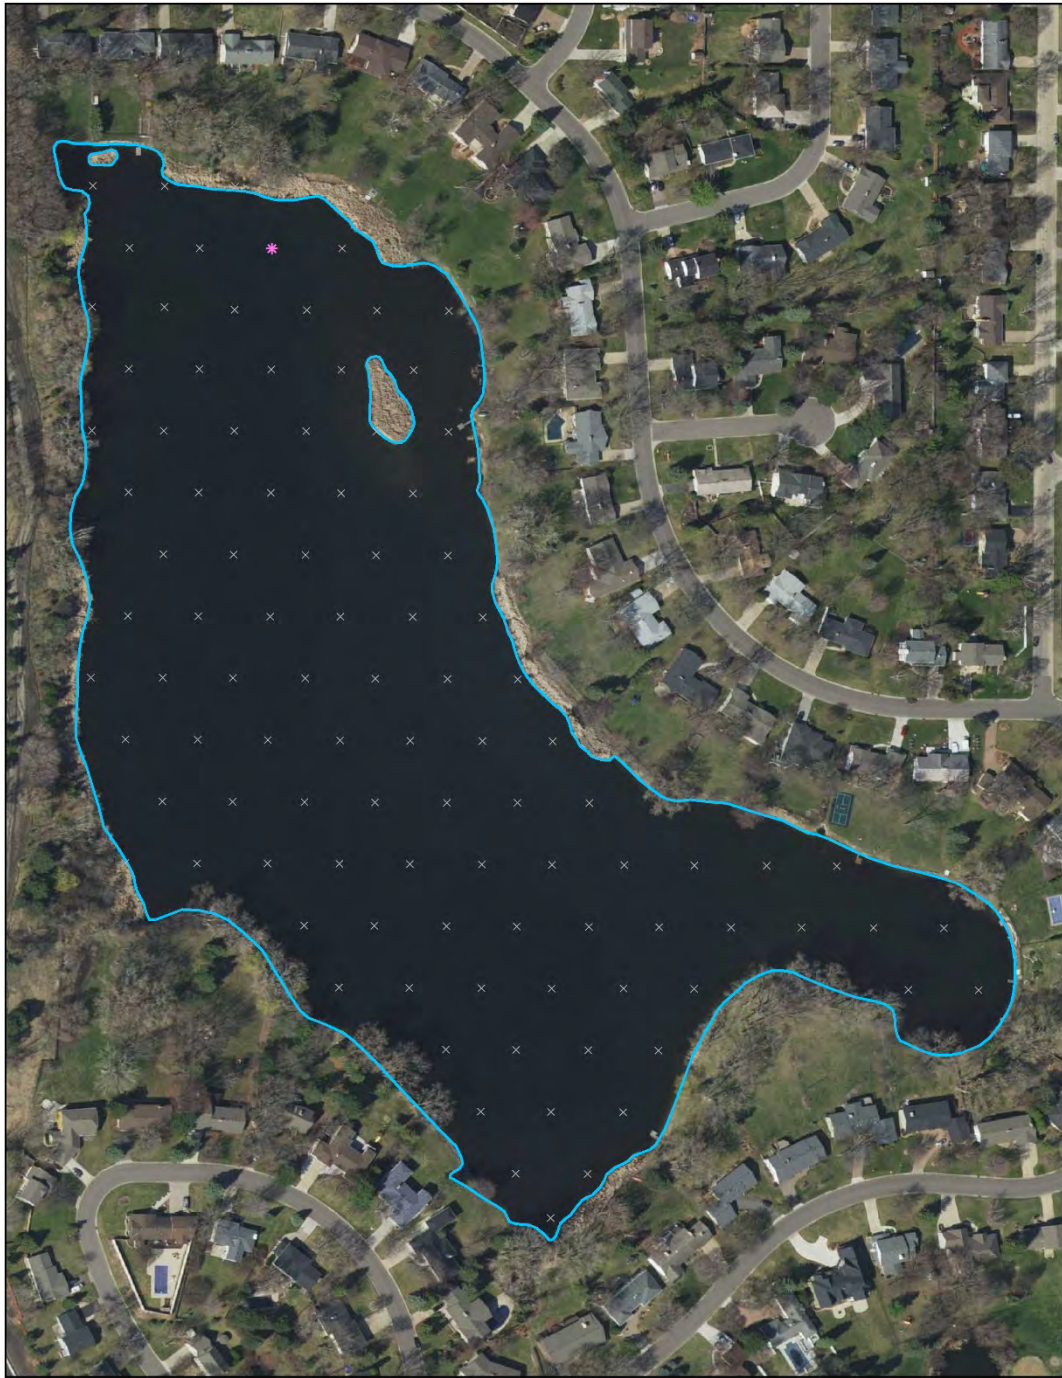
Rake Fullness Rating

- ✱ Visual
- ✱ 1
- ✱ 2
- ✱ 3
- ✱ None Found

Small pondweed
(Potamogeton pusillus)
 Point Intercept Macrophyte Survey
 Lake Edina
 Nine Mile Creek Watershed District
 Hennepin County, MN
 June 26, 2019

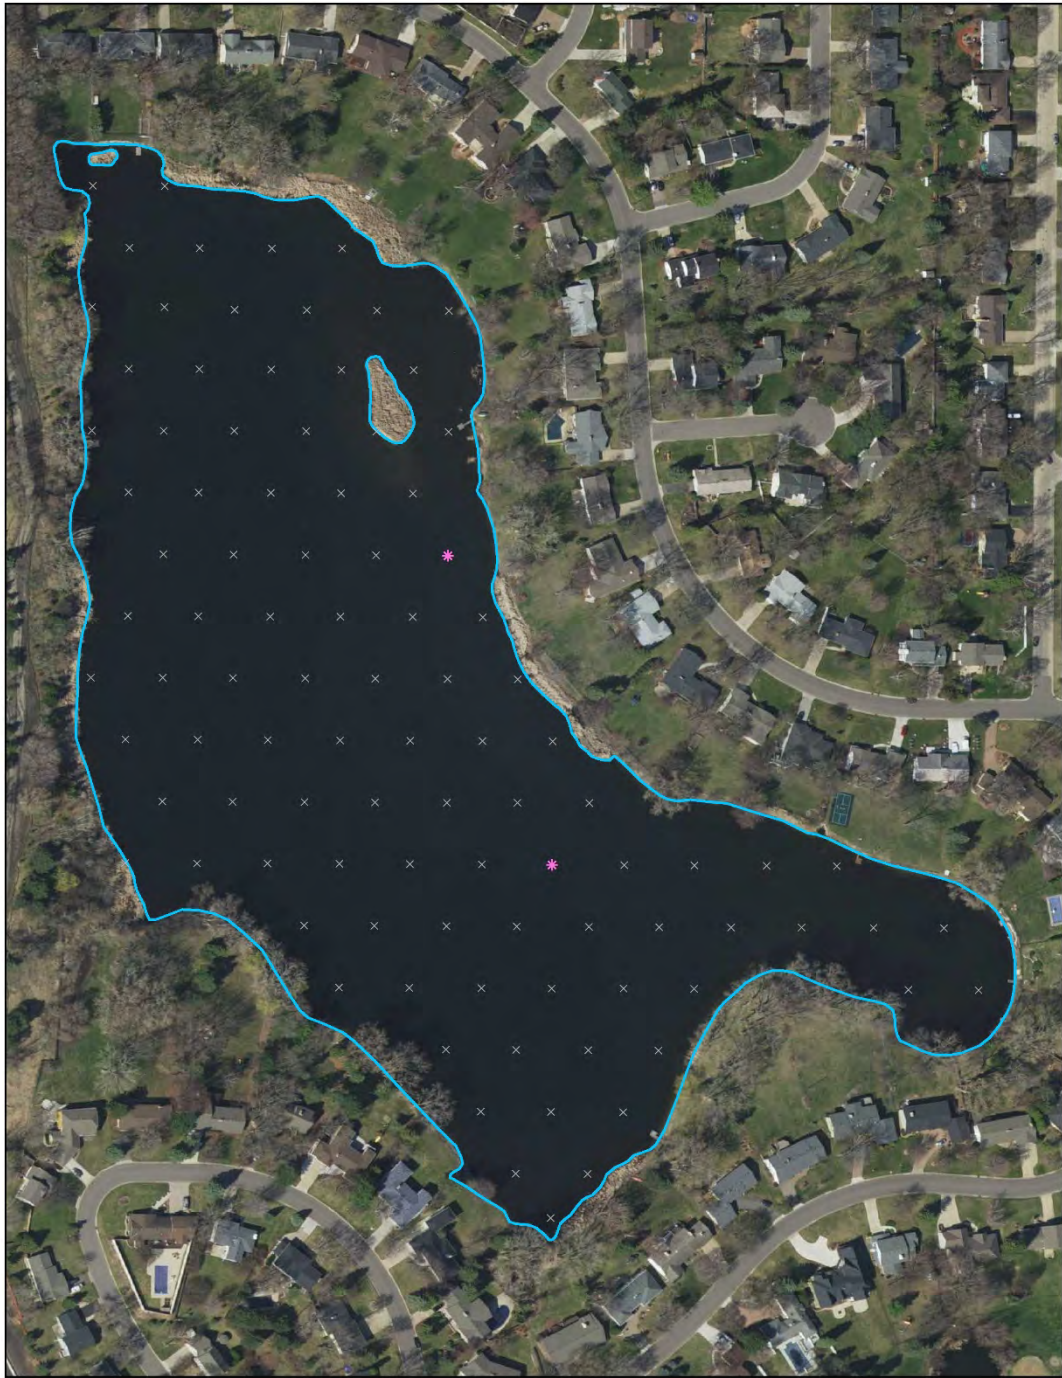
Rake Fullness Rating

- ✱ Visual
- ✱ 1
- ✱ 2
- ✱ 3
- ✕ None Found

Sago pondweed
(Stuckenia pectinata)
 Point Intercept Macrophyte Survey
 Lake Edina
 Nine Mile Creek Watershed District
 Hennepin County, MN
 June 26, 2019

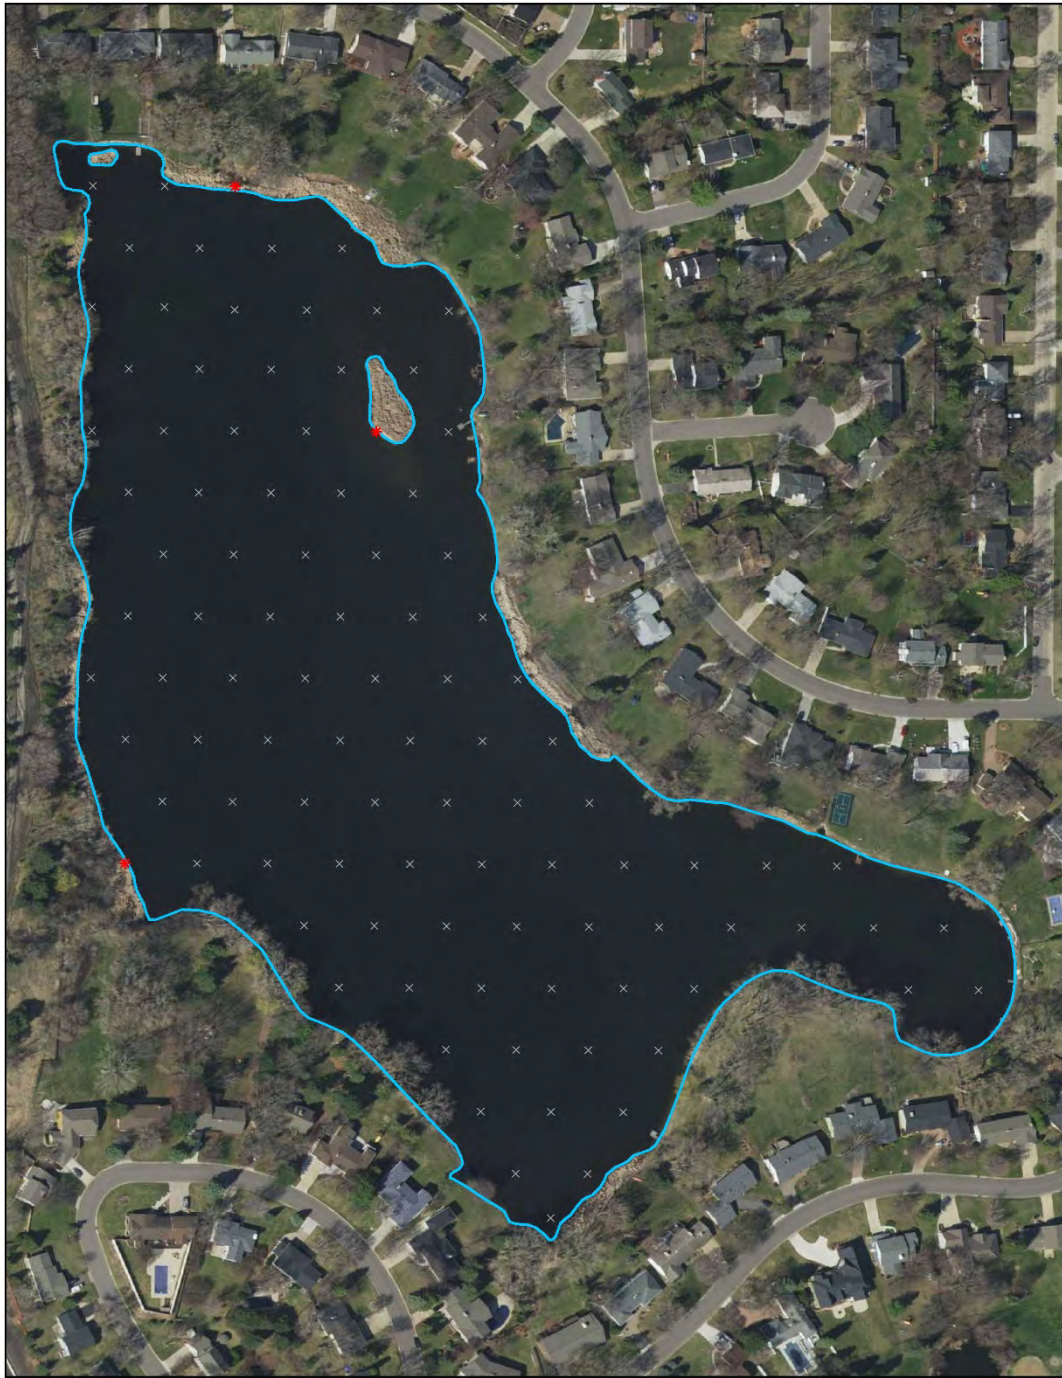
Rake Fullness Rating

- ✱ Visual
- ✱ 1
- ✱ 2
- ✱ 3
- ✕ None Found

Narrow-leaved cattail
(Typha angustifolia)
 Point Intercept Macrophyte Survey
 Lake Edina
 Nine Mile Creek Watershed District
 Hennepin County, MN
 June 26, 2019

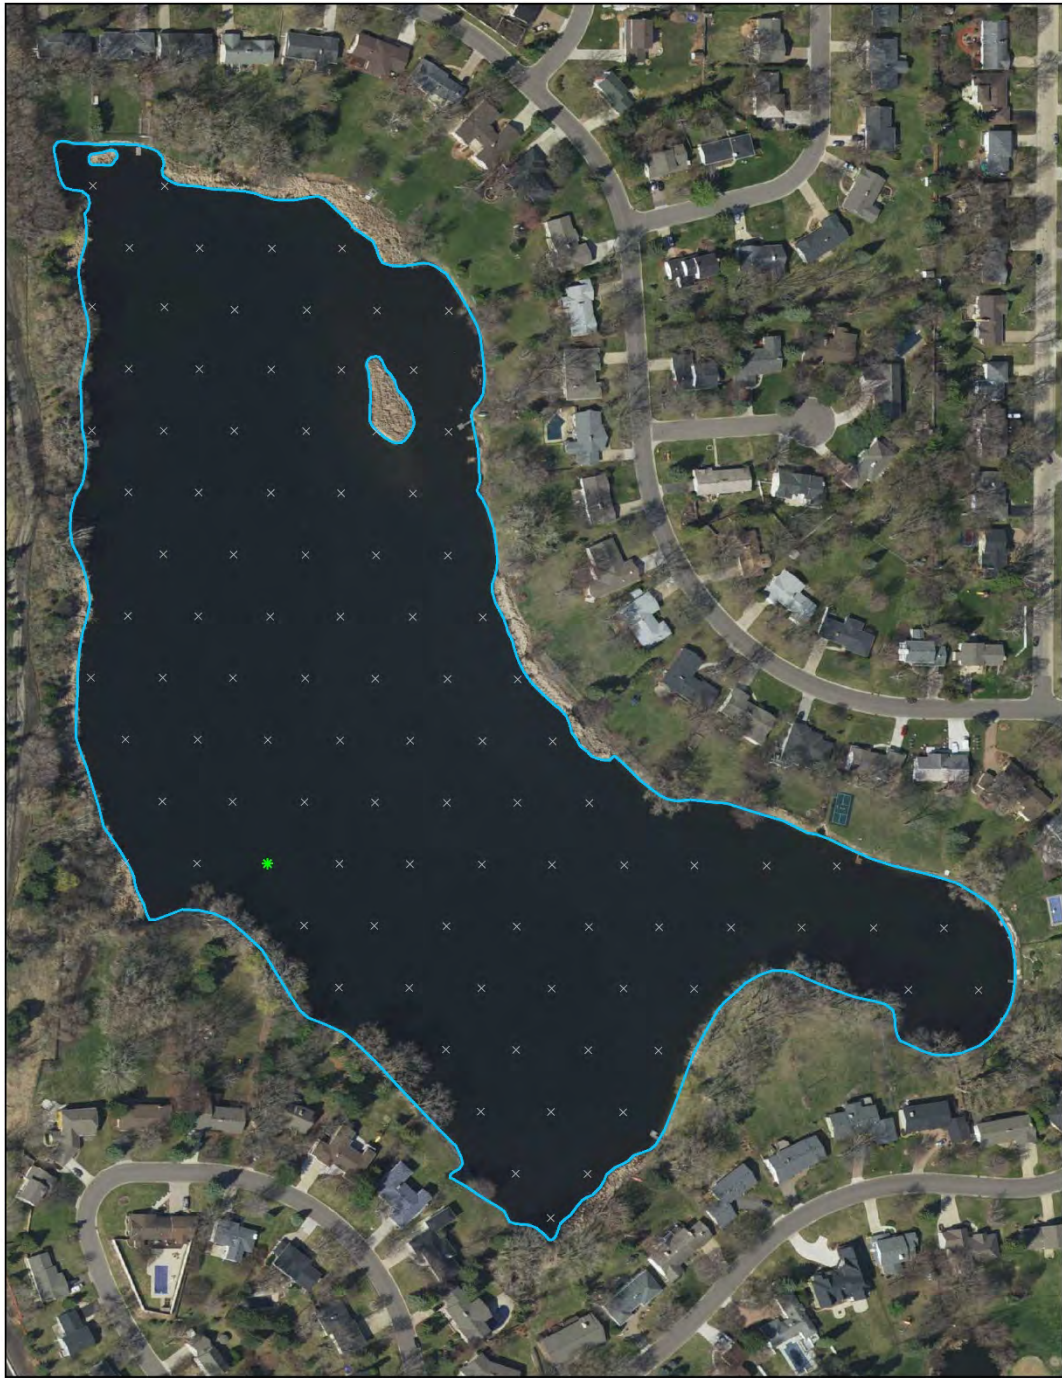
Rake Fullness Rating

- ✱ Visual
- ✱ 1
- ✱ 2
- ✱ 3
- ✱ None Found

Horned pondweed
(Zannichellia palustris)
 Point Intercept Macrophyte Survey
 Lake Edina
 Nine Mile Creek Watershed District
 Hennepin County, MN
 June 26, 2019

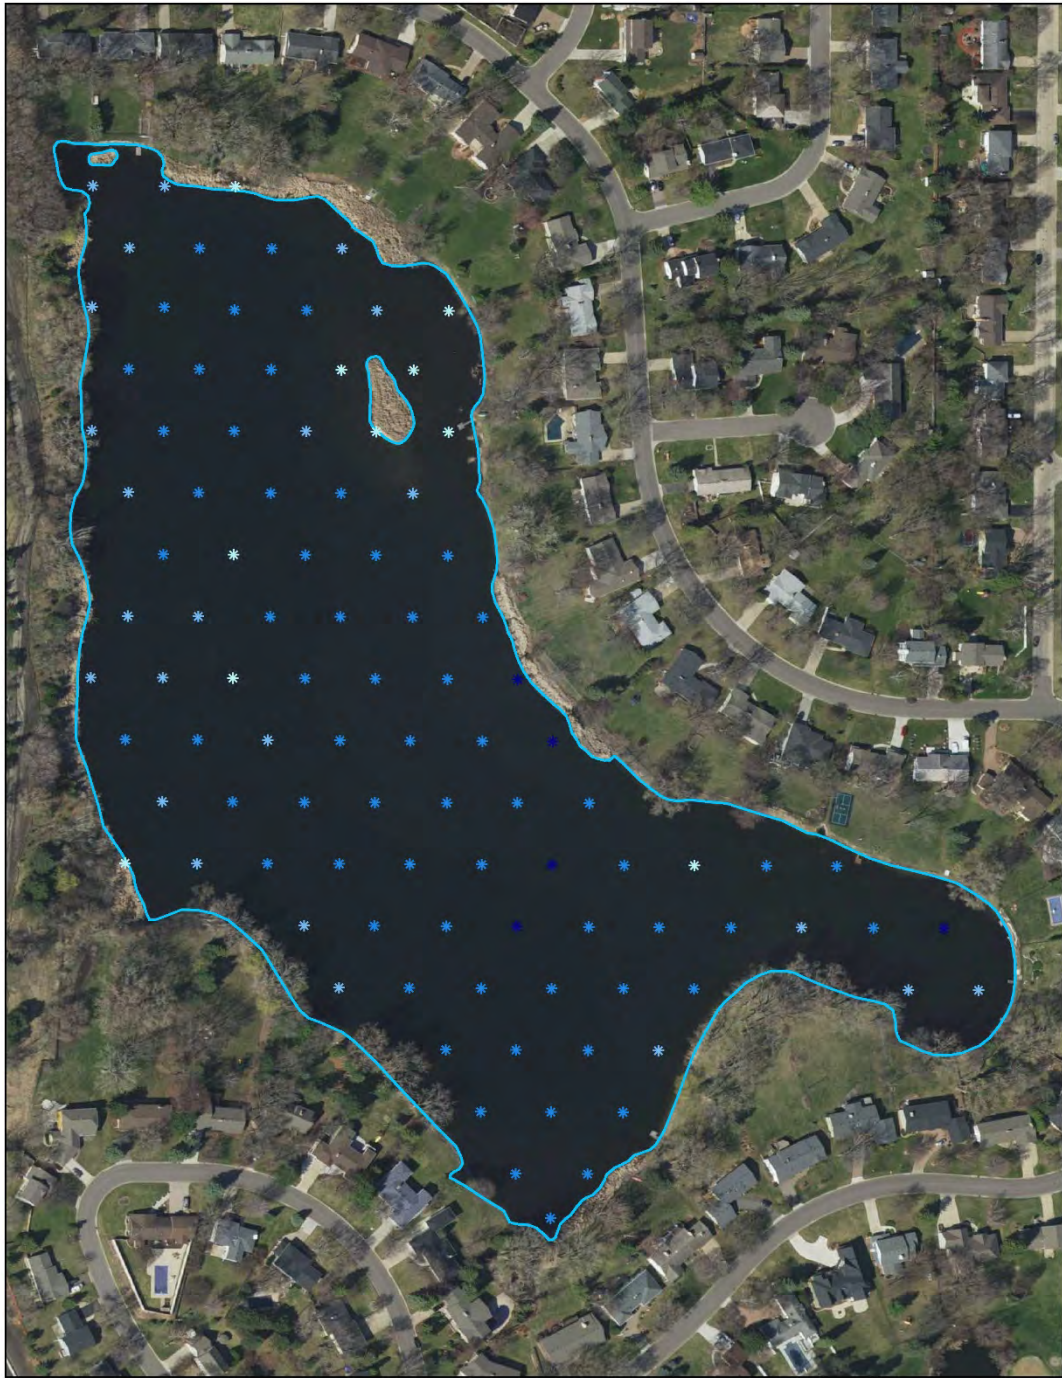
Lake Depth

Depth in ft.

- * 1.0 - 2.0
- * 2.1 - 2.5
- * 2.6 - 3.0
- * 3.1 - 4.0

Point Intercept Macrophyte Survey
 Lake Edina
 Nine Mile Creek Watershed District
 Hennepin County, MN
 August 24, 2019

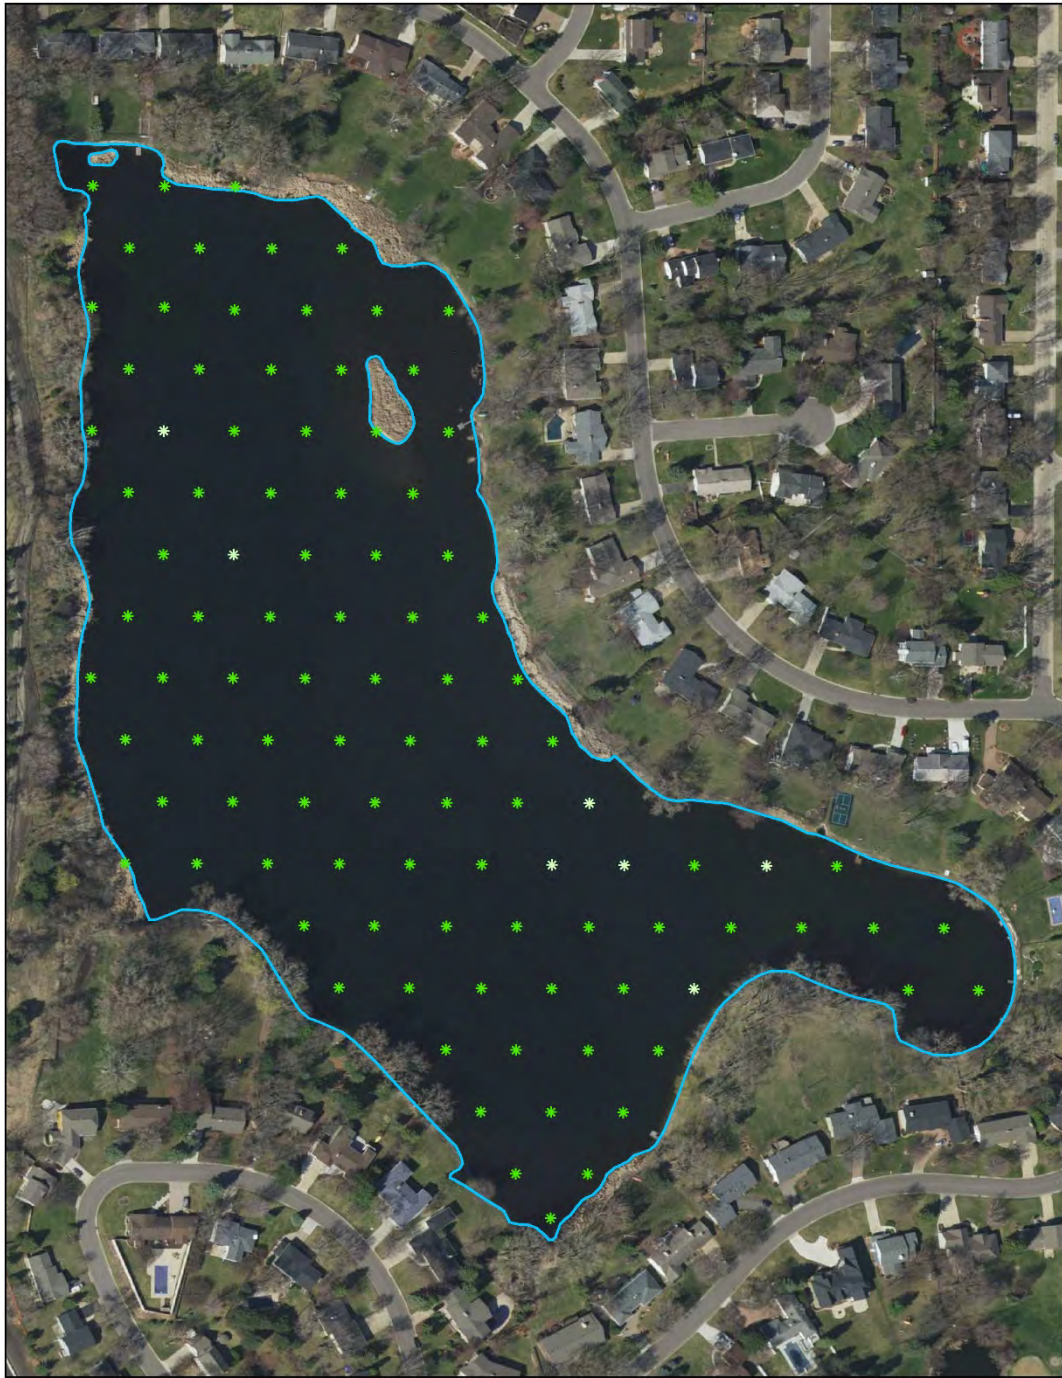
- * Littoral Zone
- * Littoral Zone with Plants

Littoral Zone
 Point Intercept Macrophyte Survey
 Lake Edina
 Nine Mile Creek Watershed District
 Hennepin County, MN
 August 24, 2019

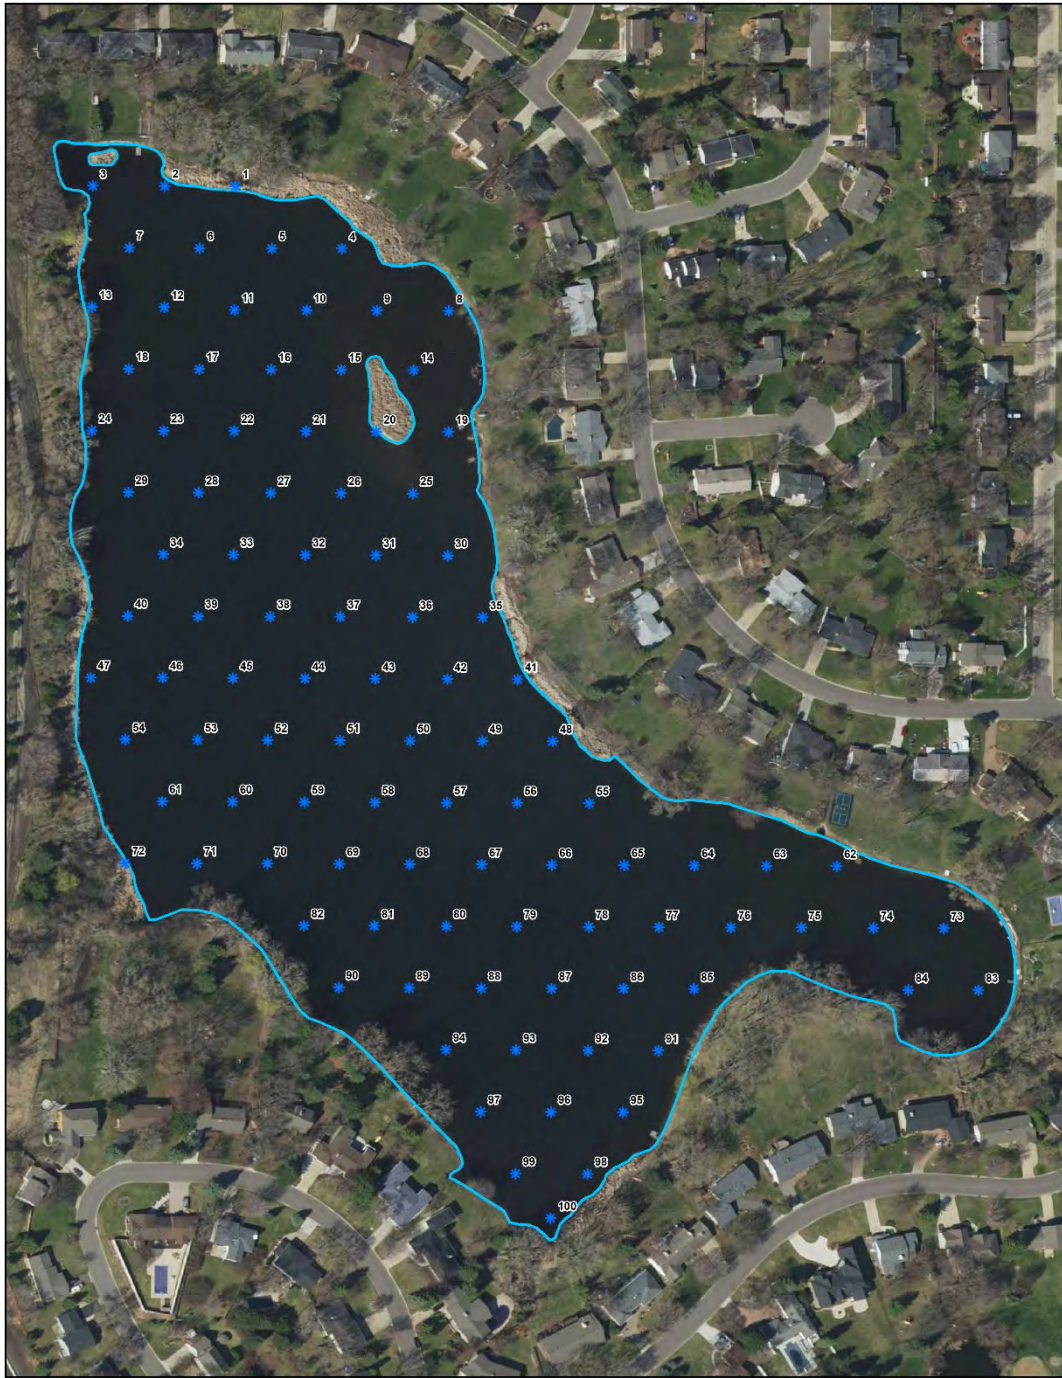
Survey Sample Points

* Sample Point

Point Intercept Macrophyte Survey
 Lake Edina
 Nine Mile Creek Watershed District
 Hennepin County, MN
 August 24, 2019
