Appendix E

Aquatic Plant Maps: Lake Edina

Aquatic Plant Survey Maps: Lake Edina

Point Intercept Macrophyte Survey
 Lake Edina
 Nine Mile Creek Watershed District
 Hennepin County, MN
 June 26, 2019

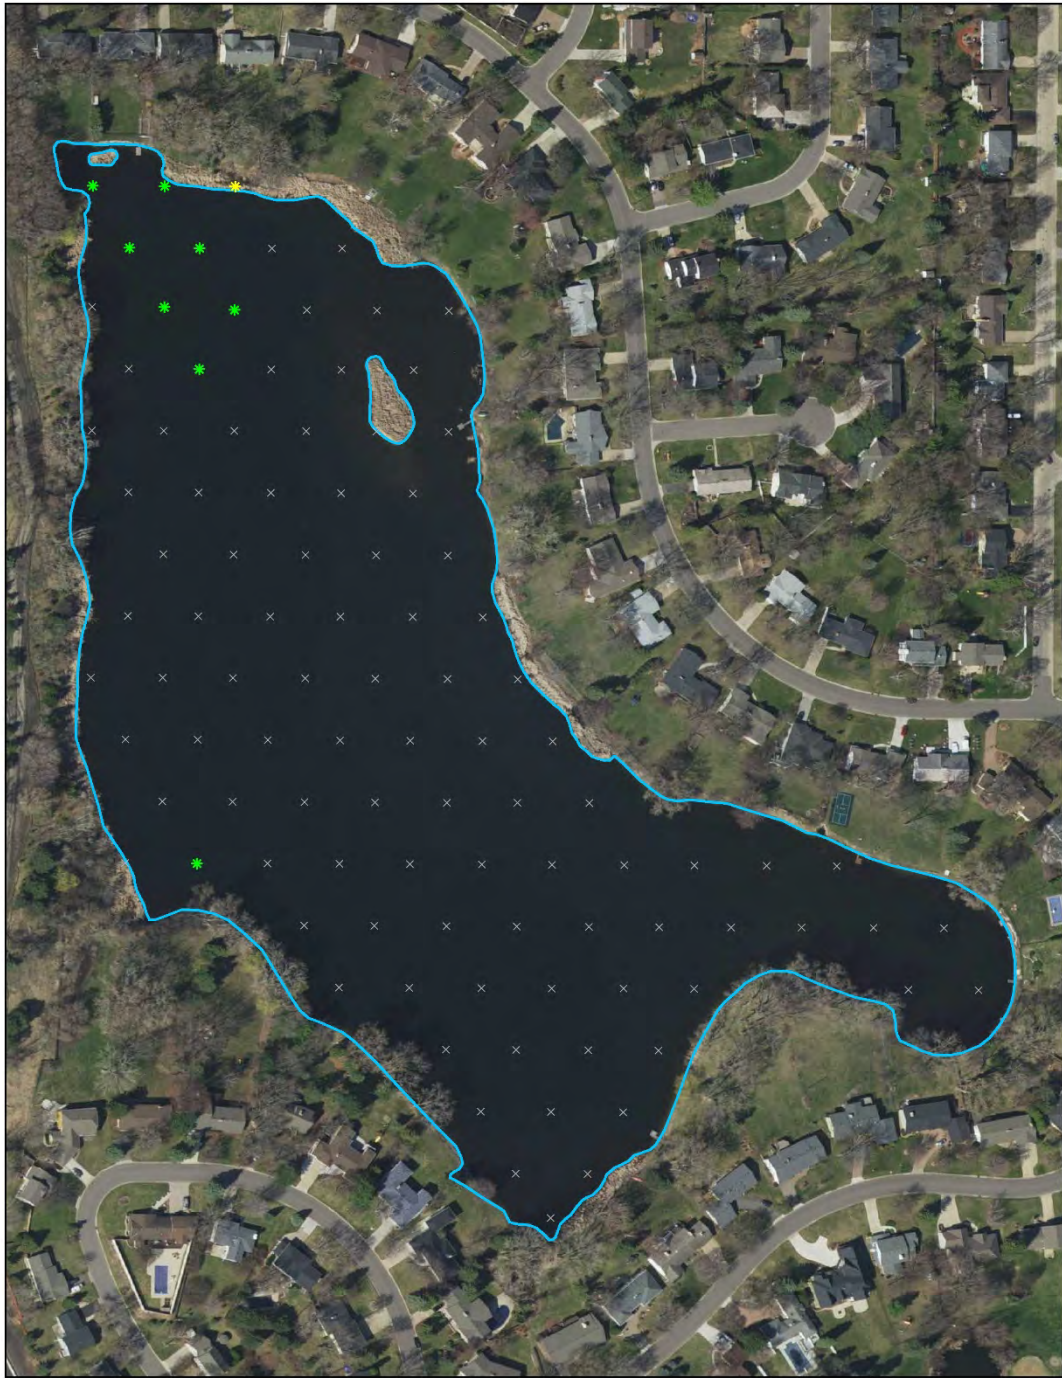
Rake Fullness Rating

- ✱ Visual
- ✱ 1
- ✱ 2
- ✱ 3
- ✕ None Found

Water star-grass
(Heteranthera dubia)
 Point Intercept Macrophyte Survey
 Lake Edina
 Nine Mile Creek Watershed District
 Hennepin County, MN
 August 24, 2019

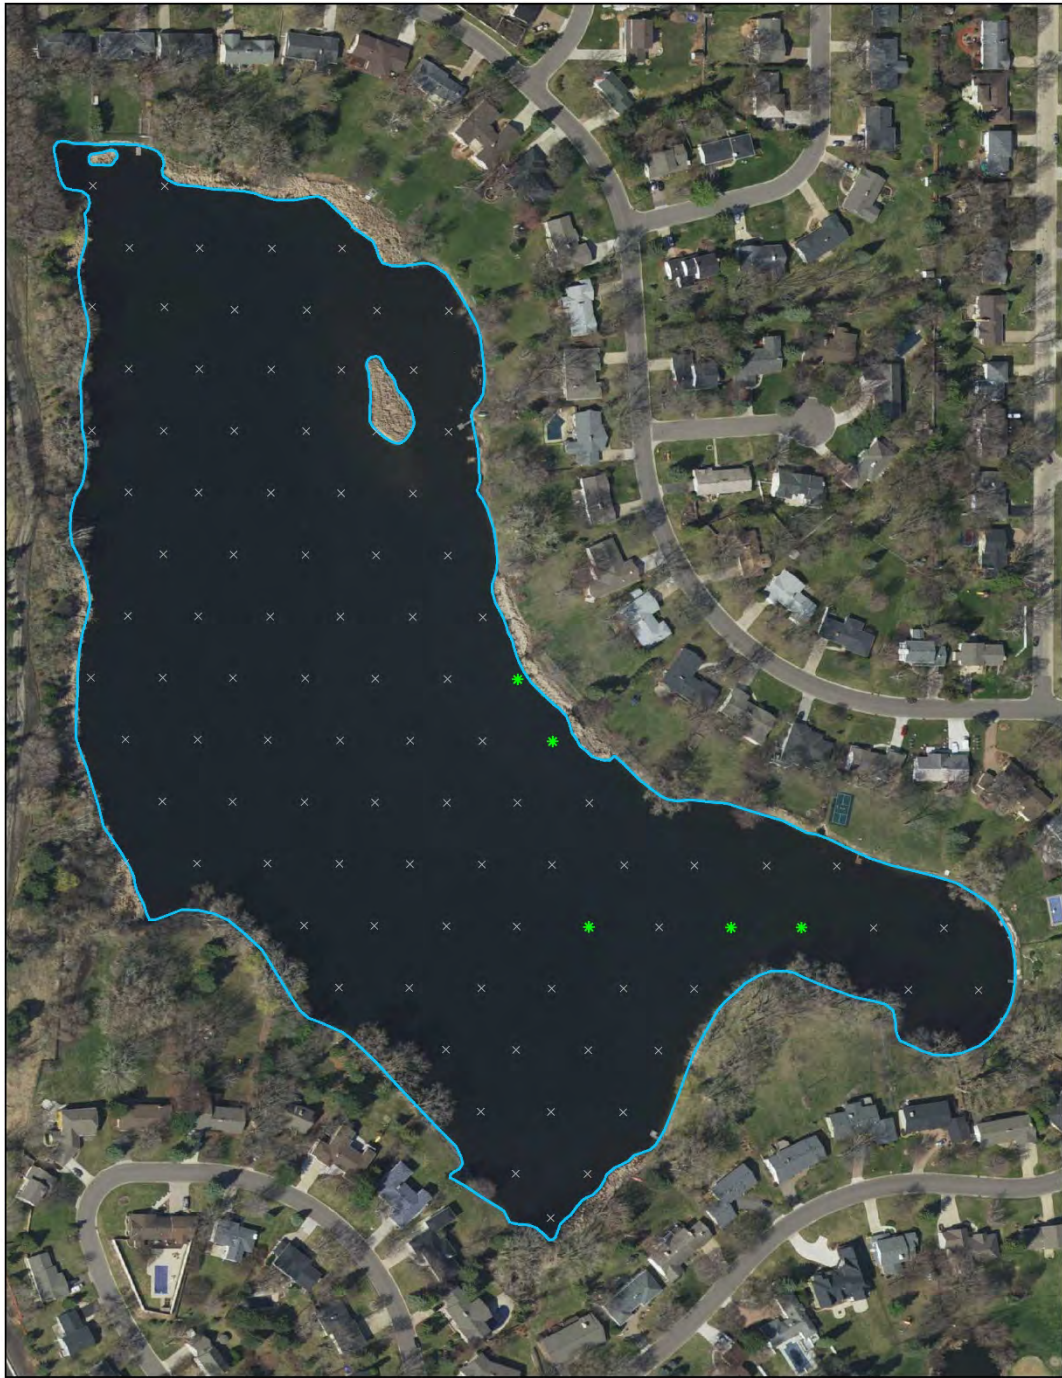
Rake Fullness Rating

- ✱ Visual
- ✱ 1
- ✱ 2
- ✱ 3
- ✕ None Found

Large duckweed
(Spirodela polyrhiza)
 Point Intercept Macrophyte Survey
 Lake Edina
 Nine Mile Creek Watershed District
 Hennepin County, MN
 August 24, 2019

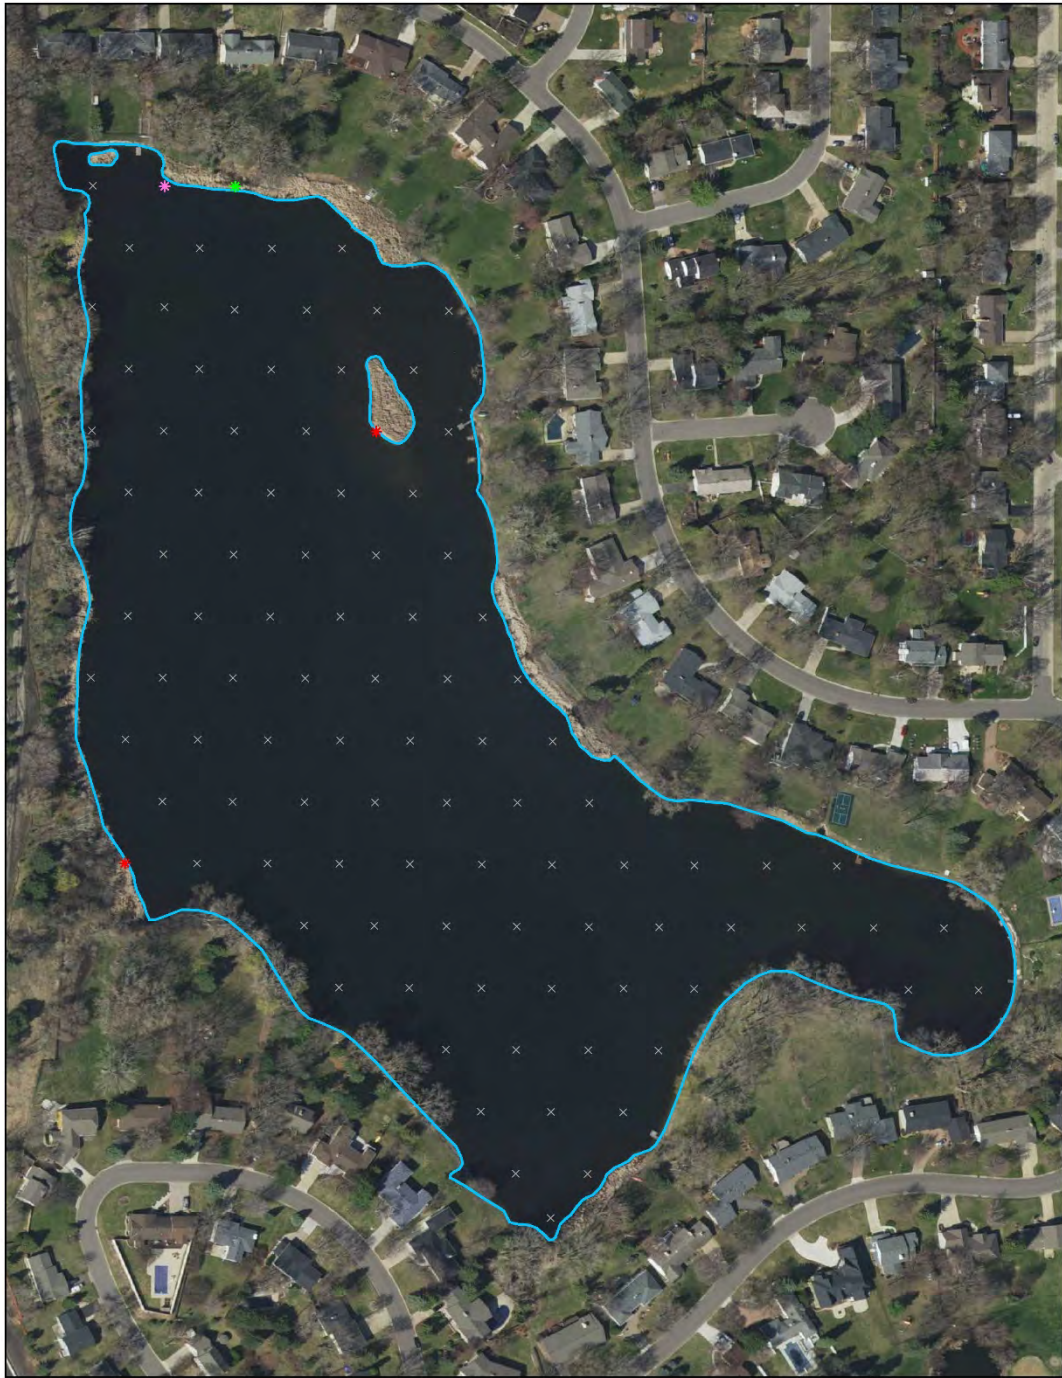
Rake Fullness Rating

- ✱ Visual
- ✱ 1
- ✱ 2
- ✱ 3
- ✕ None Found

Narrow-leaved cattail
(Typha angustifolia)
 Point Intercept Macrophyte Survey
 Lake Edina
 Nine Mile Creek Watershed District
 Hennepin County, MN
 August 24, 2019
