Figure 5-5. Project Synopsis: Bush Lake Use Attainability Analysis

Nine Mile Creek Watershed District

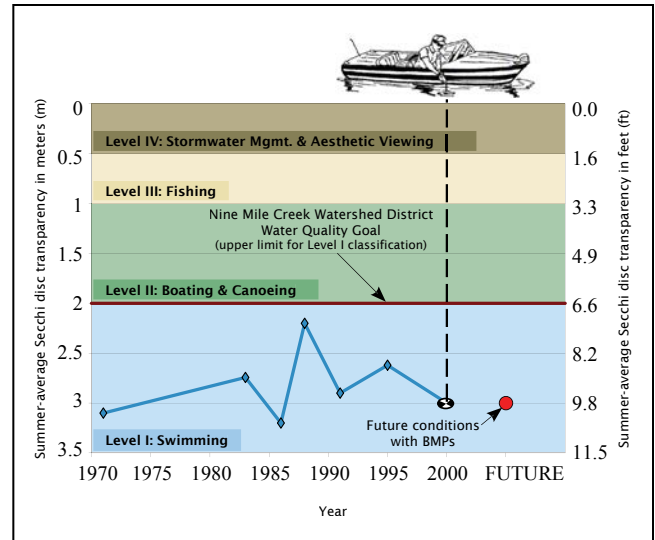
This graph illustrates Bush Lake’s historic and predicted future summer-average water clarity (transparency). Transparency is measured as the depth at which a black-and-white patterned disc (a Secchi disc) disappears from view as it is lowered into the water.

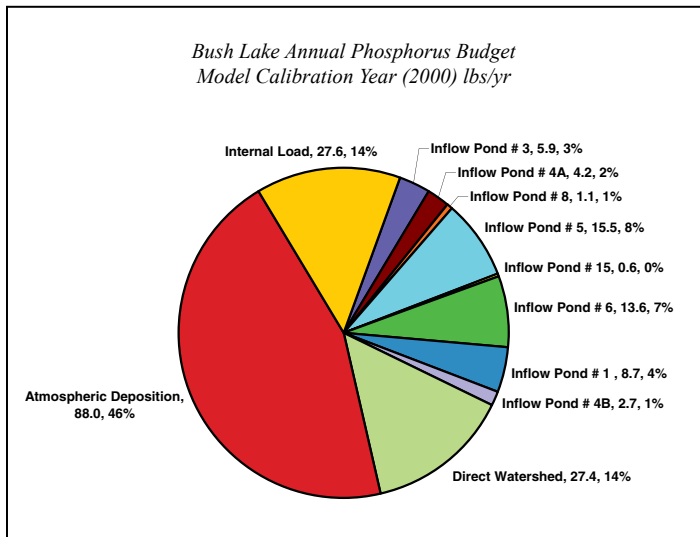
Atmospheric deposition accounts for more than 46 percent of Bush Lake’s annual phosphorus load.

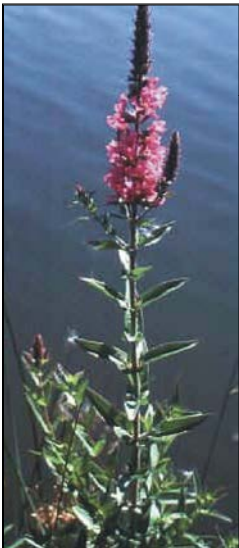
Purple loosestrife is an exotic species that invades wetlands and lake shorelines. It out-competes native species and, if left unchecked, will eventually become the dominant plant wherever it appears.

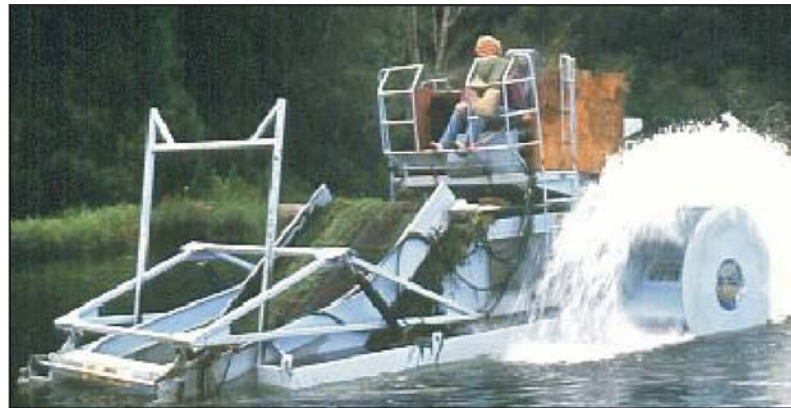
Harvesting Eurasian watermilfoil is a biological management technique used on many area lakes.

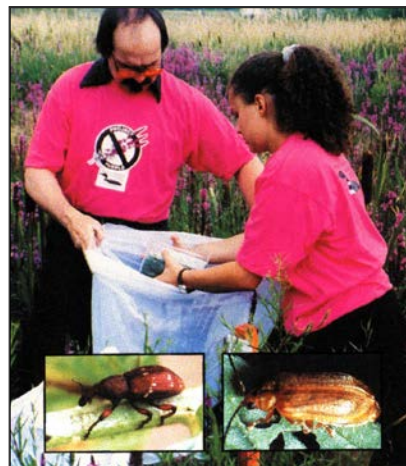
Purple loosestrife can be managed by releasing root-boring weevils onto the plants.

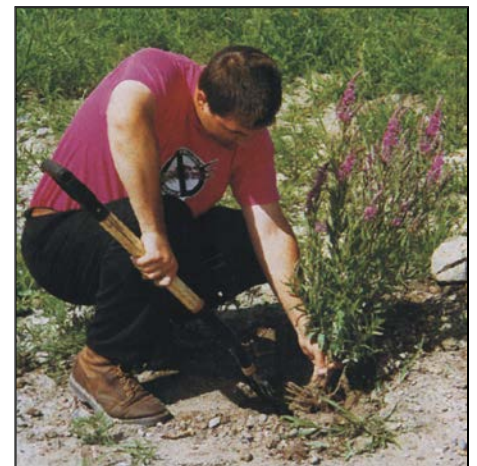
Digging loosestrife by hand is another possible management method.
