Nine Mile Creek Streambank Restoration

Soil Pillows

Constructed Riffle

Stone Toe Protection

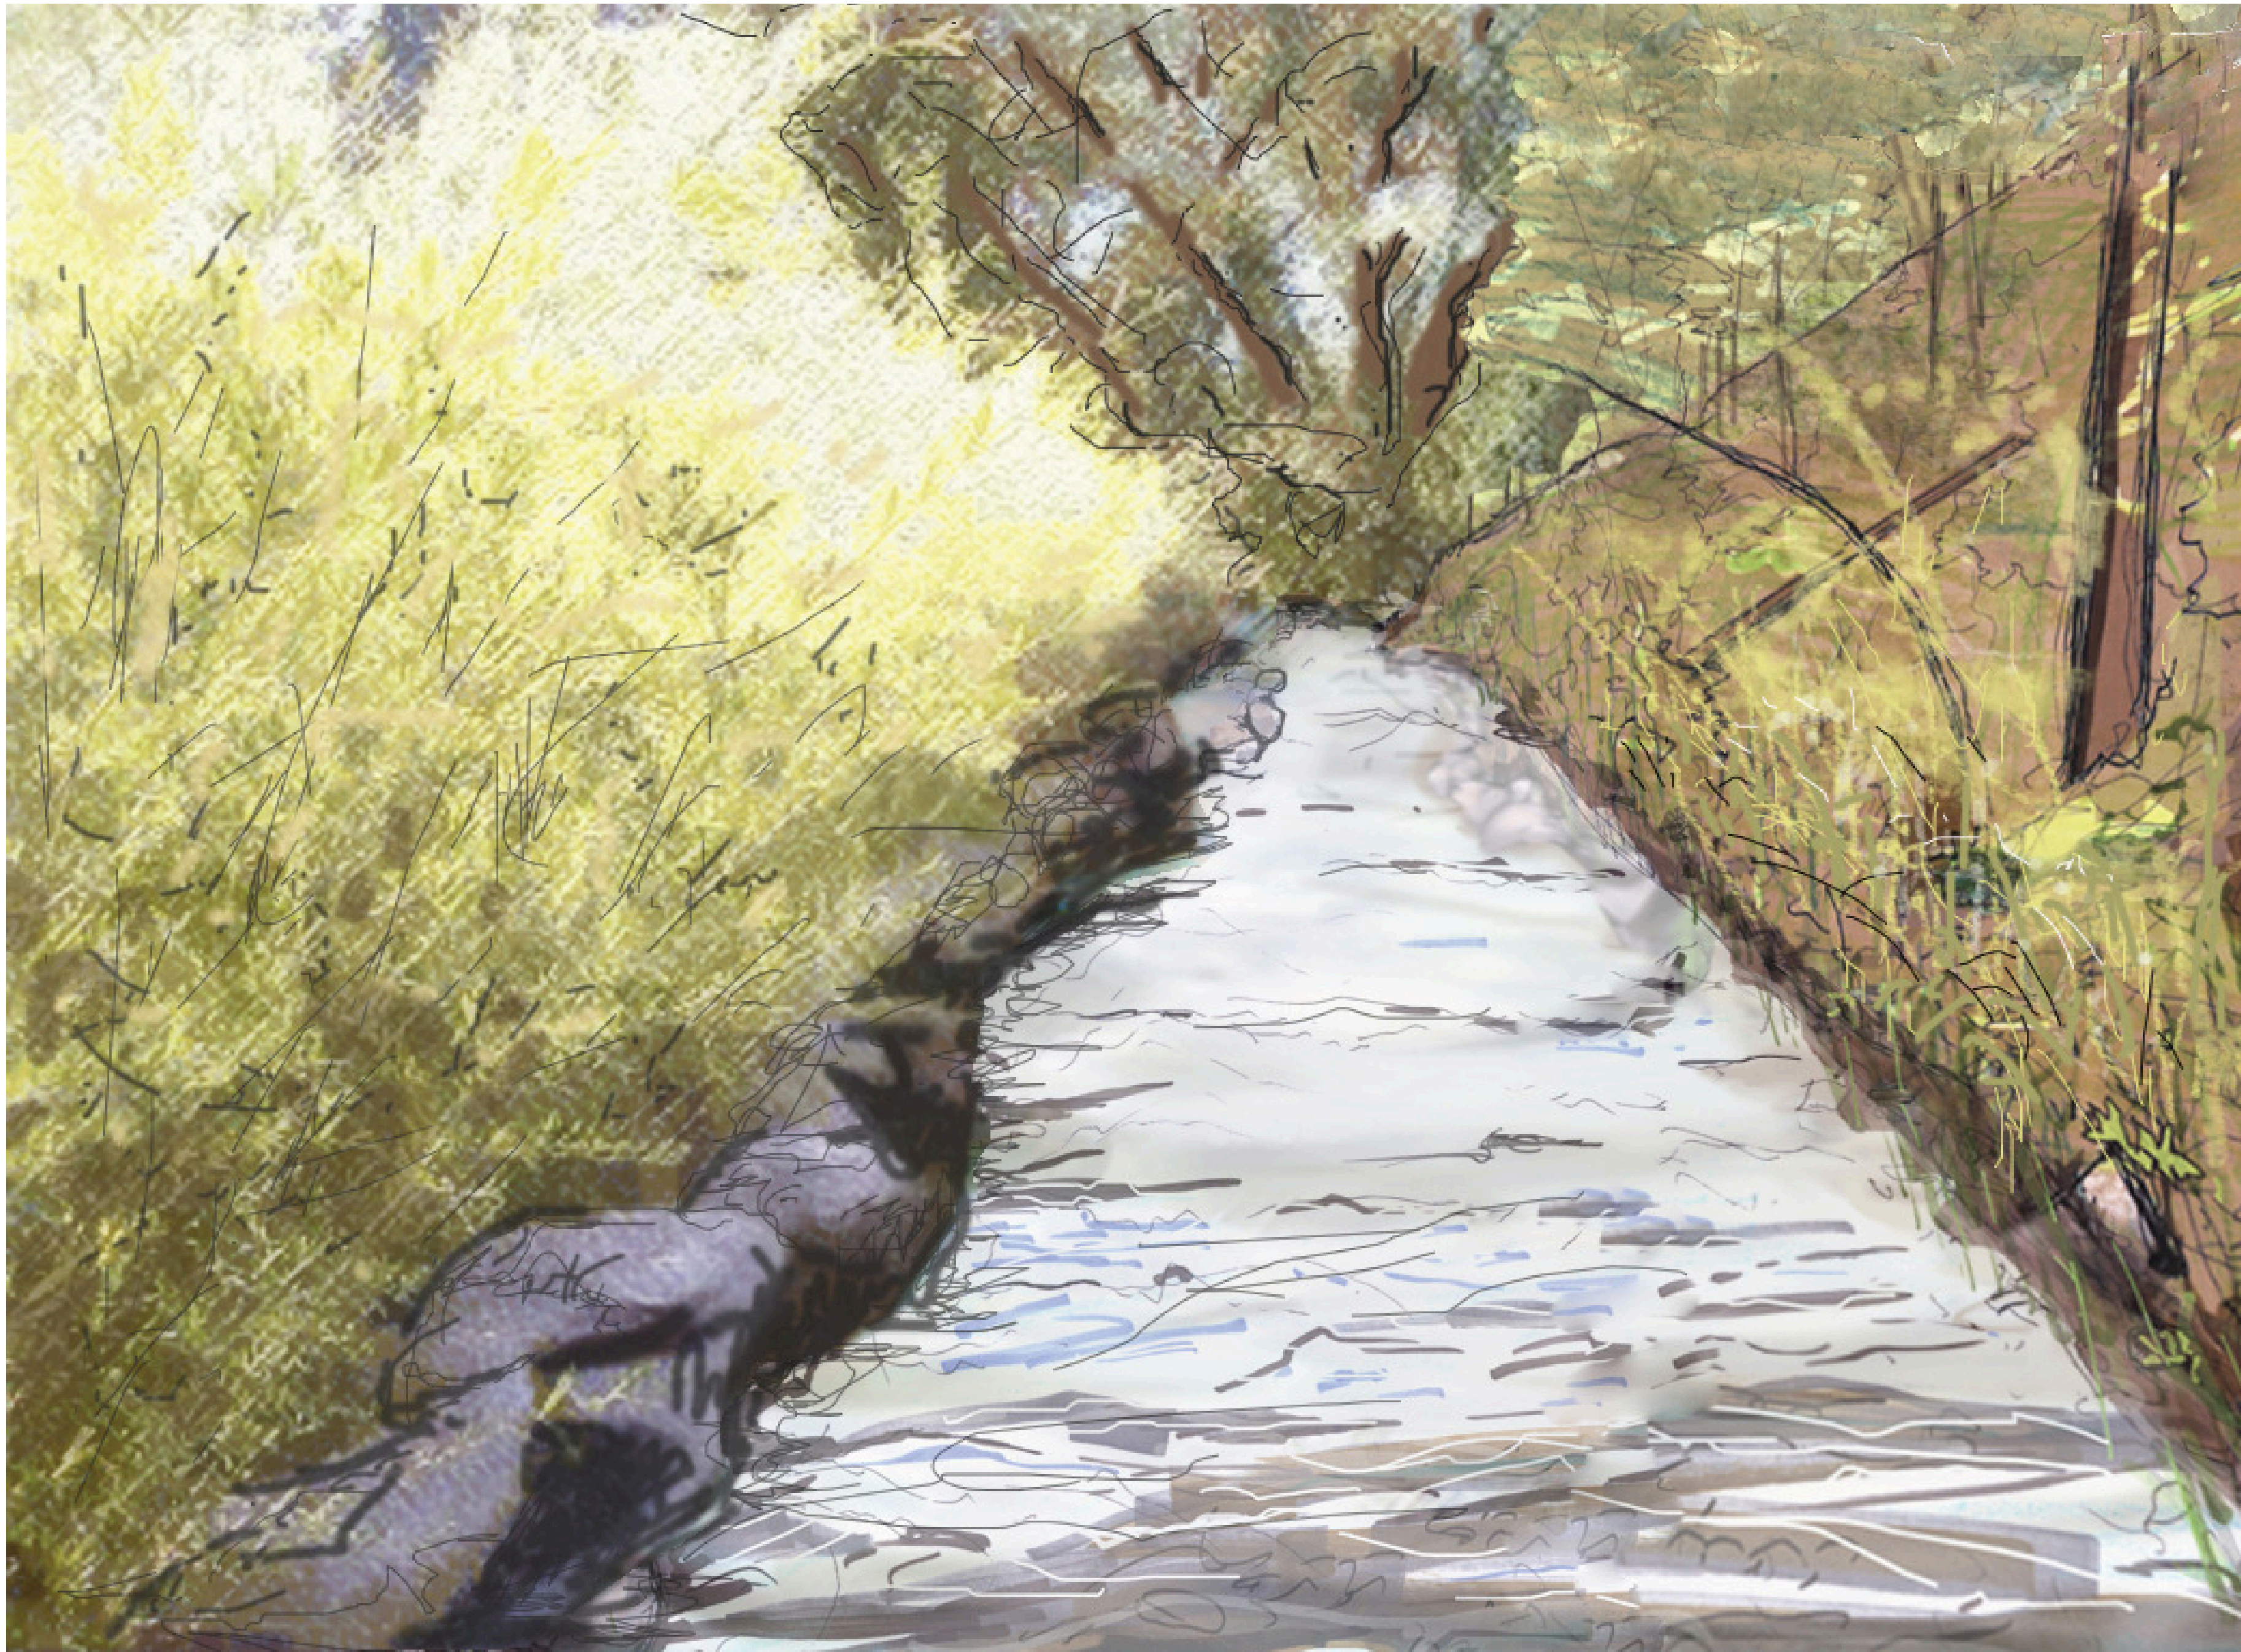
Soil Pillows are utilized in a bioengineering method known as Vegetated Reinforced Slope Stabilization (VRSS). The method combines rock, specialized fabric, soil, and plants to stabilize steep, eroding slopes in a structurally sound manner. VRSS typically involves protecting layers of soils with a specialized fabric (e.g. erosion control blanket) and vegetating the slope with either water tolerant shrubs (often willow or dogwood species) between the soil layers or by seeding the soil with desired species before it is covered by the protective material. In either case, with adequate light and moisture, the vegetation grows quickly and provides significant root structure to strengthen the bank. In places where the channel is confined and where the streambanks are steep, soil pillows are a feasible solution.

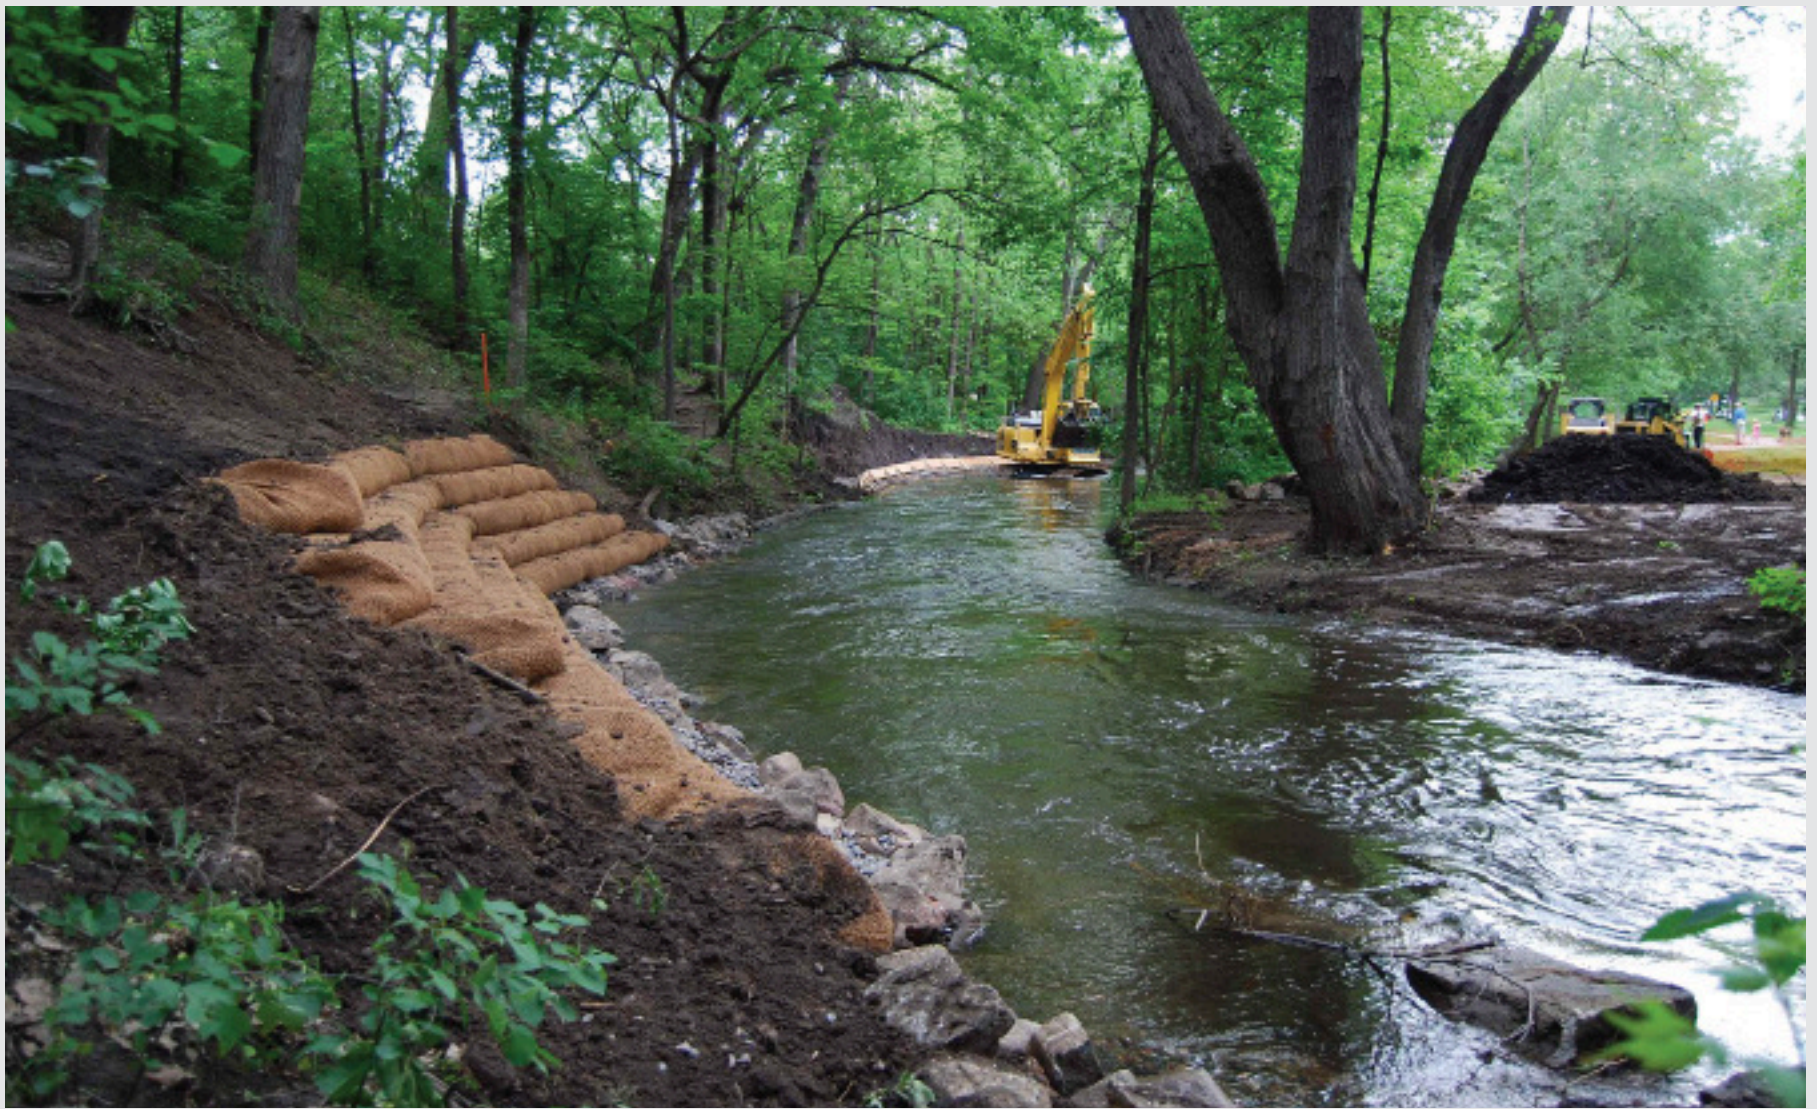
SIMILAR PROJECT

A nearly continuous stretch of Minnehaha Creek was stabilized from Portland Avenue to Bloomington Avenue during the winter of 2007/08. The stream reach, located within the Minnehaha Creek Regional Park was degraded from streambank erosion and failing infrastructure, which posed an immediate threat to the stability and structural integrity of property, banks and infrastructure in and along the creek. Among the methods employed for bank stabilization, Soil Pillows were used at several locations having very steep banks in order to minimize the amount of soil excavation that would be needed. The site shown is located a short distance downstream of Interstate I-35W.

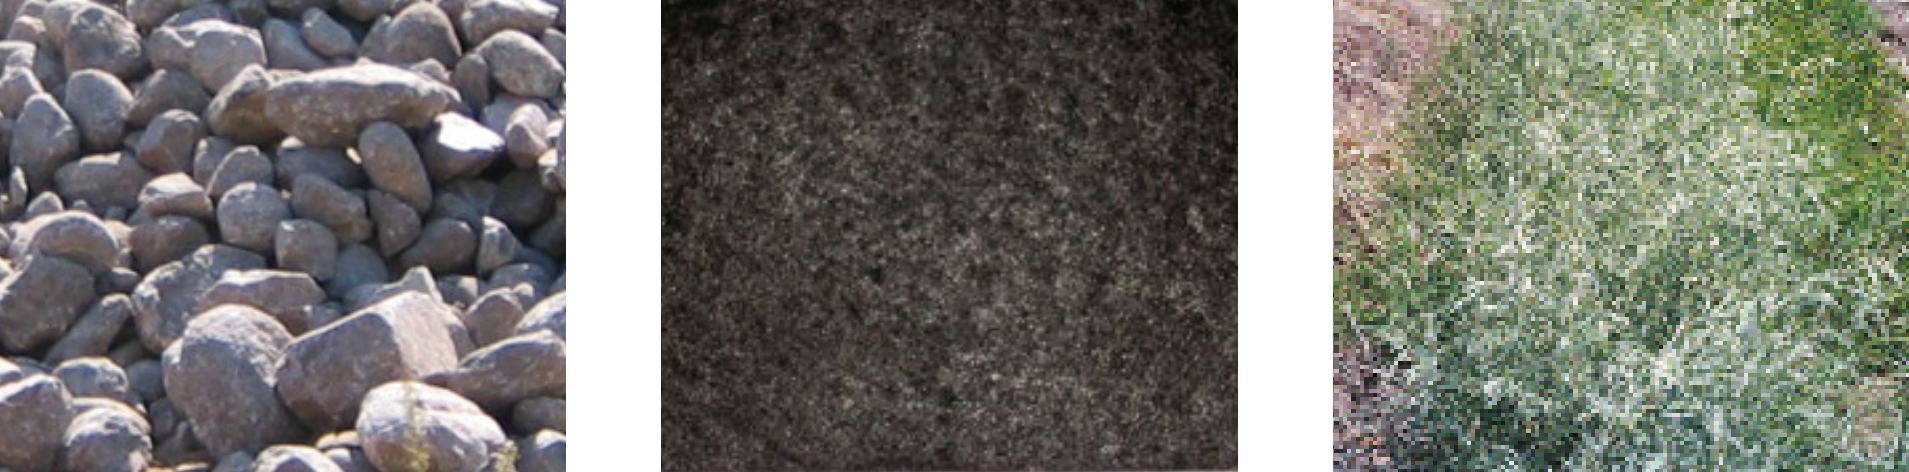
Materials consist of graded rock for the lower layers of the structure and for internal drainage, if necessary. Geotextile fabric is used to wrap the soil. Plants, such as willow or dogwood, or seed mixture is used for planting in and between the soil pillows.

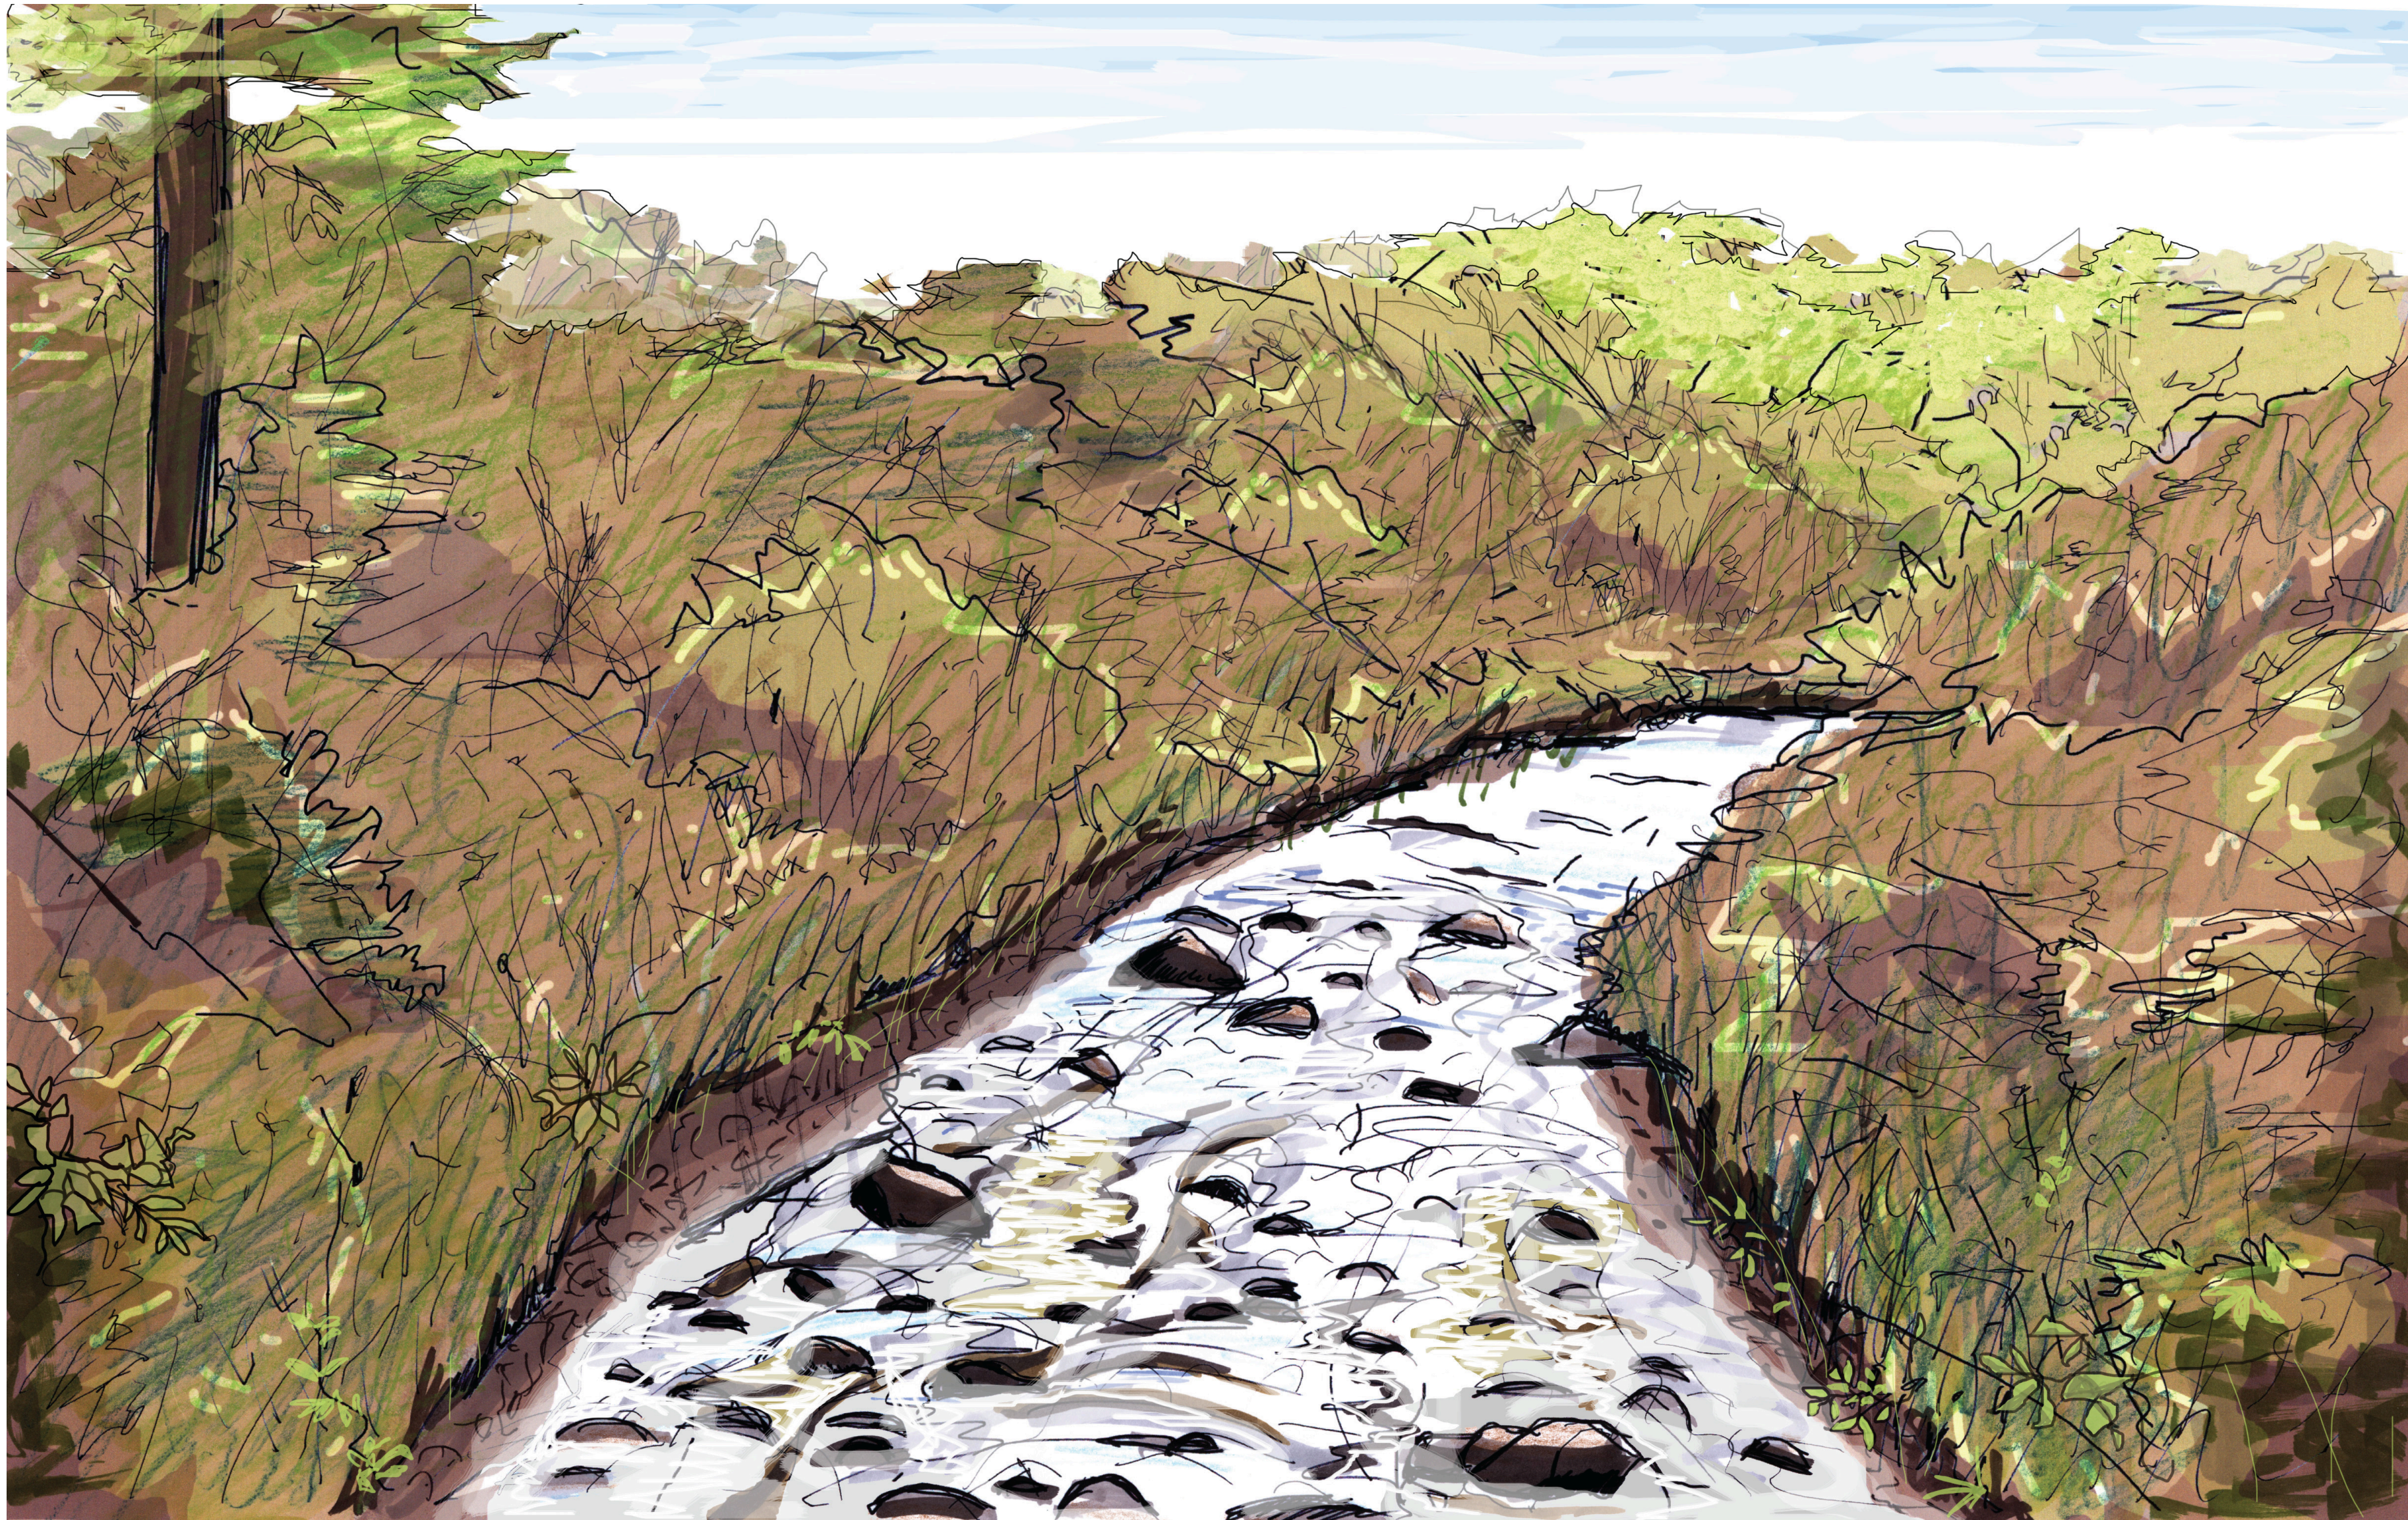
Grade control measures are used where channel downcutting has occurred. Various types of weirs are commonly used to provide grade control on streams, particularly in steeper systems. Weirs can be constructed of sheetpile, concrete, or natural materials such as rock. For Nine Mile Creek, natural rock will be used to mimic natural riffles. Large boulders will comprise the core of the structure, with smaller rock material placed on the upstream and downstream sides of the boulders to provide a gradual transition to the channel. The riffles will raise the surface of the water profile, and will reconnect the stream to its floodplain areas. Following the installation of the riffles, pools will be created upstream of the riffles. These pools will fill with sediment over time, which will in effect raise the channel bottom to the desired elevation.

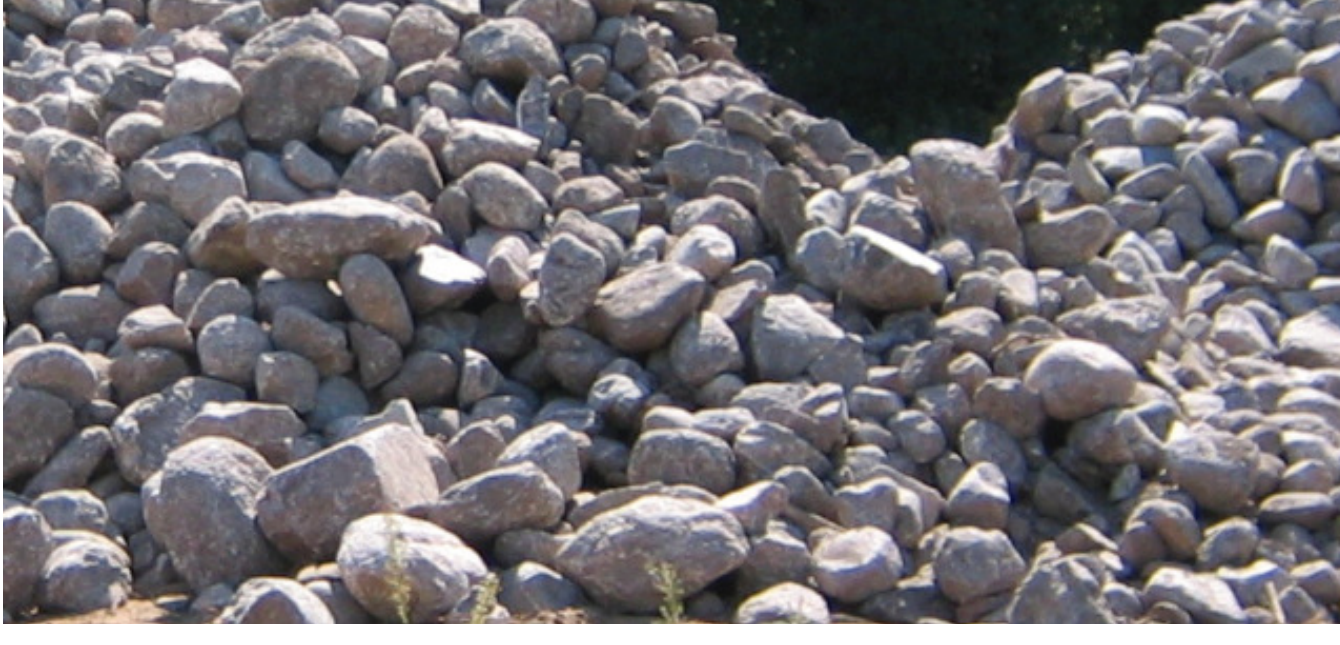
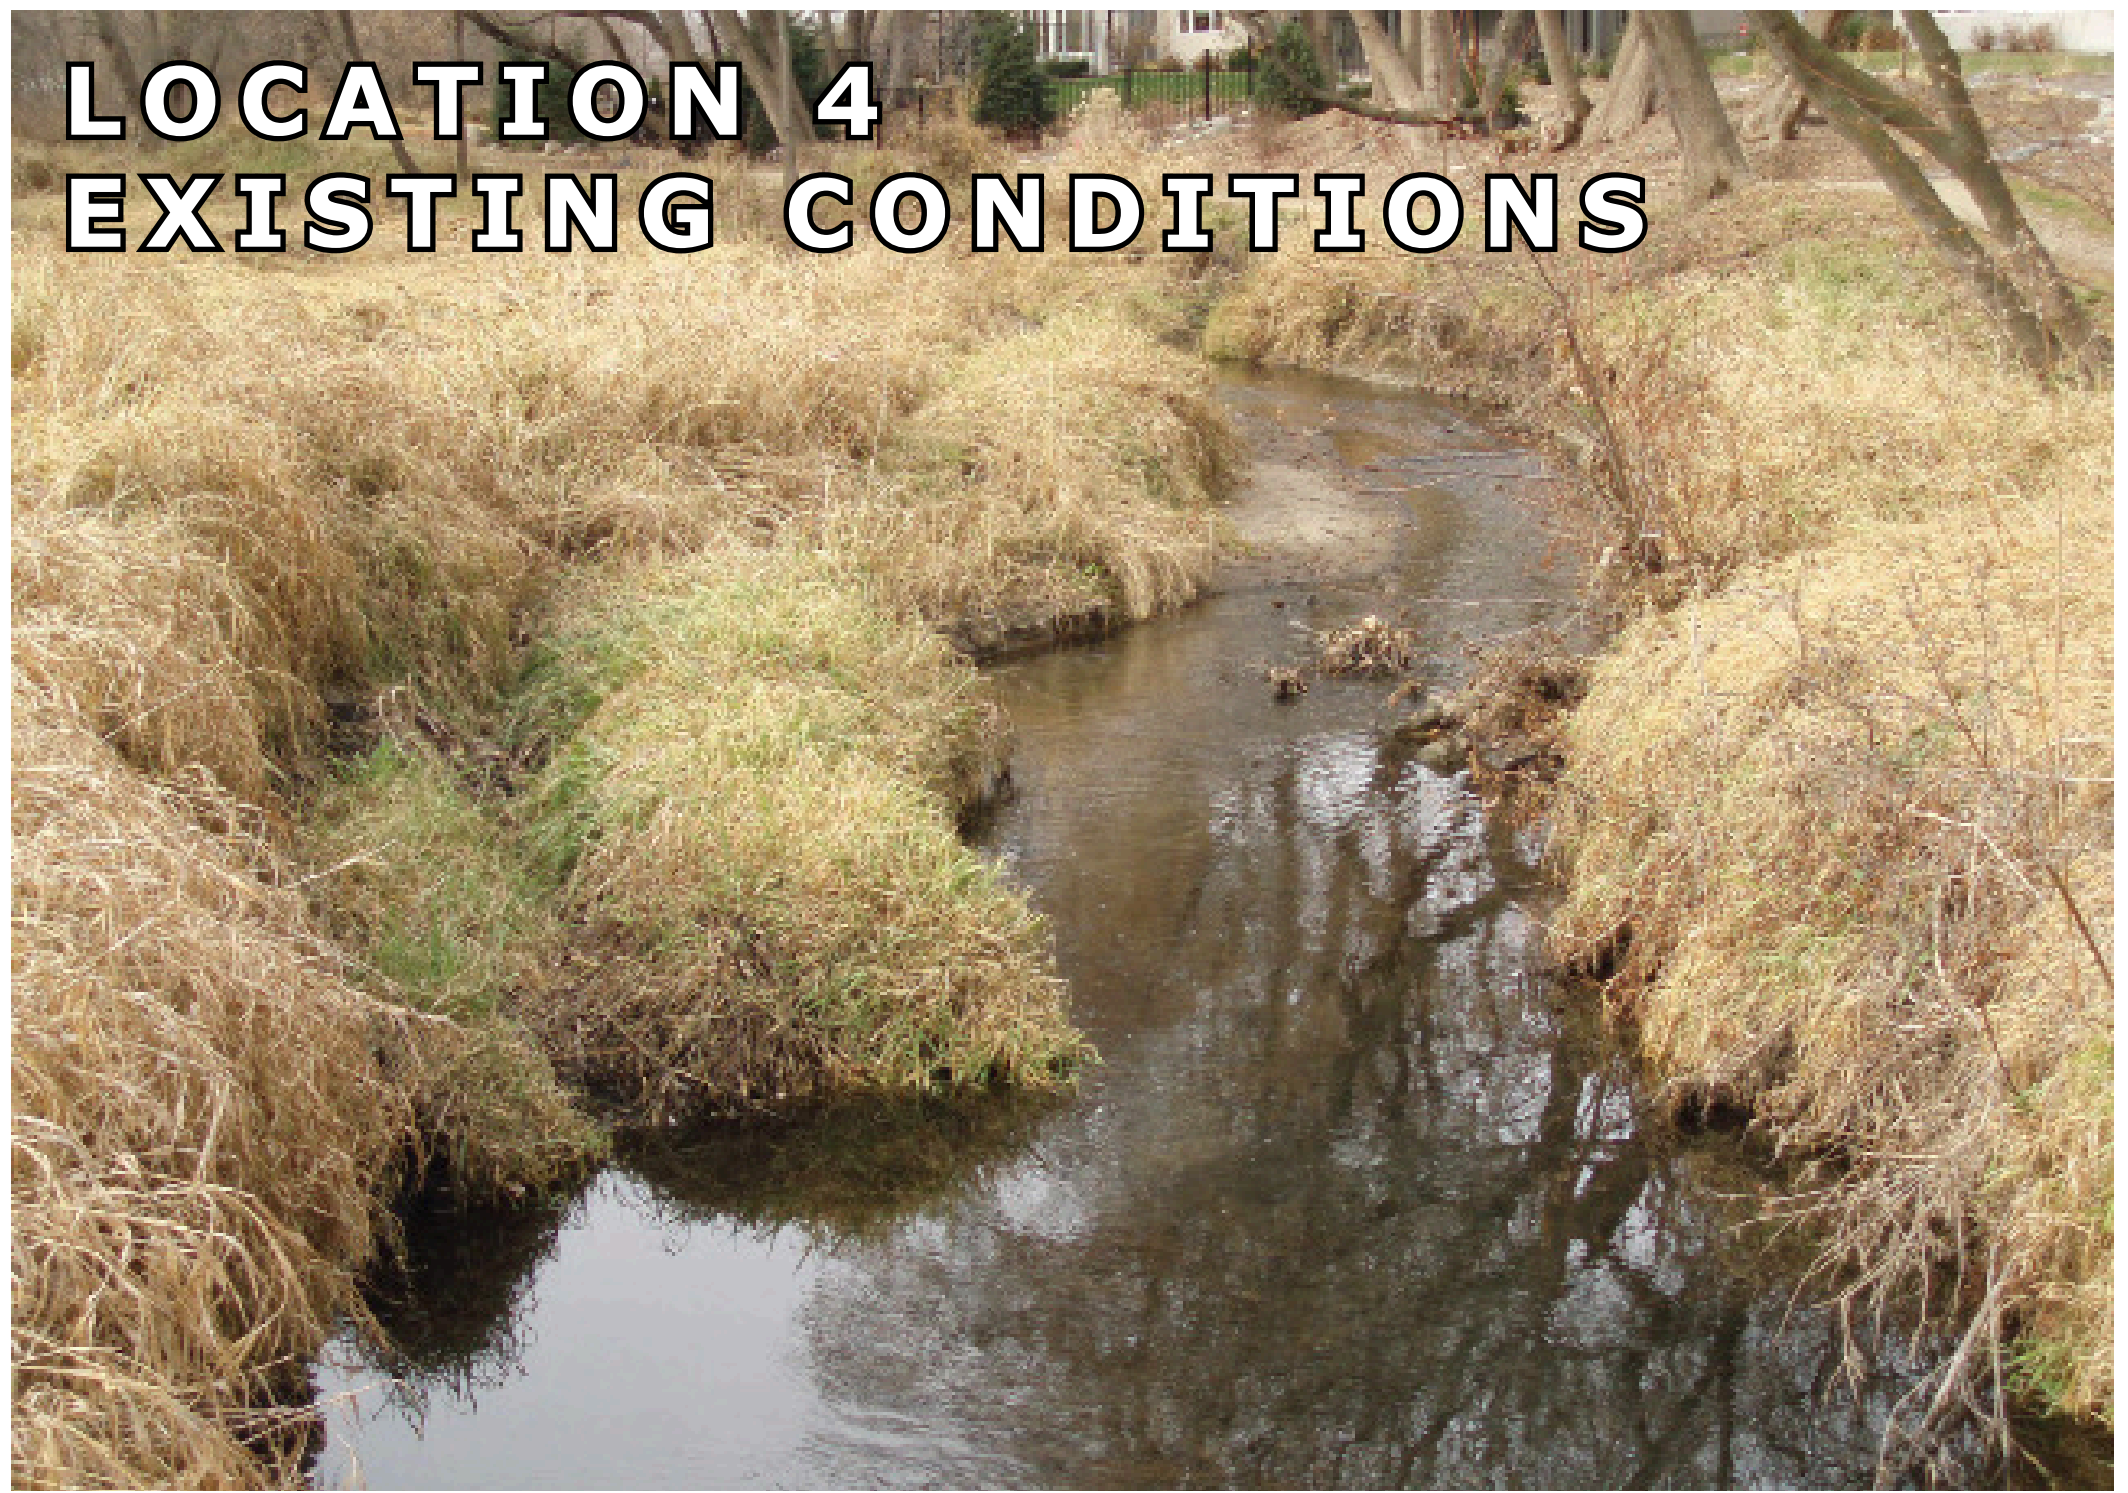
Constructed riffle materials consist of various gradations of rock, ranging from large, 3-foot boulders to coarse gravel.

Constructed riffles will be used to help stabilize a relatively steep portion of Nine Mile Creek as it transitions from the community gardens area to the large, flat wetland located west of Highway 169. They will also be used further upstream to provide channel stability. The riffles will stabilize the channel profile and will help the creek to dissipate excess energy in a controlled manner, thereby reducing bank erosion. The riffles will also provide diversity to the creek, which is beneficial to aquatic life.

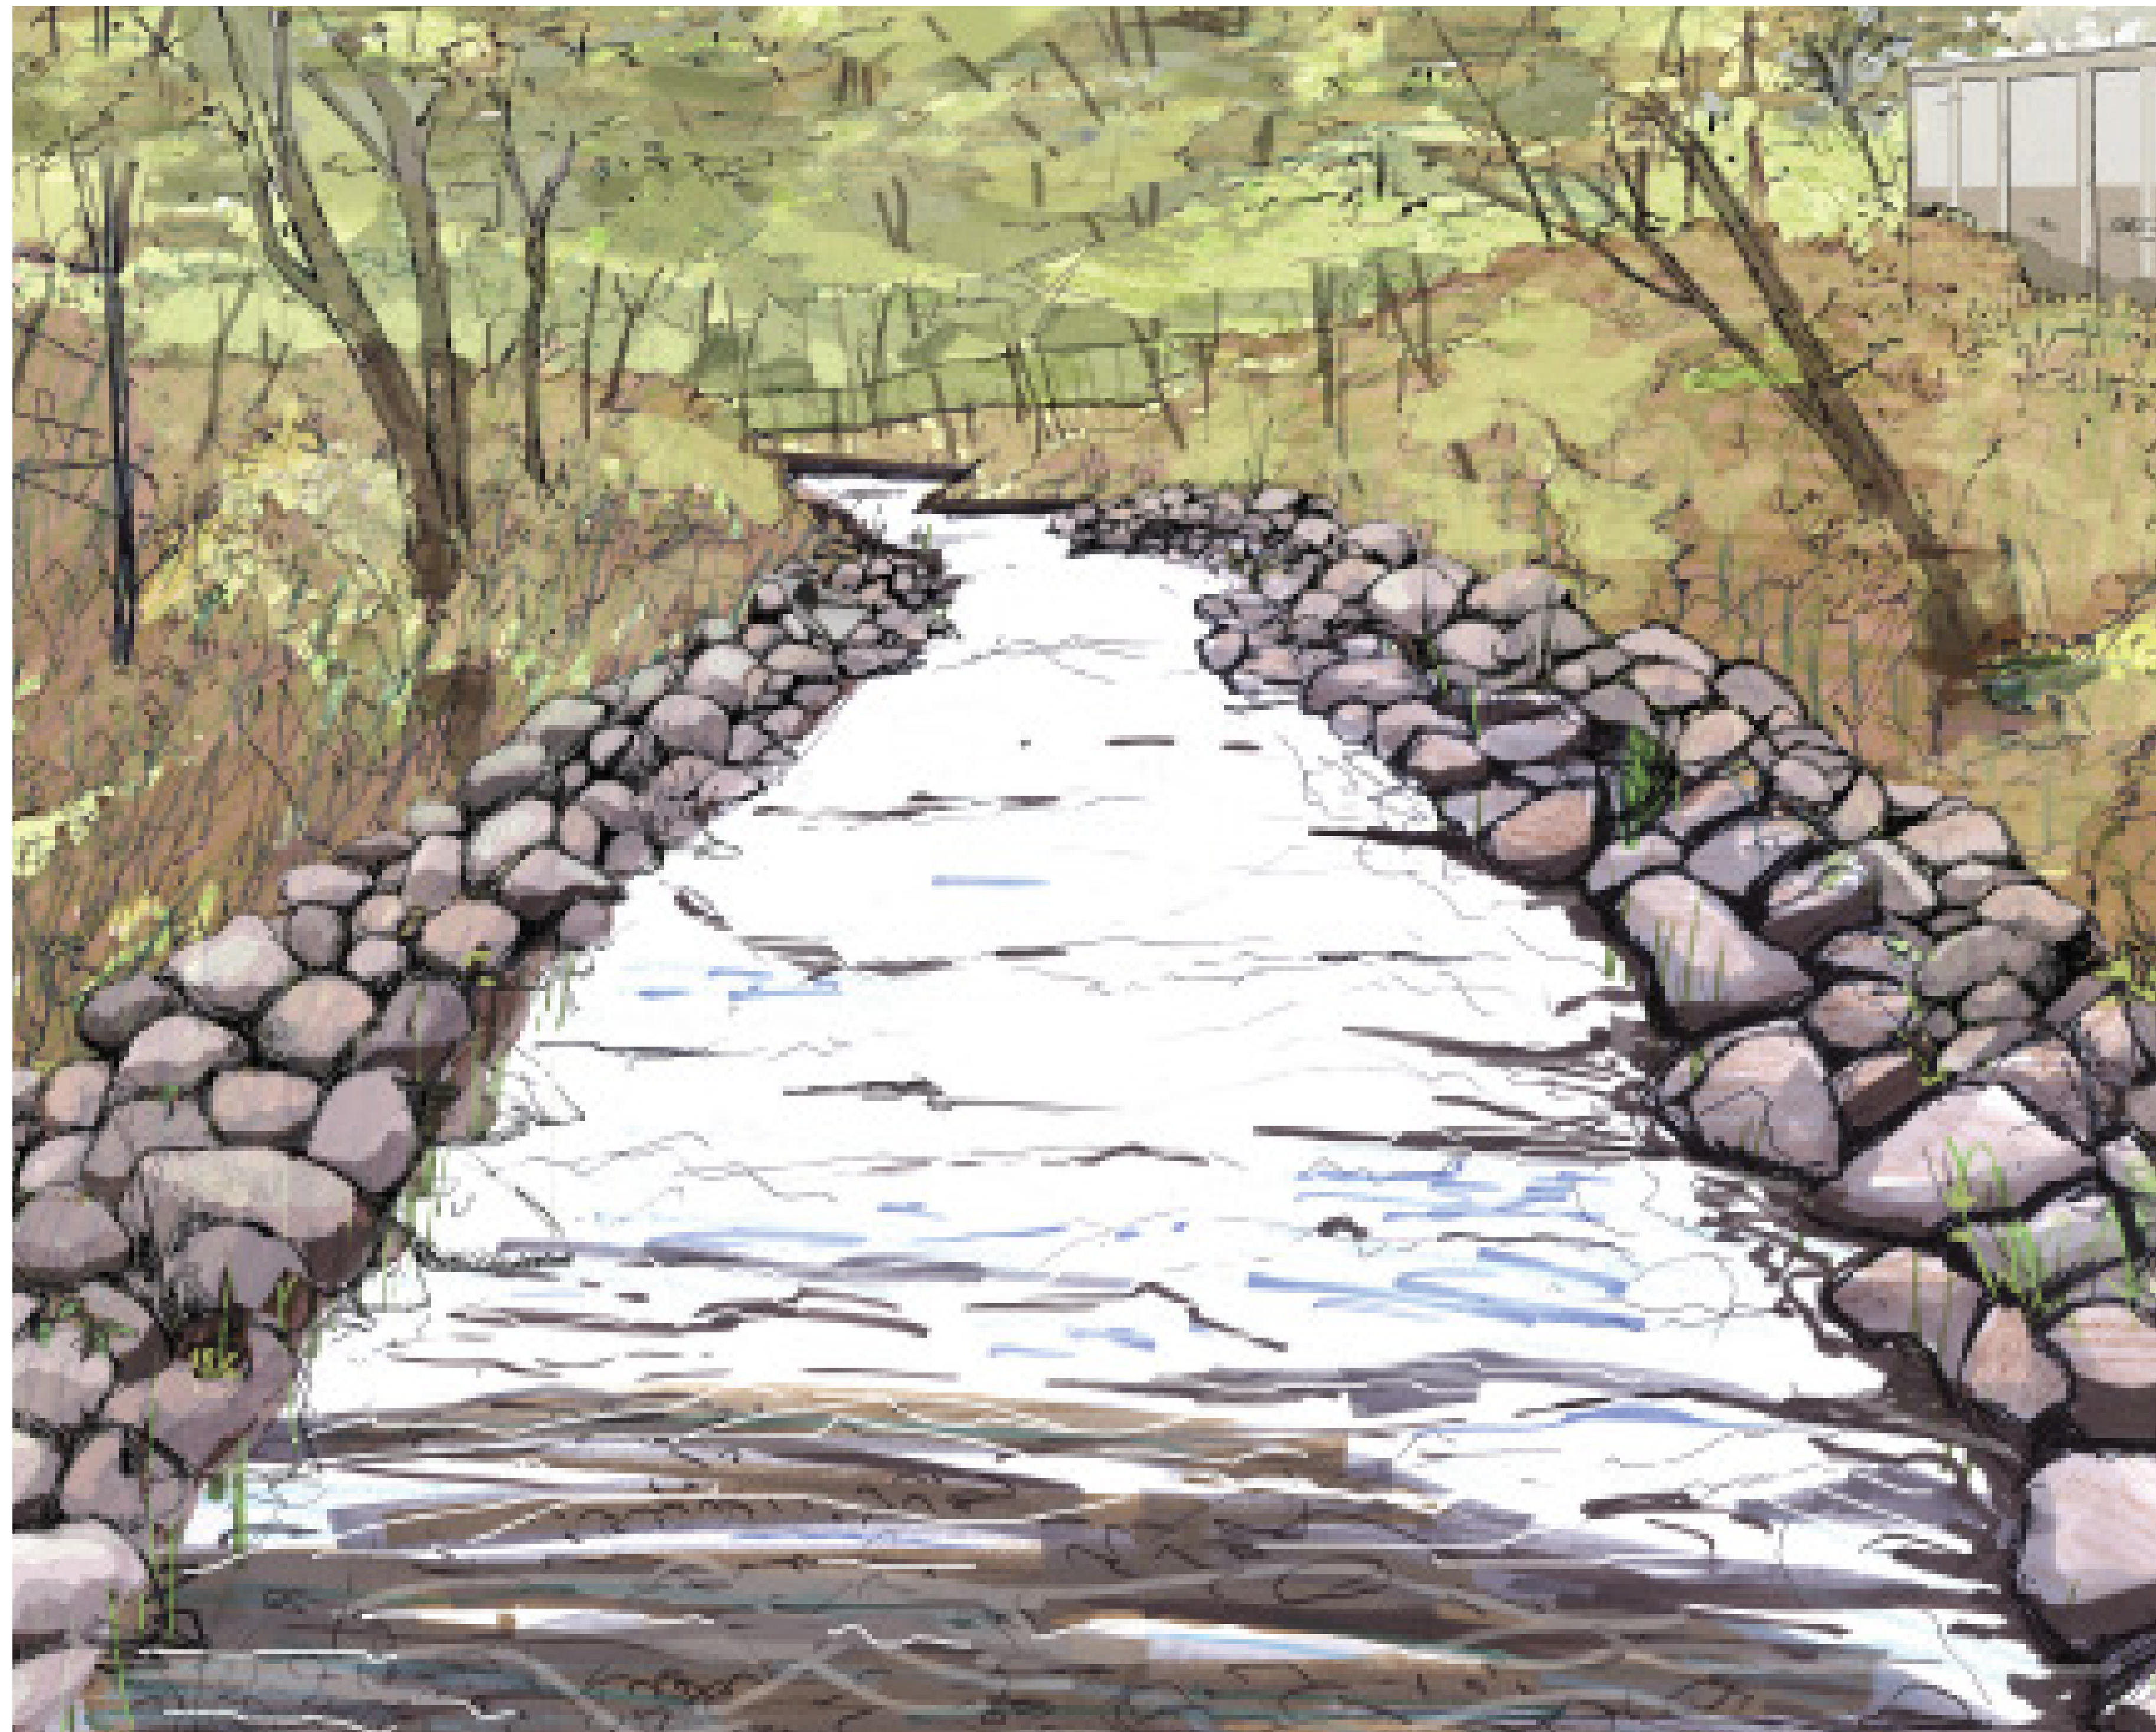
Stone Toe Protection is constructed from cobble-sized rock on the creek edges. It extends to approximately the bankfull level, which will protect the channel banks for flow events that occur every 1 to 2 years or less. The material will extend below the channel bed to resist scour. Coarse gravel is used to separate the larger rock material from underlying soil. Stone toe protection is typically used in conjunction with revegetation of the upper banks.

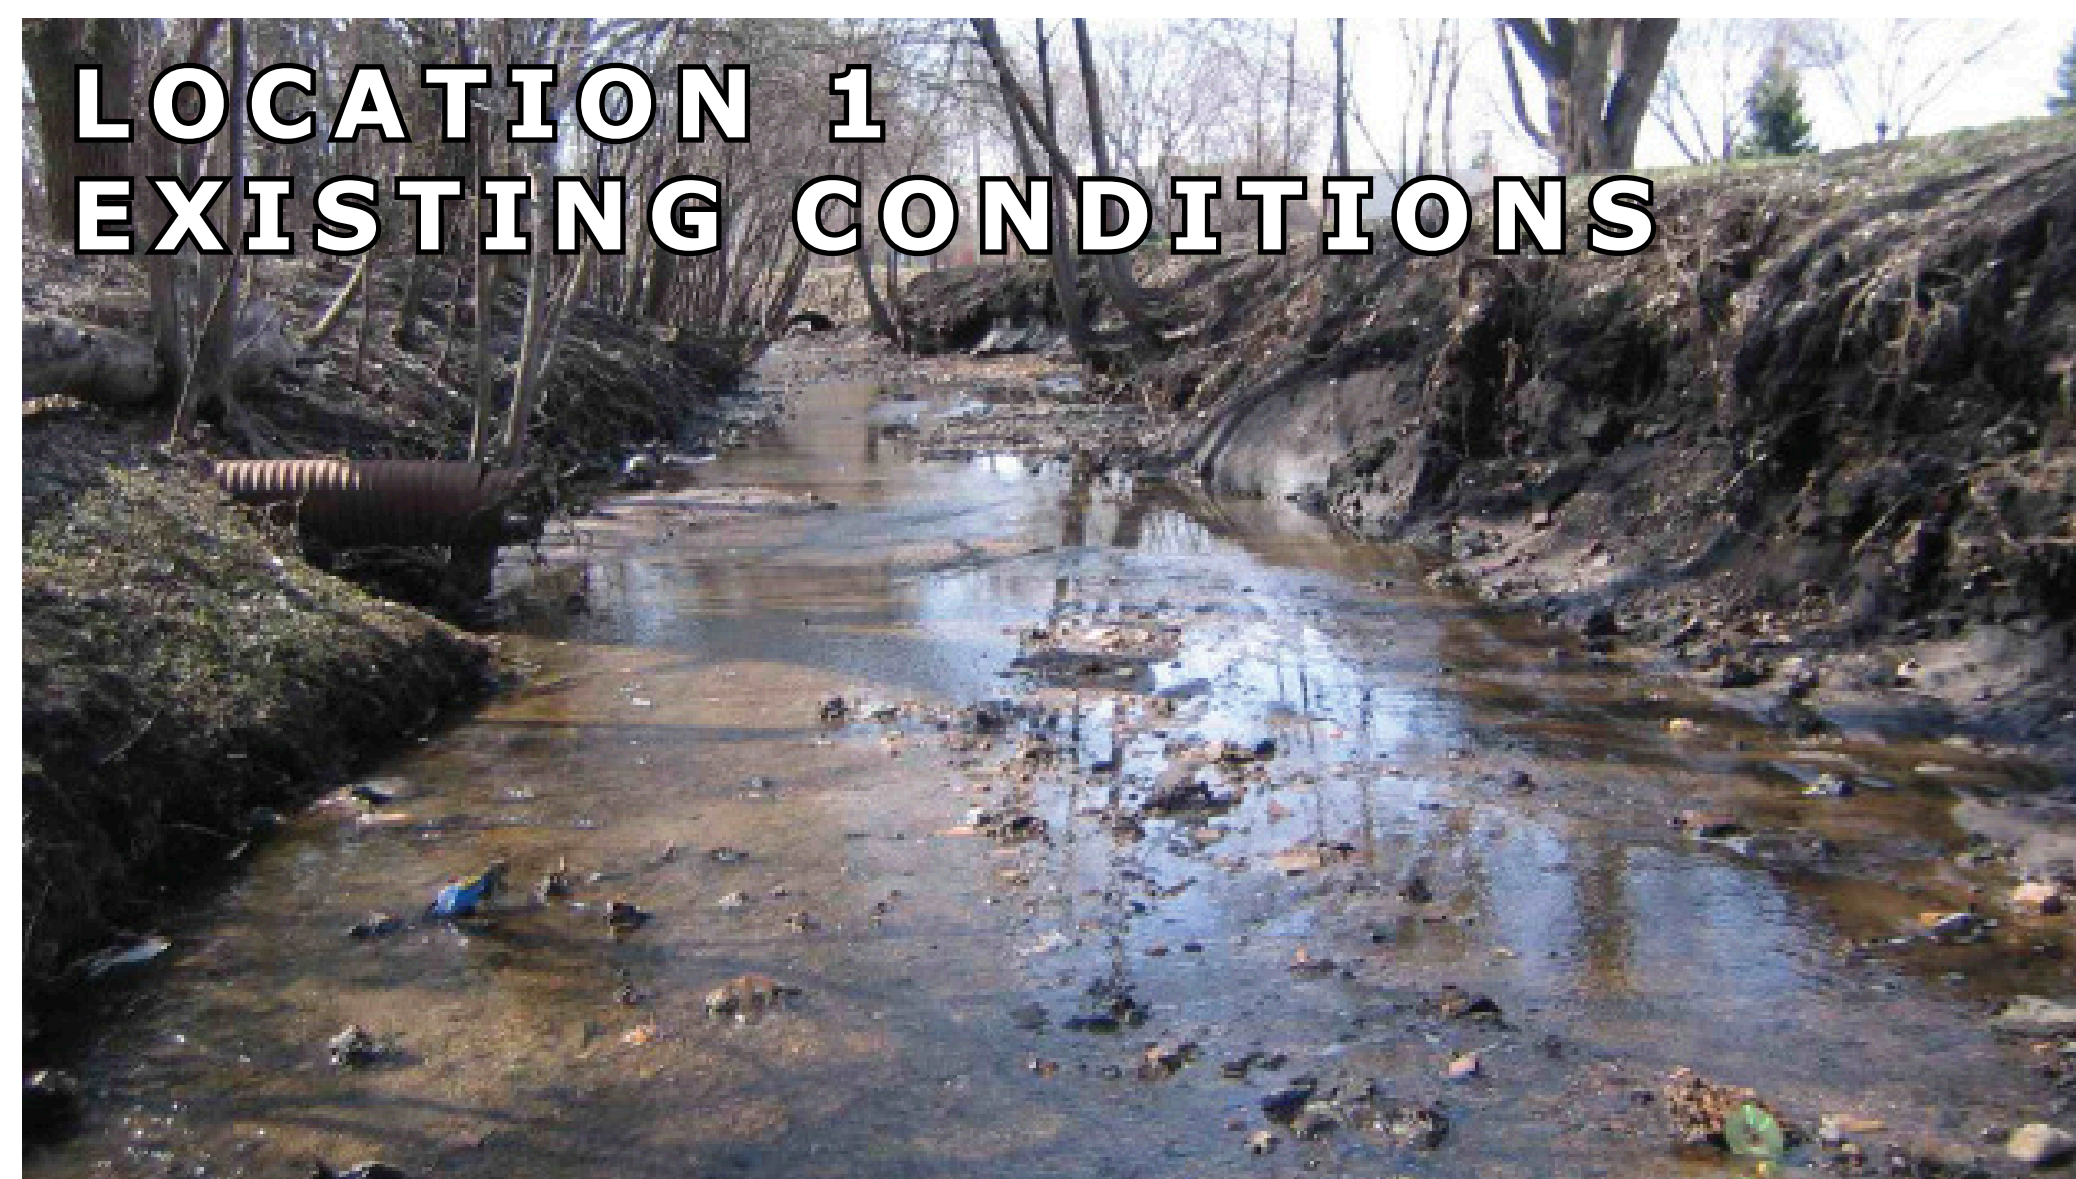
**LOCATION 1
EXISTING CONDITIONS**

Severe bank erosion is evident along much of Nine Mile Creek between Excelsior Boulevard and 9th Street South. The stream channel is deep and confined between parking lots and buildings, with very little floodplain to provide relief during high flows. As a result, flow velocities can be very high during large flood events. In these areas, lining the lower banks with cobble-sized rock will protect the banks from being undercut by frequent flood events. Native vegetation will be planted to protect the upper banks from less-frequent flood events.
