Nine Mile Creek Streambank Restoration

Soil Pillows

Constructed Riffle

Stone Toe Protection

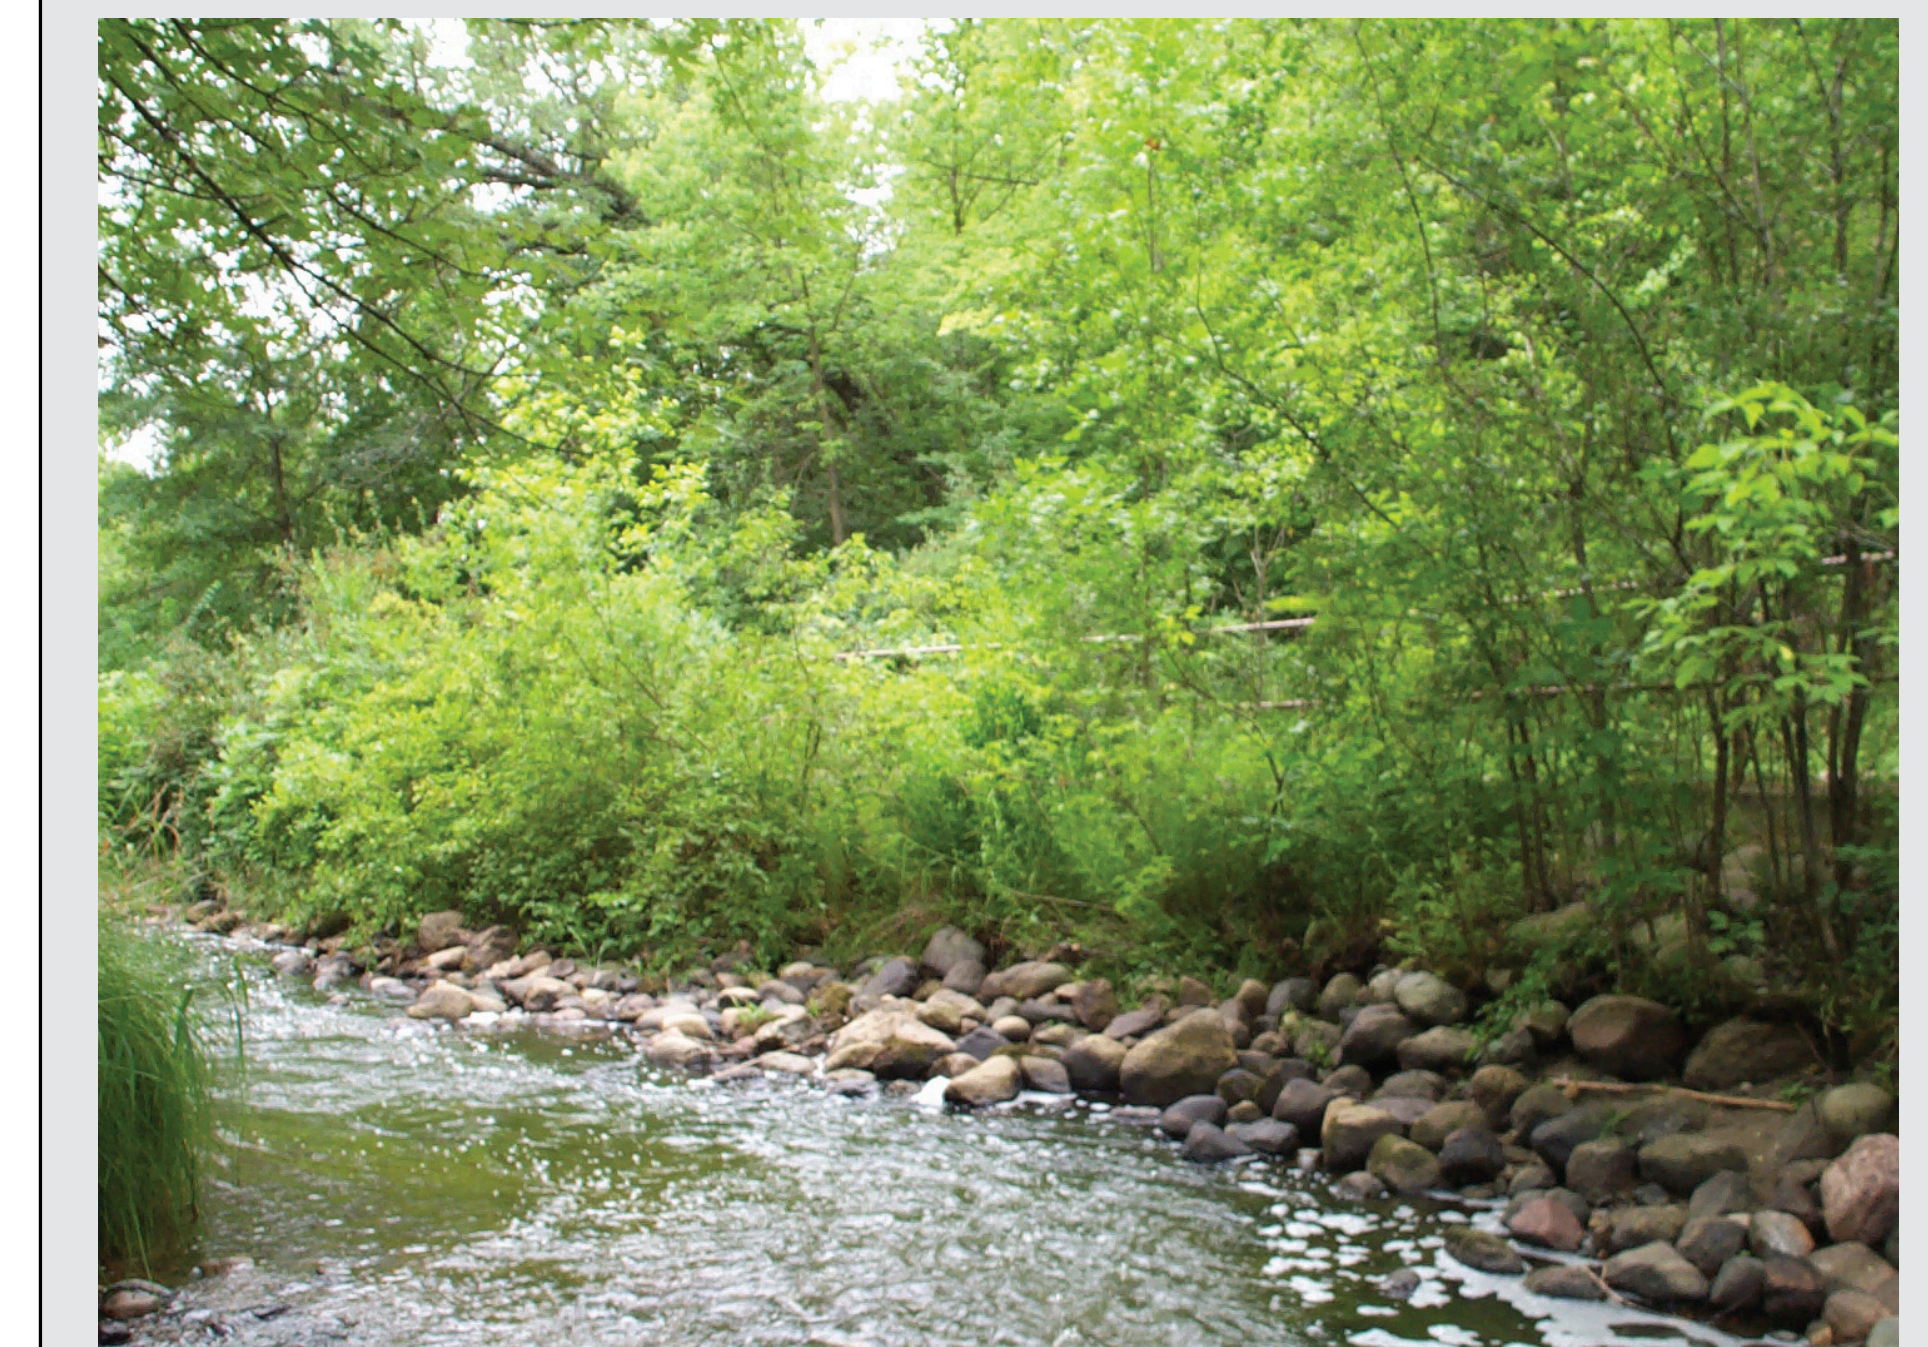
SIMILAR PROJECT

Stone toe protection has been used extensively in Nine Mile Creek's Lower Valley, in conjunction with deflector dikes, grade control measures and stabilization of large bank failures. Following the 1987 "super storm," the proposed design allowed the stream to continue its course while taking measures to protect areas where water flow was eroding valley walls. The resulting measures have stabilized the stream channel and valley walls while blending seamlessly with the natural environment.

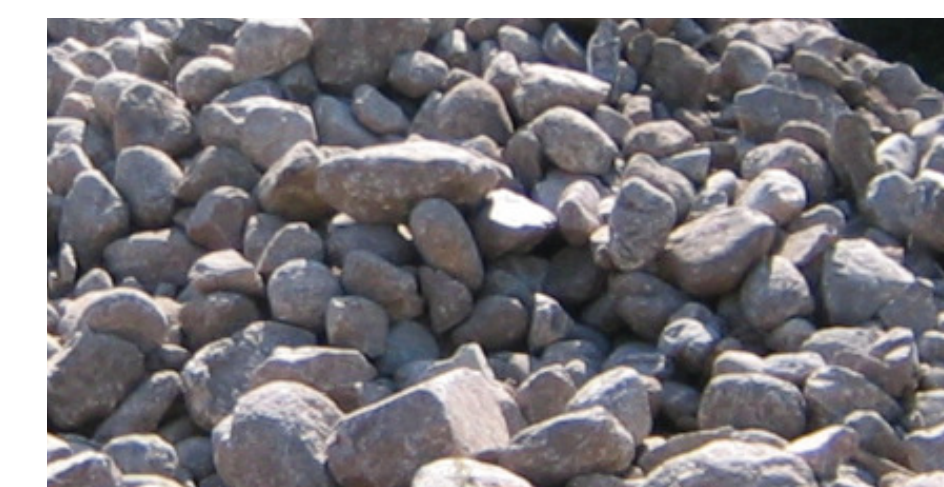
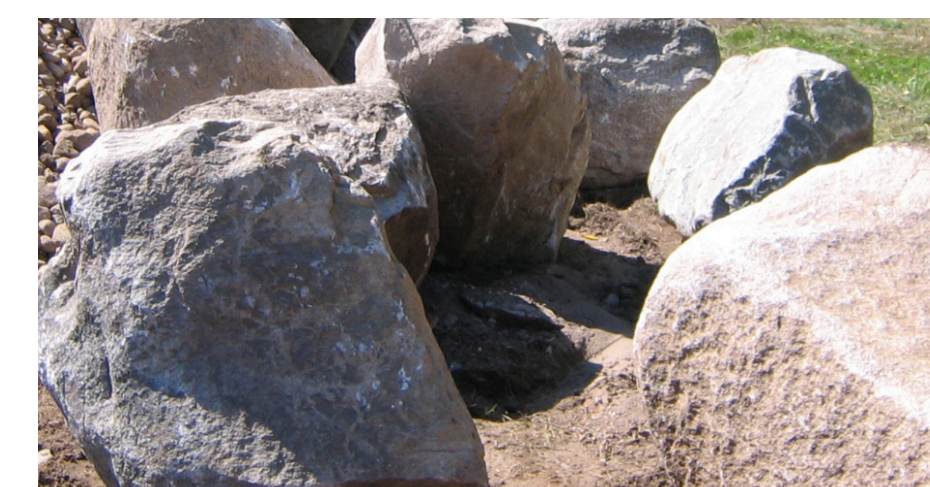
Rock vanes are constructed using boulders on the creek bottom. They function by diverting flow toward the center of the channel and away from the eroding bank. They point upstream and disappear into the channel bottom, making them largely inconspicuous. Rock vanes are often constructed in series to protect a greater length of channel.

Materials consist of various gradations of rock, ranging from large, 3-foot boulders to coarse gravel.

Some portions of Nine Mile Creek have severe erosion on only one of the banks. This is generally due to one bank being higher than the other, and may be worsened by a bend in the channel. In these situations, rock vanes can be used to direct flow away from the higher eroding bank and toward the lower, more stable bank.

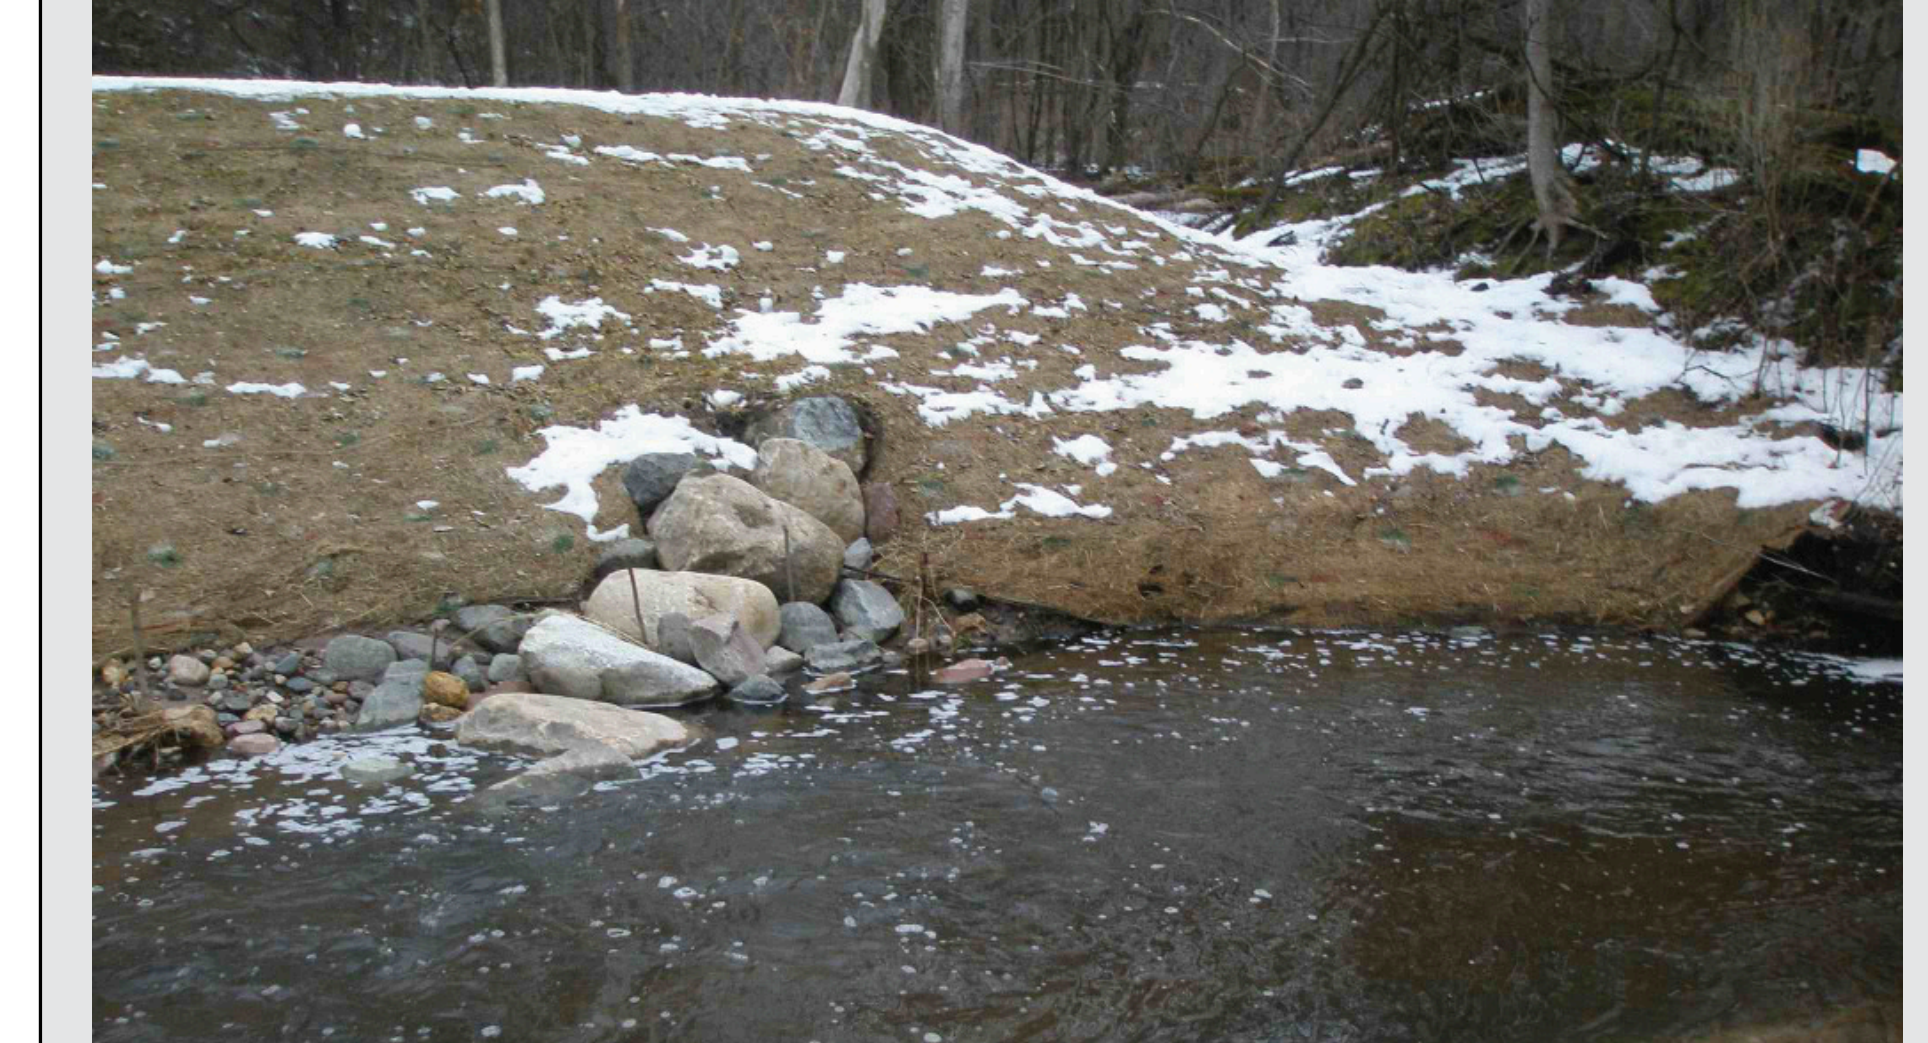
SIMILAR PROJECT

Rock vanes were used to stabilize an eroding bend on Valley Creek in Afton, Minnesota. The vanes were carefully designed to maintain surrounding trout habitat, including a deep scour hole a short distance downstream. The upper banks were vegetated with native grasses and shrubs. Construction was completed in fall 2008.
