For the Nine Mile Creek Watershed District

August 8, 2022

South Fork Nine Mile Creek Bank Stabilization Feasibility Report

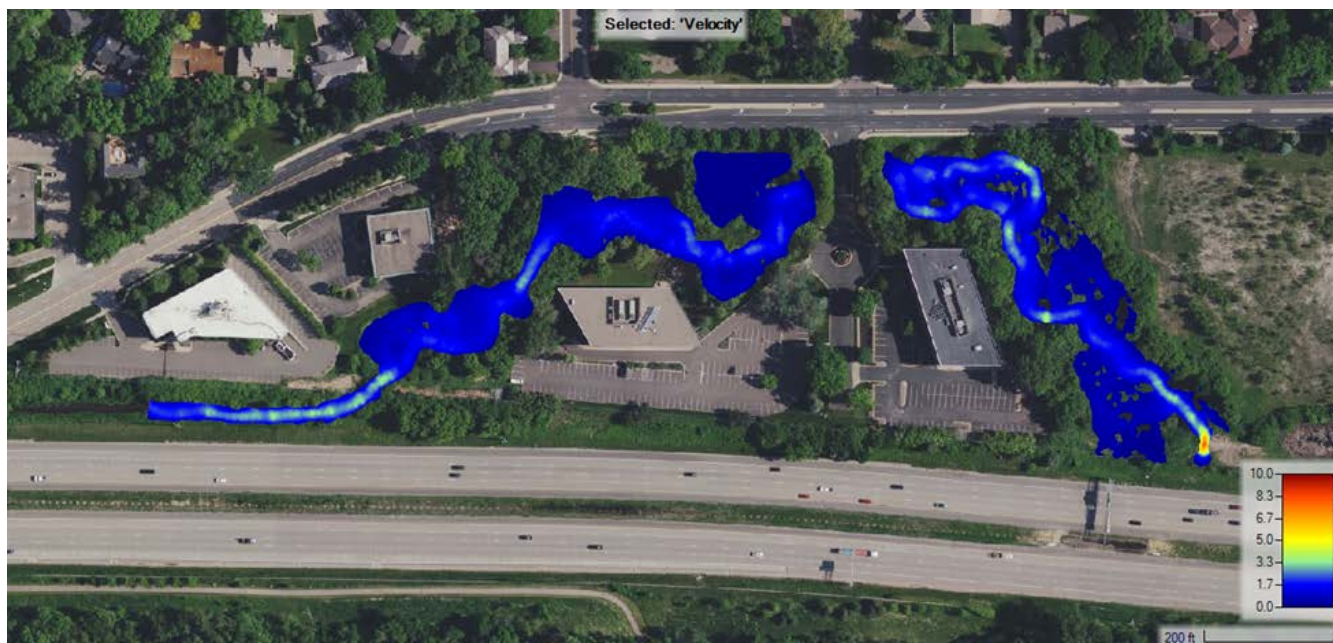
Figure 8. 2-Year Recurrence Interval Flow Velocities (ft/s) for Reaches 16-17

Figures 5-7 show the velocity patterns for the 2-year, 10-year, and 100-year recurrence intervals for reaches 6-8 and Figures 8-10 show the velocity patterns for the 2-year, 10-year, and 100-year recurrence intervals for reaches 16-17. The highest modeled flow velocities occur along channel constrictions and downstream of existing road culverts. The high velocities shown at the inlet to Bryant Lake in Reach 8 are the result of downstream boundary conditions that were set at normal depth in the model. This neglects the possible backwater effects that could be caused by high water levels in Bryant Lake. Since lake levels are largely

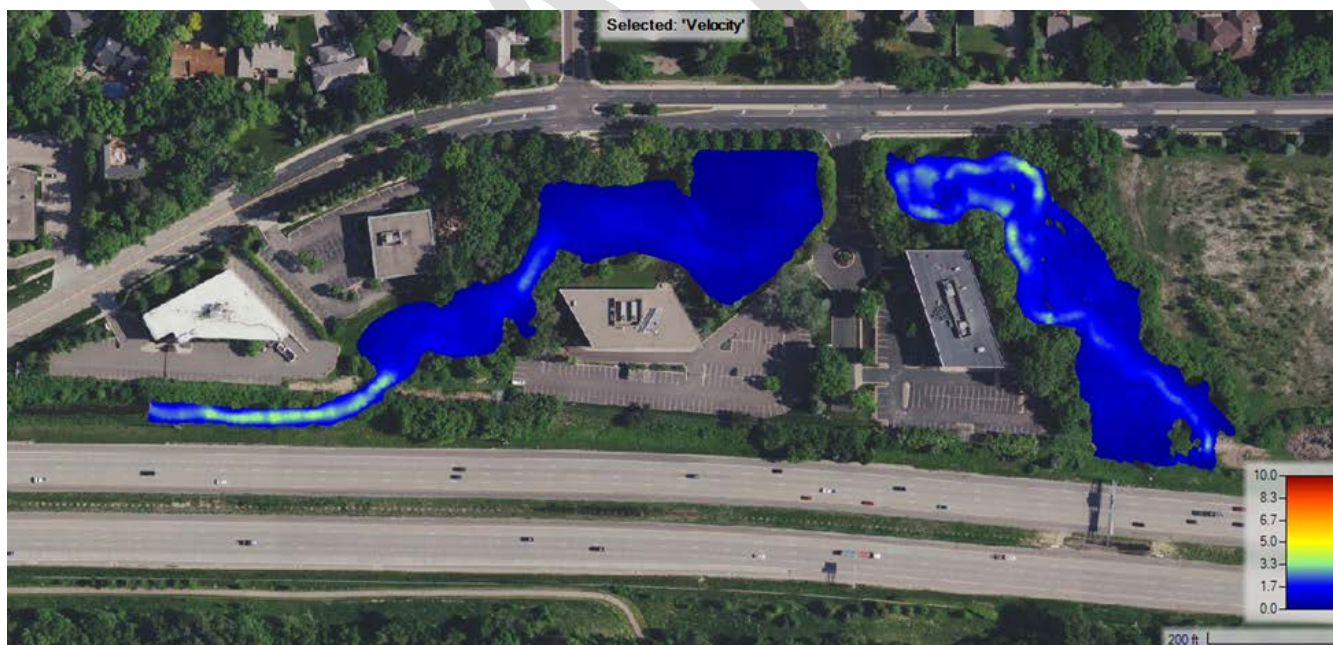
Figure 9. 10-Year Recurrence Interval Flow Velocities (ft/s) for Reaches 16-17

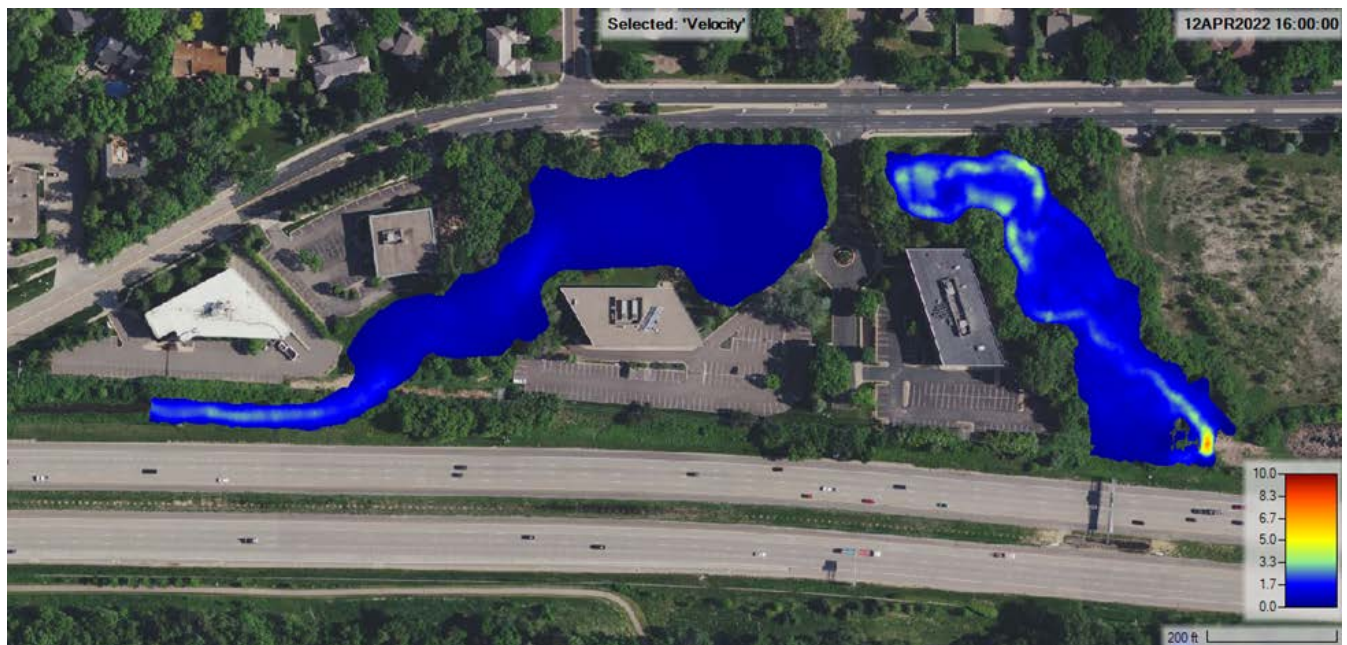
Figure 10. 100-Year Recurrence Interval Flow Velocities (ft/s) for Reaches 16-17

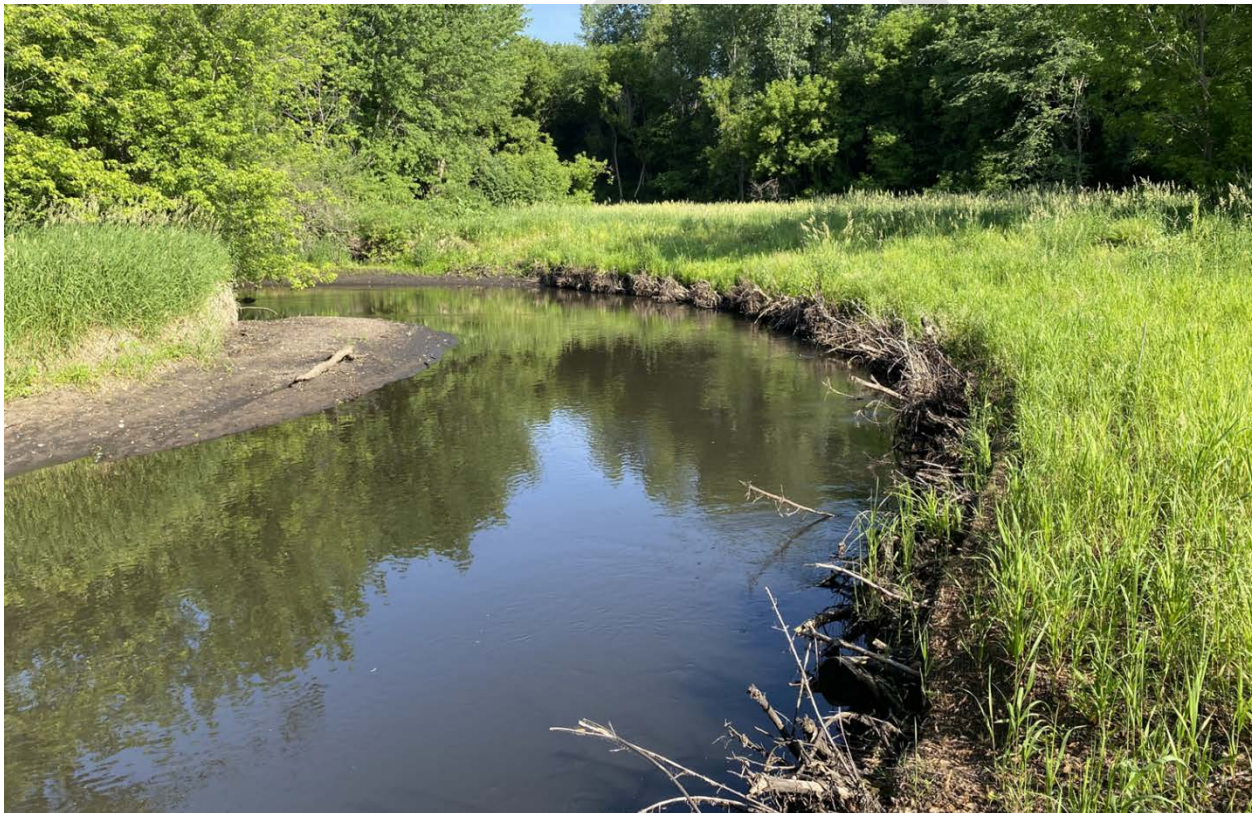
Figure 11. Example of Toewood Installed Post-Construction

The toewood practice utilizes natural materials (primarily large tree trunks, rootwads, and branches) to reconstruct a stable stream bank (Figure 11). Native soil is used as fill between the logs and branches with topsoil salvaged for use in a soil lift above the toewood structure. The rootwads and large tree trunks can be used to build-out the stream bank, thereby reestablishing a stream bank formerly lost to erosion. Building out the stream bank will also improve fine sediment transport and maintain deep pool habitat by creating a narrower stream channel. Based on the existing size and number of trees within the project reaches, it appears there is ample woody material that could be harvested on-site for many of the bank erosion sites. Harvesting wood onsite offers a dual benefit for the project by reducing import of materials and providing selective thinning of the tree canopy to allow more sunlight to reach the ground surface, thereby allowing for the establishment of deep-rooted grasses and forbs to further stabilize the stream banks and increase the diversity of riparian vegetation.

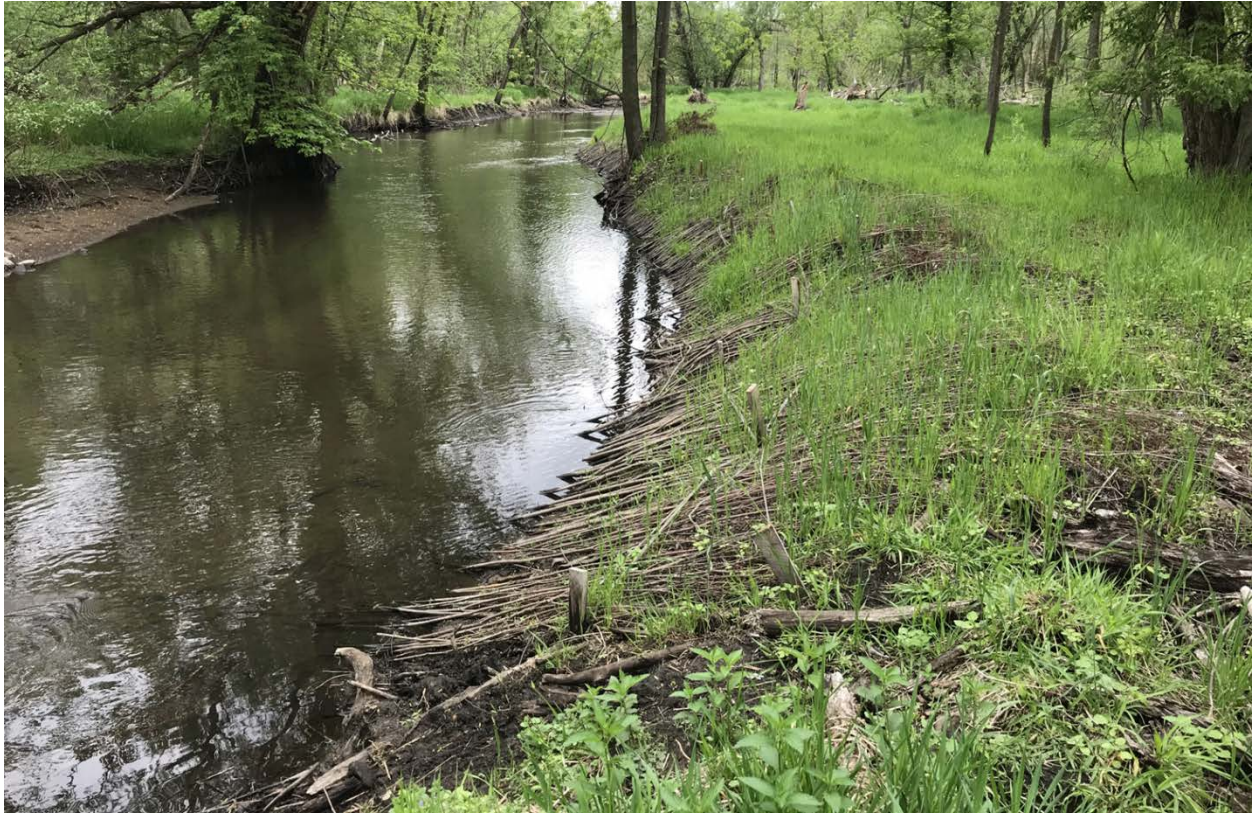
Figure 12. Example of Brush & Rootwads Installed Post Construction

This practice uses smaller trees and branches installed in a layered fashion along the bank toe to protect the stream bank (Figure 12). Small bundles of branches and brush will be installed parallel to the bank toe with rootwads used to anchor the brush bundles in place. Small trenches will need to be excavated into the bank for proper placement and anchoring of the rootwads to hold the brush bundles against the bank toe. Excess soil from rootwad trenching will be used as fill within the brush bundles for added ballast and

substrate for vegetation establishment above the bundles. This practice is proposed in areas where minor channel adjustments are needed to create a narrower creek channel.

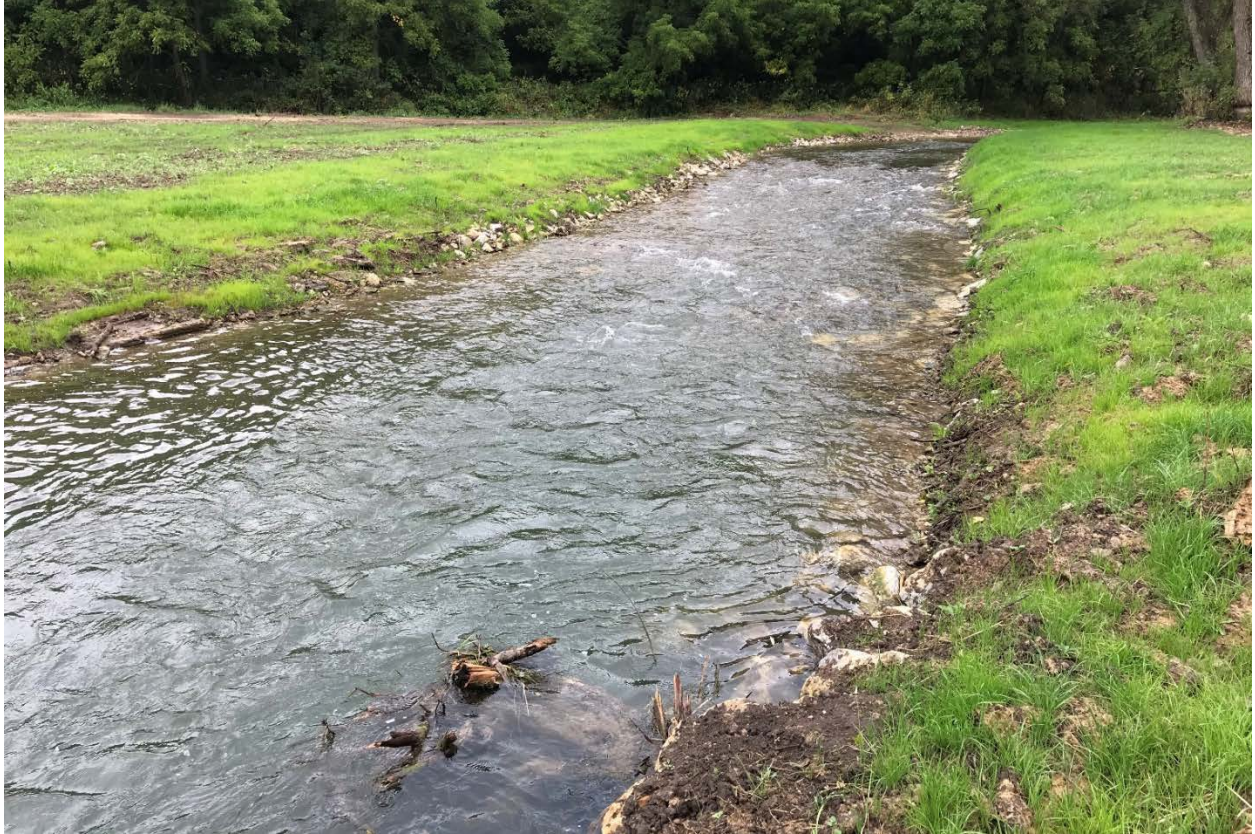
Figure 13. Example of Riffle Grade Control and Deep Pool Habitat with Rootwads

This practice incorporates a combination of bank grading, grade control, and strategic placement of woody material to reconnect the floodplain and provide deep pool habitat (Figure 13). A gradation of boulders, cobbles, and gravels will be used to create grade control riffles to increase and stabilize the bed elevation, thereby restoring channel slope and floodplain connectivity while also increasing pool depths and concentrated flow over riffles. Minor bank grading may be required based on the new bed elevation and established bankfull elevation. Logs and rootwads will be installed in pools to provide additional instream habitat. As with the approaches above, this practice will require harvest of woody material that will allow for selective tree thinning and establishment of herbaceous riparian vegetation near the stream channel.

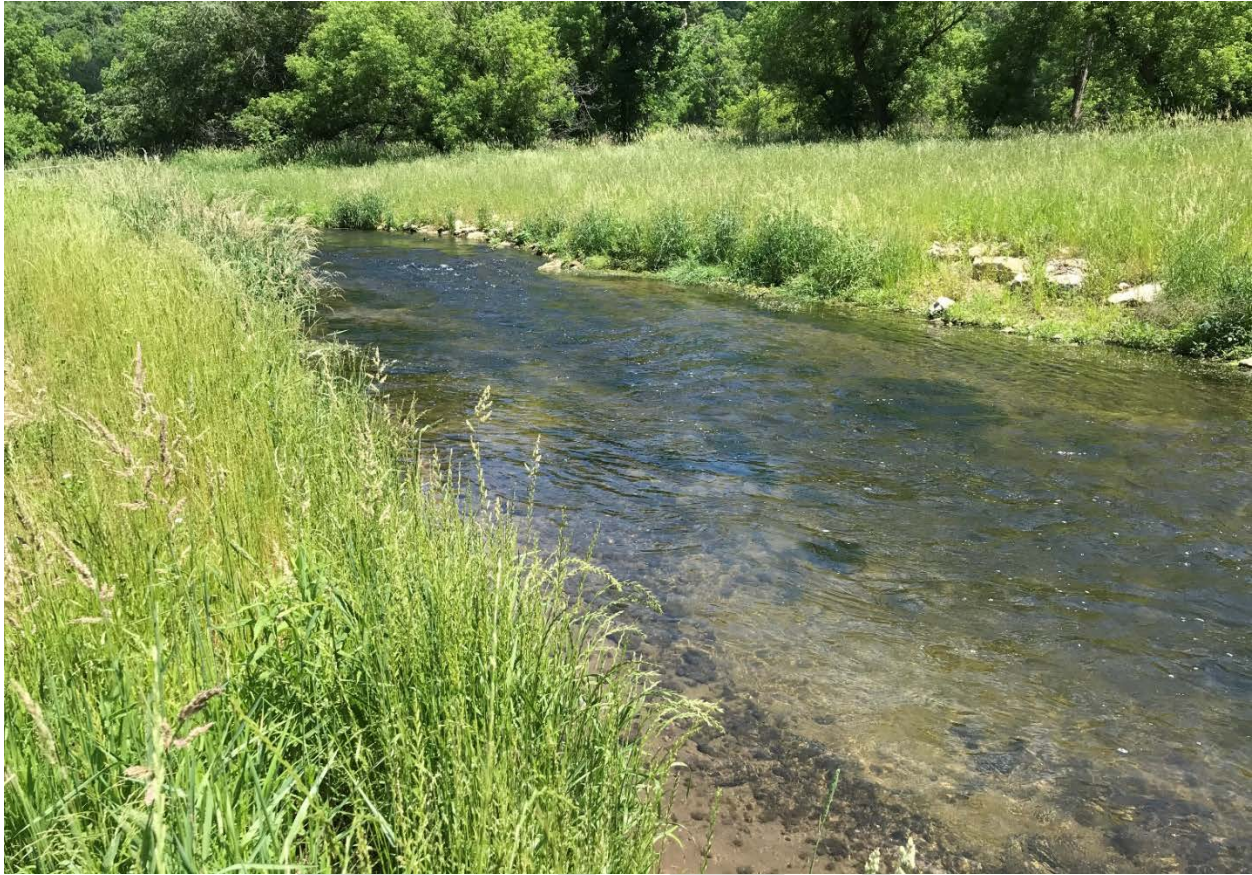
Figure 14. Example of Vegetated Boulder Toe 1-Year Post Construction

Boulder toe stabilization will be installed in areas immediately downstream of culvert crossings where flood energy and channel gradient are highest including the downstream end of the box culvert in Reach 7 and downstream of the road culvert under Creekridge Circle in Reach 17. Boulder toe rock will be installed along the bank toe and at a shallow slope (minimum 4:1) to allow for incorporation of native fill for establishment of vegetation within the boulder toe rock (Figure 14). The vegetated boulder toe will extend up to the bankfull elevation, and a bankfull bench will be graded at the top of the boulder toe.

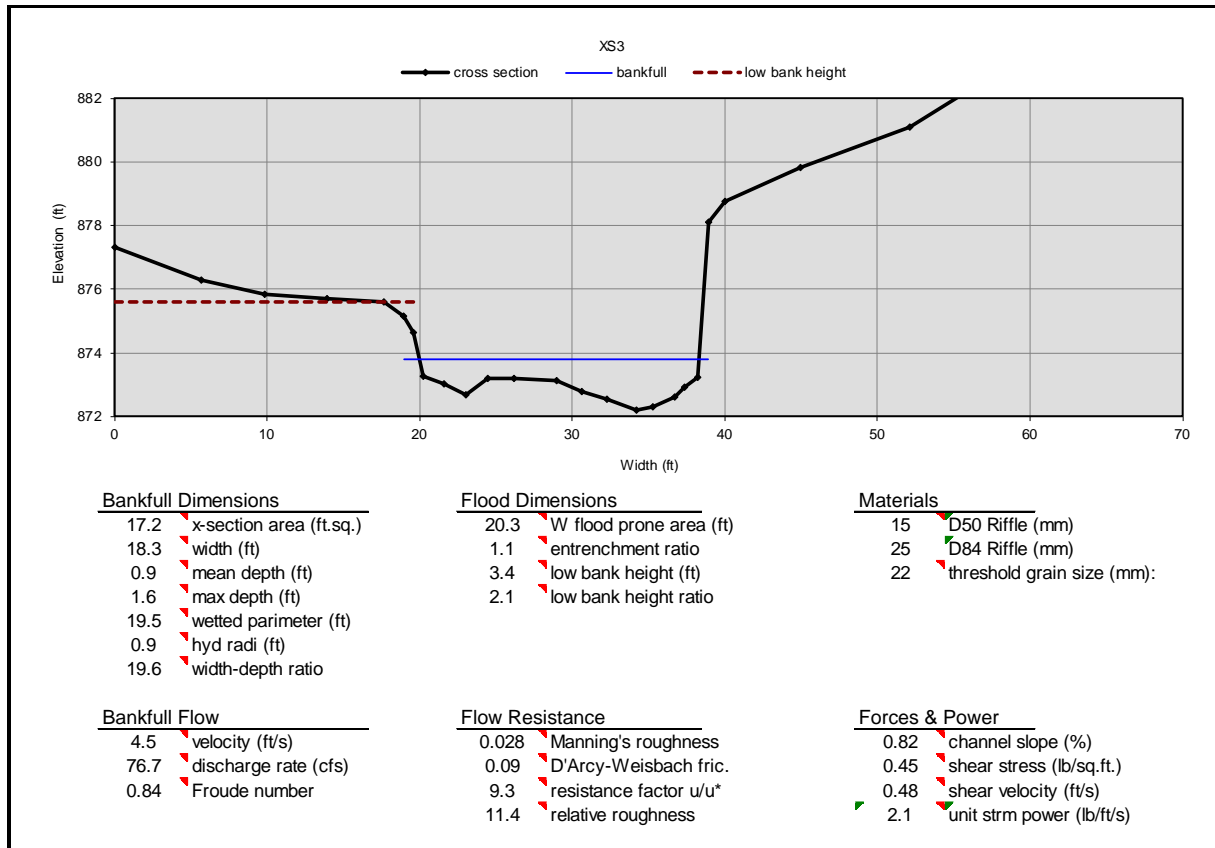
Reaches 6-8 Cross Section Graphs & Geomorphic Data

Location maps of all surveyed cross sections are included for reference in Appendix A and cross section graphs and associated geomorphic data summaries can be found in Appendix B.

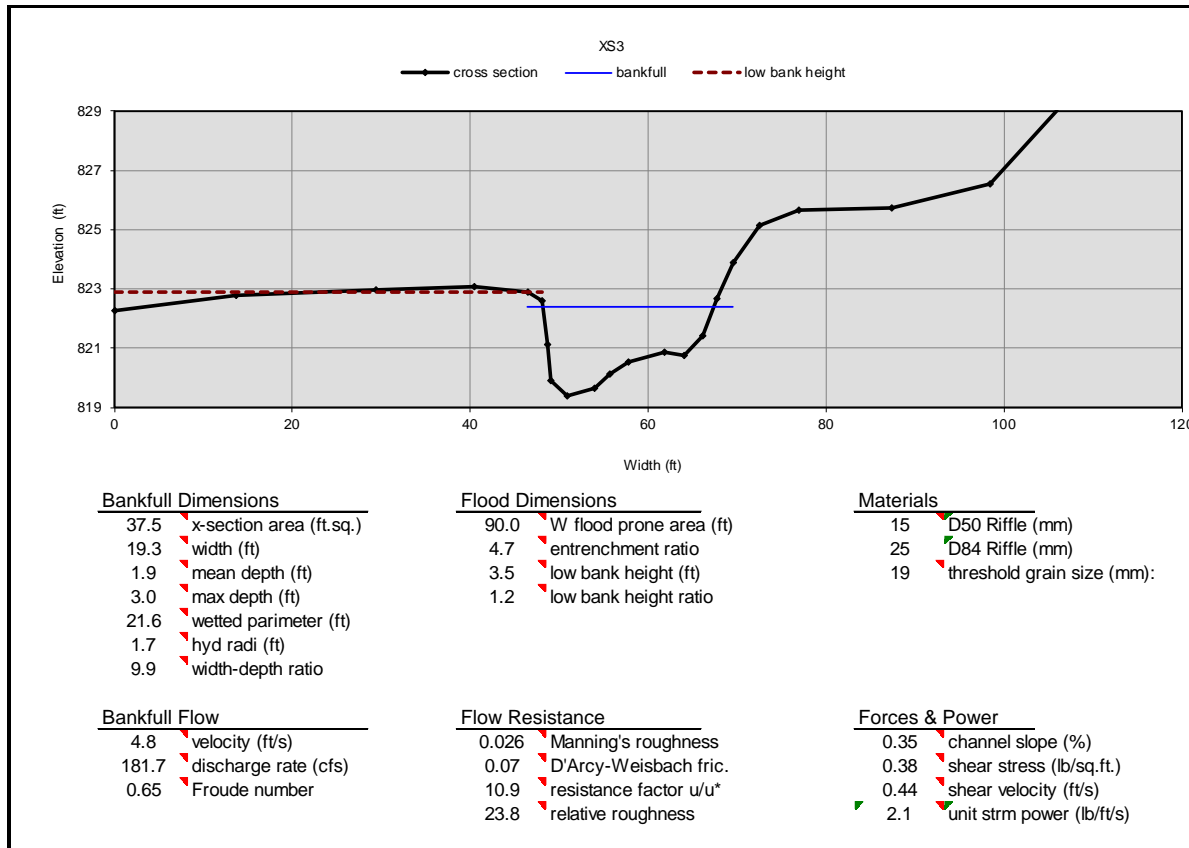
Reaches 16-17 Cross Section Graphs & Geomorphic Data
