Figure 5-6. Project Synopsis: Glen Lake Use Attainability Analysis

Nine Mile Creek Watershed District

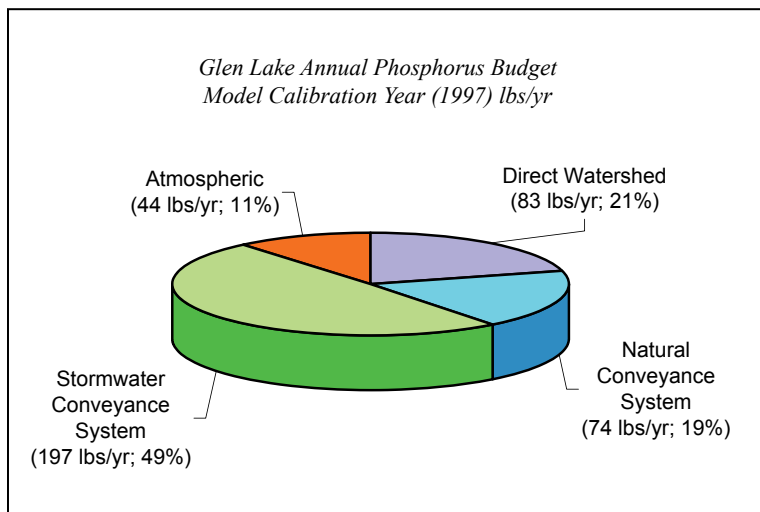
The stormwater conveyance system contributes roughly half of Glen Lake’s annual phosphorus load.

Cause: Urban stormwater runoff conveying large amounts of phosphorus to the lake

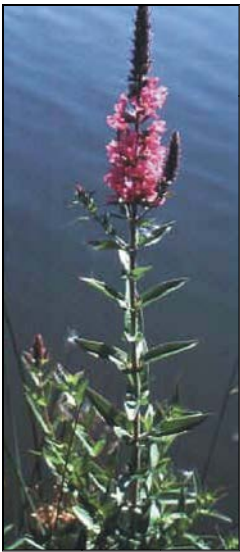
Purple loosestrife is an exotic species that invades wetlands and lake shorelines. It out-competes native species and, if left unchecked, will eventually become the dominant plant wherever it appears.

Problem: Exotic lake weed species (see left)

Cause: Purple loosestrife

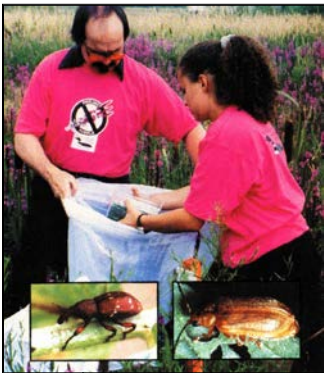
Purple loosestrife can be managed by releasing root-boring weevils onto the plants.

- Aquatic plant management (see left)

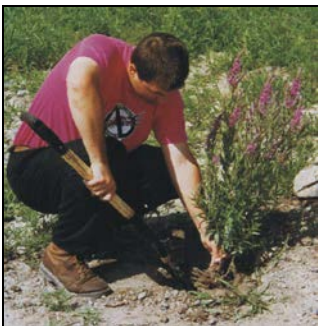
Digging loosestrife by hand is another possible management method.
