# REPORT SUMMARY

Lake Holiday, Wing  
Lake, and Lake Rose  
Water Quality Study

Prepared for  
Nine Mile Creek  
Watershed District

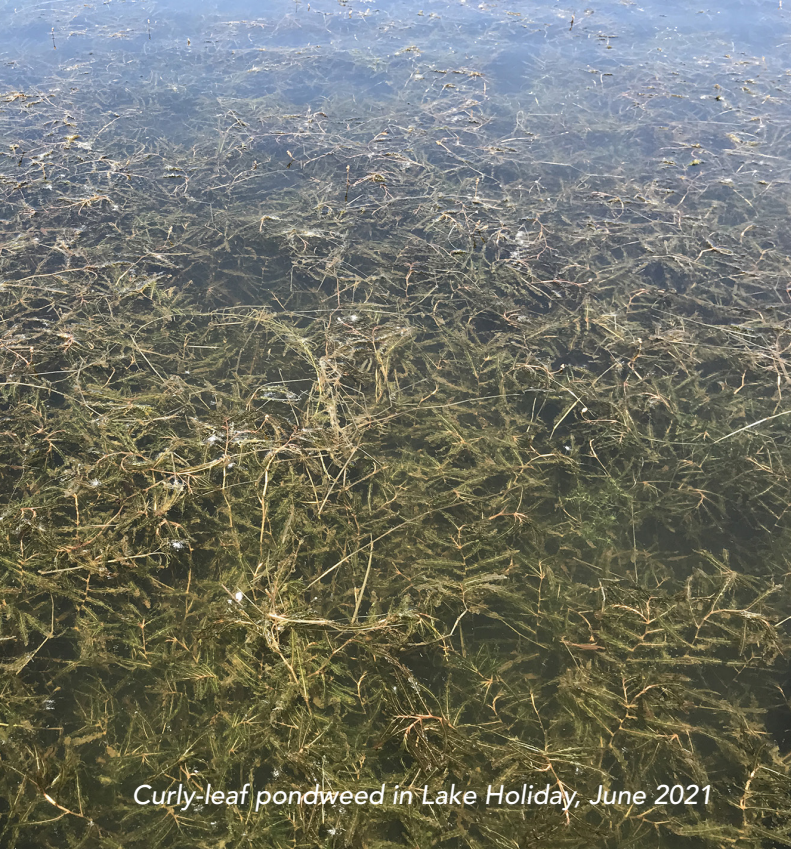
Curly-leaf pondweed in Lake Holiday, June 2021

Review of historic data indicates that water quality in Lake Holiday is poor, with summer average total phosphorus and chlorophyll-a concentrations generally above the state standard for shallow lakes. The poor water quality is primarily due to excess nutrients in the lake, which fuels algal growth and decreases water clarity. The phosphorus in Lake Holiday comes from several sources, including stormwater runoff from the watershed and internal sources such as nutrient-rich sediments. Additionally, the low diversity of plant species, substantial growth of the invasive species, curly-leaf pondweed, as well as the low quantity of plants in the lake throughout the growing season is likely contributing to the decrease in water quality.
