# Nine Mile Creek Watershed District Summary of 2019 Water Monitoring Program

Prepared for  
Nine Mile Creek Watershed District

April 2020

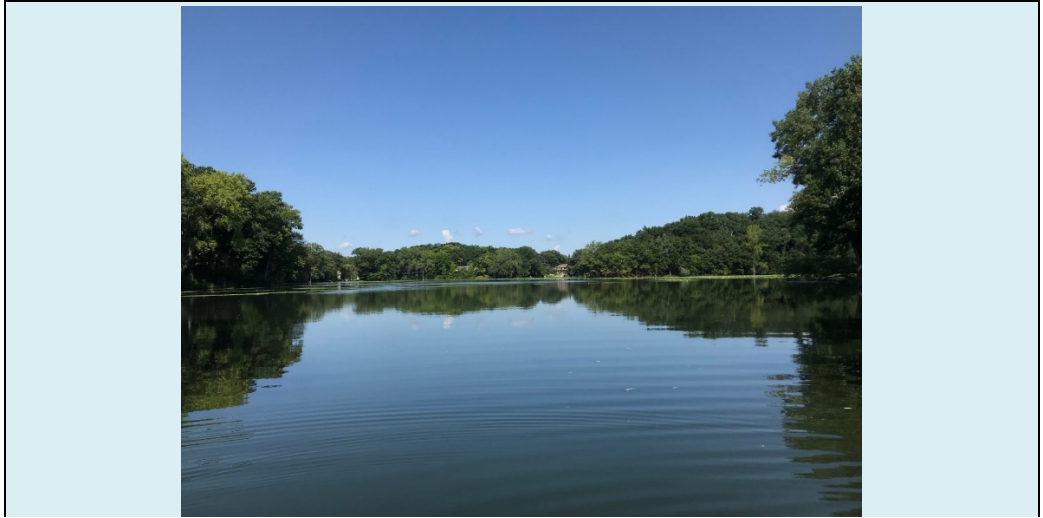
**Figure 3-2 Arrowhead Lake**

The phytoplankton data from Arrowhead Lake, pictured above, indicate the lake had an ample supply of good quality food for the lake’s zooplankton community in 2019.

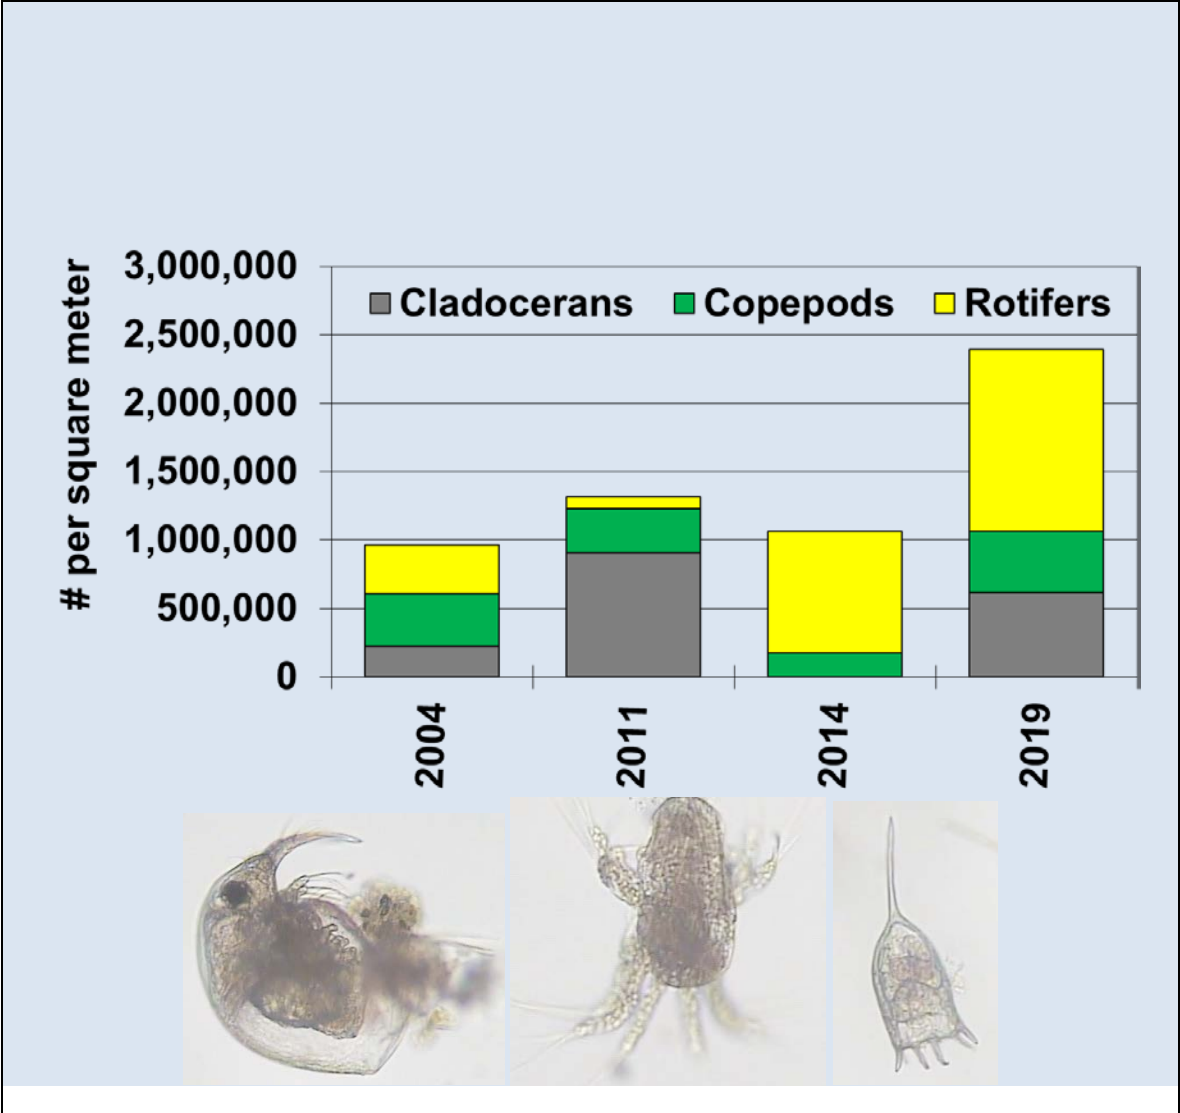
**Figure 3-4 2004, 2011, 2014, and 2019 Arrowhead Lake zooplankton summer average**  
 Top Summer average numbers and bottom, microscopic pictures of zooplankton species found in the lake, from left to right, *Bosmina longirostris* (cladoceran), nauplii (baby copepod), and *Keratella cochlearis* (rotifer).

All three groups of zooplankton (rotifers, copepods, and cladocerans) were represented in 2019; higher numbers were observed in 2019 than previous years (Figure 3-4). The data indicate the zooplankton community provided an abundant supply of food for planktivorous fish in the lake.

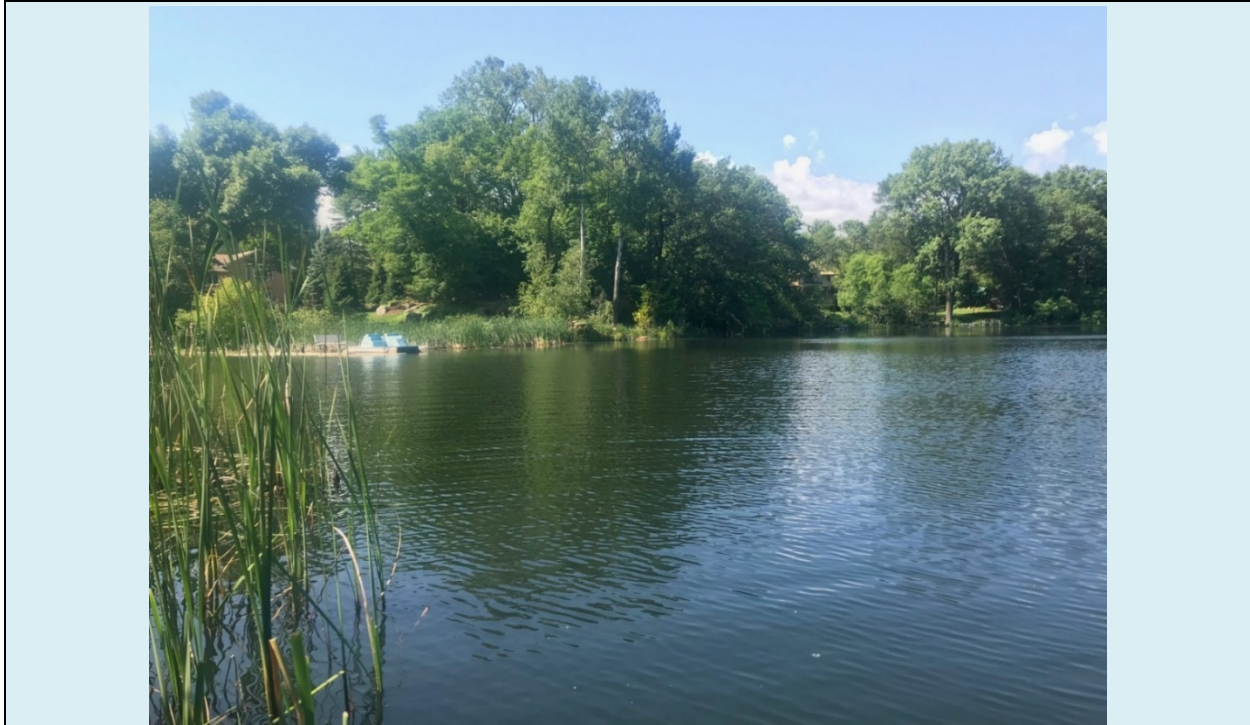
**Figure 4-2 Indianhead Lake**

2019 phytoplankton data collected from Indianhead Lake, pictured above, indicated the lake had an ample supply of good quality food for the lake's zooplankton community.

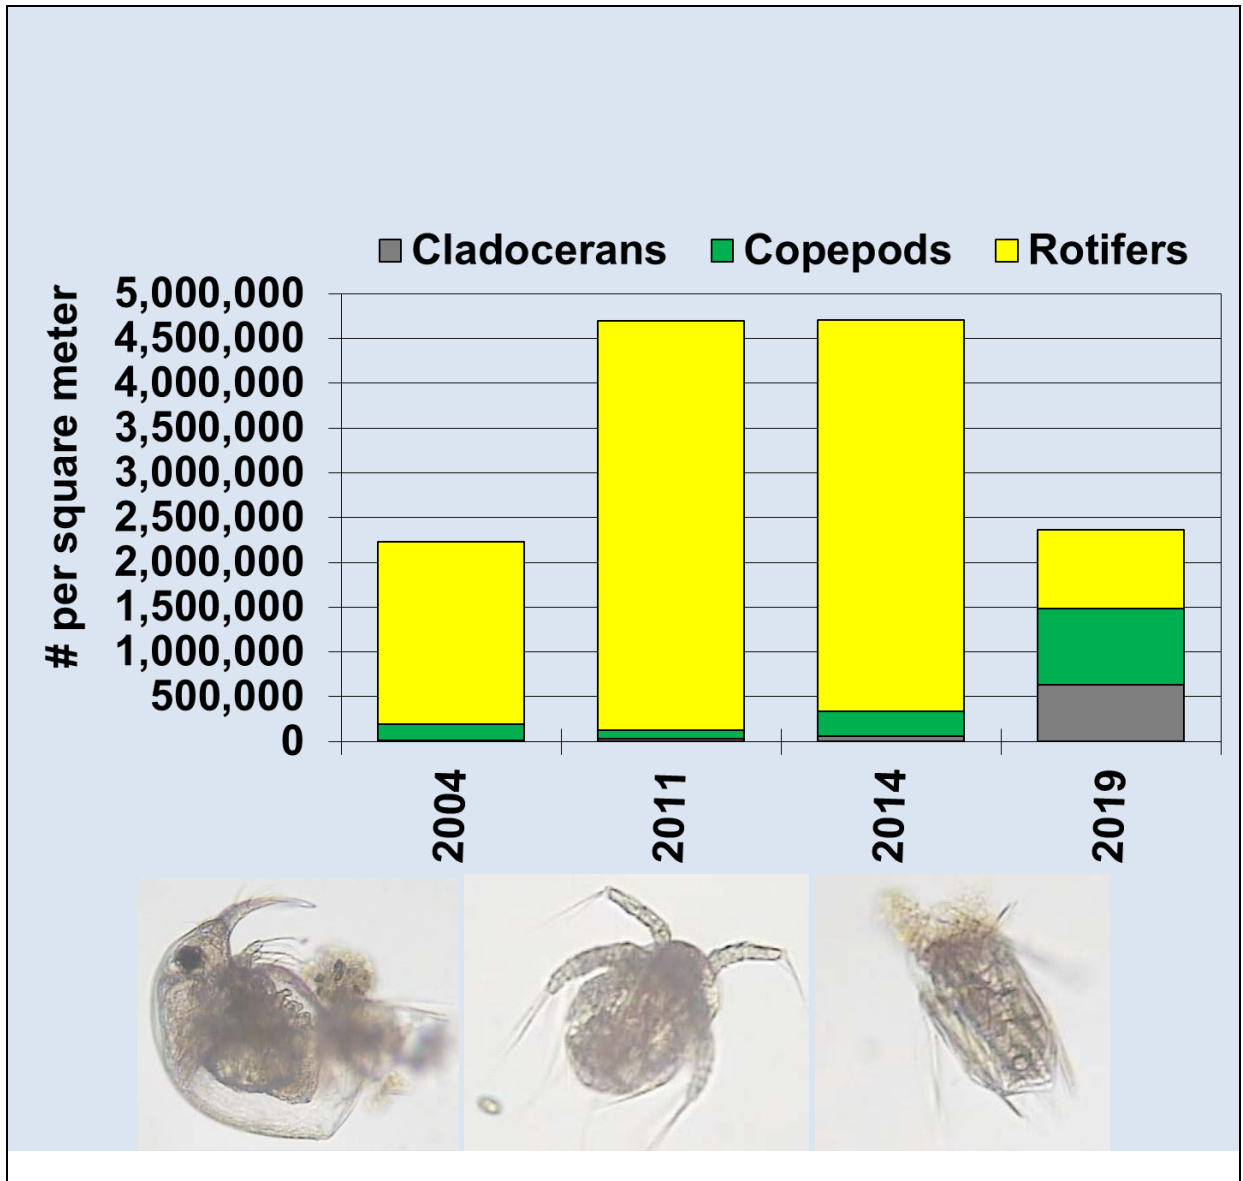
Top, 2004, 2011, 2014, and 2019 Indianhead Lake zooplankton numbers and bottom, microscopic pictures of zooplankton

**Figure 4-4 2004, 2011, 2014, and 2019 Indianhead Lake zooplankton**

species from the lake, from left to right, *Bosmina longirostris* (cladoceran), nauplii (baby copepod), and *Polyarthra vulgaris* (rotifer).

However, the total number of zooplankton in 2019 was, on average, lower than numbers observed in 2011 and 2014. The changes in numbers probably reflect the impacts of fish predation. Decreased extent and density of aquatic plants within the lake in 2019 may have reduced hiding places for zooplankton to avoid predation from fish and resulted in lower numbers than observed in 2011 and 2014 (Figure 4-4). Nonetheless, the 2019 data indicate the zooplankton community provided an abundant supply of food for planktivorous fish in the lake.

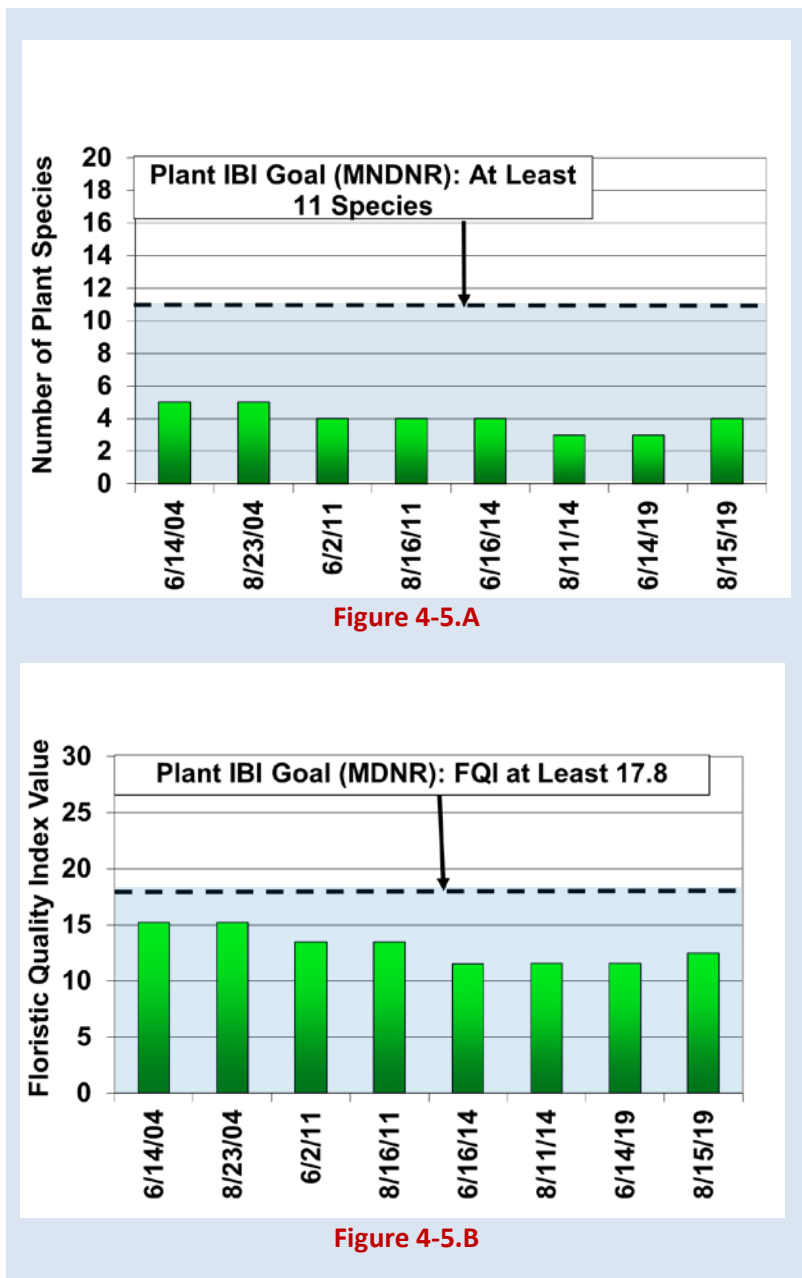
Figure 4-5 2004, 2011, 2014, and 2019 Indianhead Lake Plant Index of Biotic Integrity (IBI) Values compared with Plant IBI Thresholds: Number of Plant Species (top) and Floristic Quality Index (FQI) Values (bottom).

- Number of species:** A shallow lake (maximum depth less than 15 feet) is considered impaired when it has fewer than 11 species. During the period examined, the number of species in Indianhead Lake ranged from 3 to 5 and has been less (poorer) than the minimum impairment threshold during the entire period of record (Figure 4-5.A).
- FQI values (quality of species):** The impairment threshold for shallow lakes, as measured by FQI, is a minimum value of 17.8. During the period examined, FQI values ranged from 11.5 to 15.2 and has been less (poorer) than the minimum impairment threshold during the entire period of record (Figure 4-5.B).

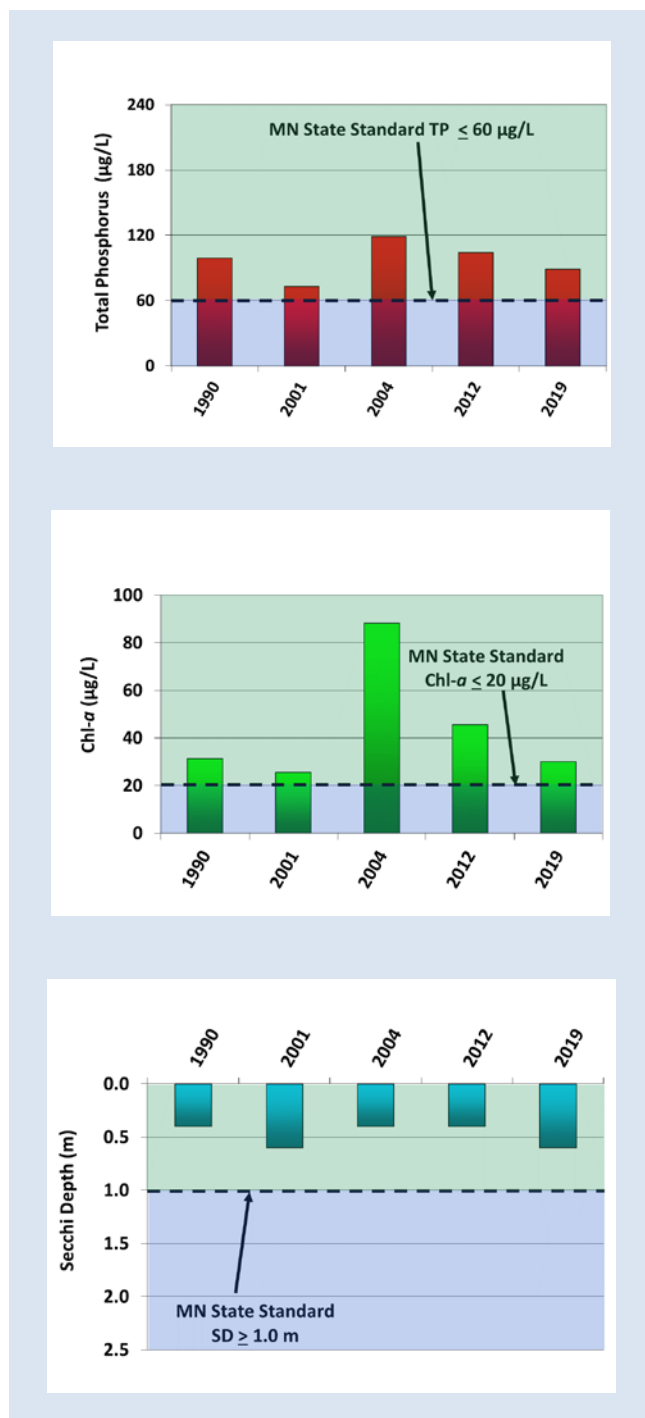
Figure 5-1 Mirror Lake summer average total phosphorus (top), chlorophyll *a* (middle), and Secchi disc (bottom) values during 1990-2019.

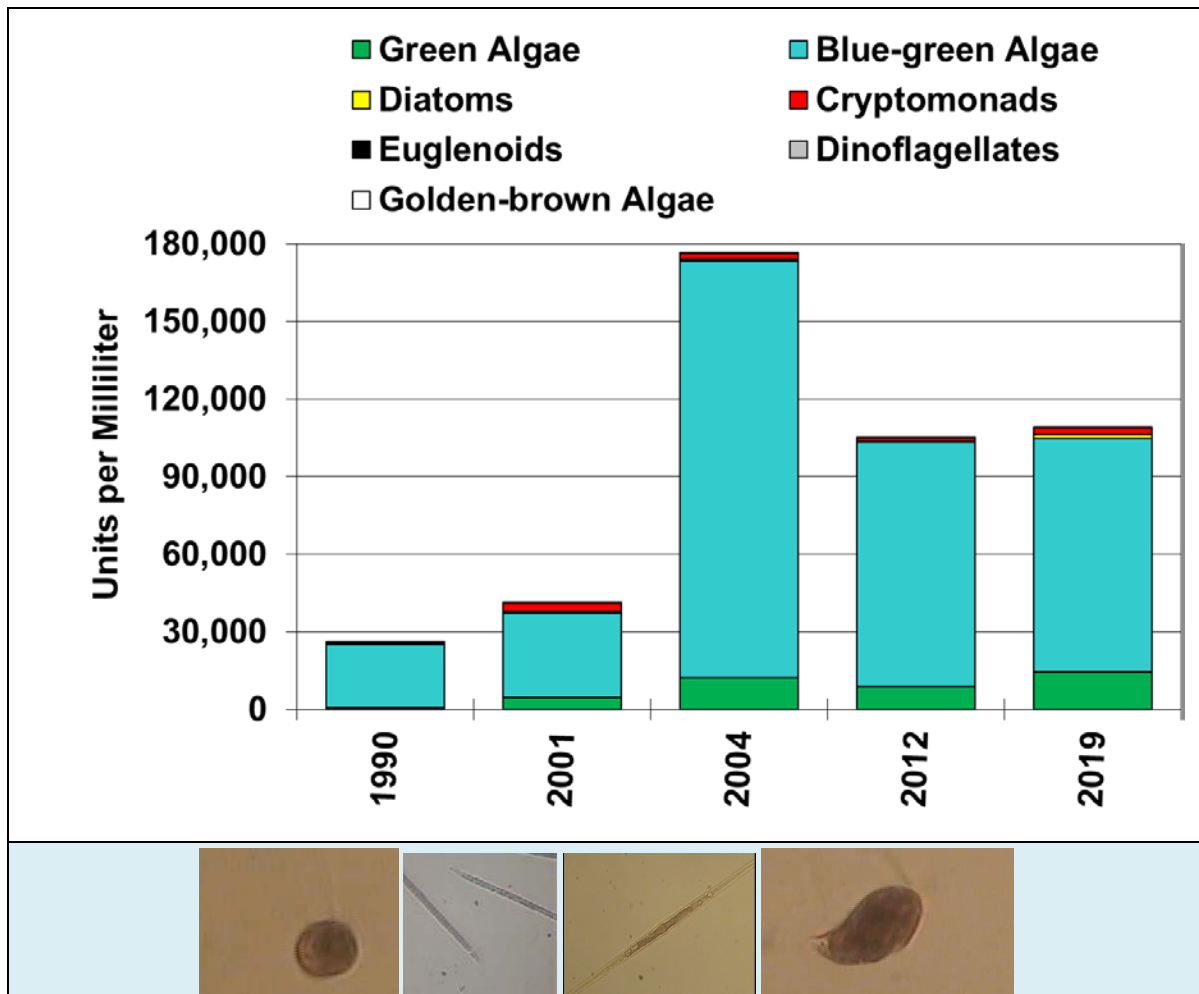
**Figure 5-2** Mirror Lake 1990-2019 summer average phytoplankton

Top, phytoplankton numbers and bottom, microscopic pictures of blue-green algae species found in the lake , from left to right, *Chlamydomonas globosa* (green algae) *Cylindrospermopsis raciborskii* (blue-green algae), *Synedra ulna* (diatom), and *Cryptomonas erosa* (cryptomonad).

High phosphorus concentrations in lakes result in blue-green algae blooms such as were observed in Mirror Lake. Blue-green algae use whatever dissolved phosphorus is available in the water column to grow and reproduce. Their community size is a direct result of the amount of phosphorus available for growth. Because the number of blue-green algae in a lake is a direct result of the quantity of phosphorus in the lake, blue-green algae can be controlled by controlling phosphorus loading to the lake.

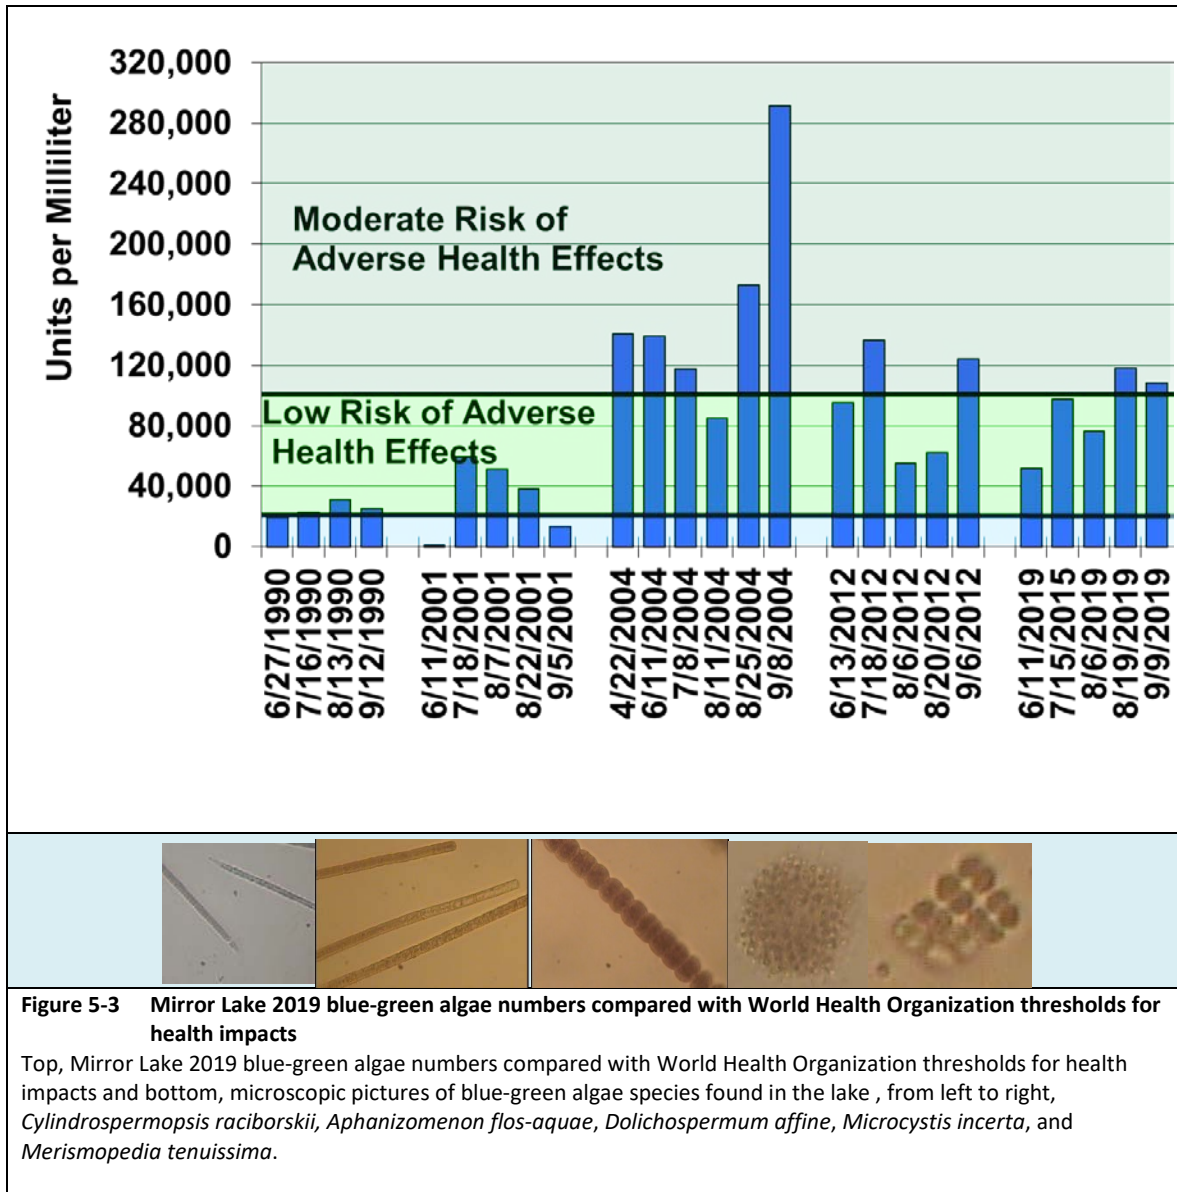
**Figure 5-3 Mirror Lake 2019 blue-green algae numbers compared with World Health Organization thresholds for health impacts**

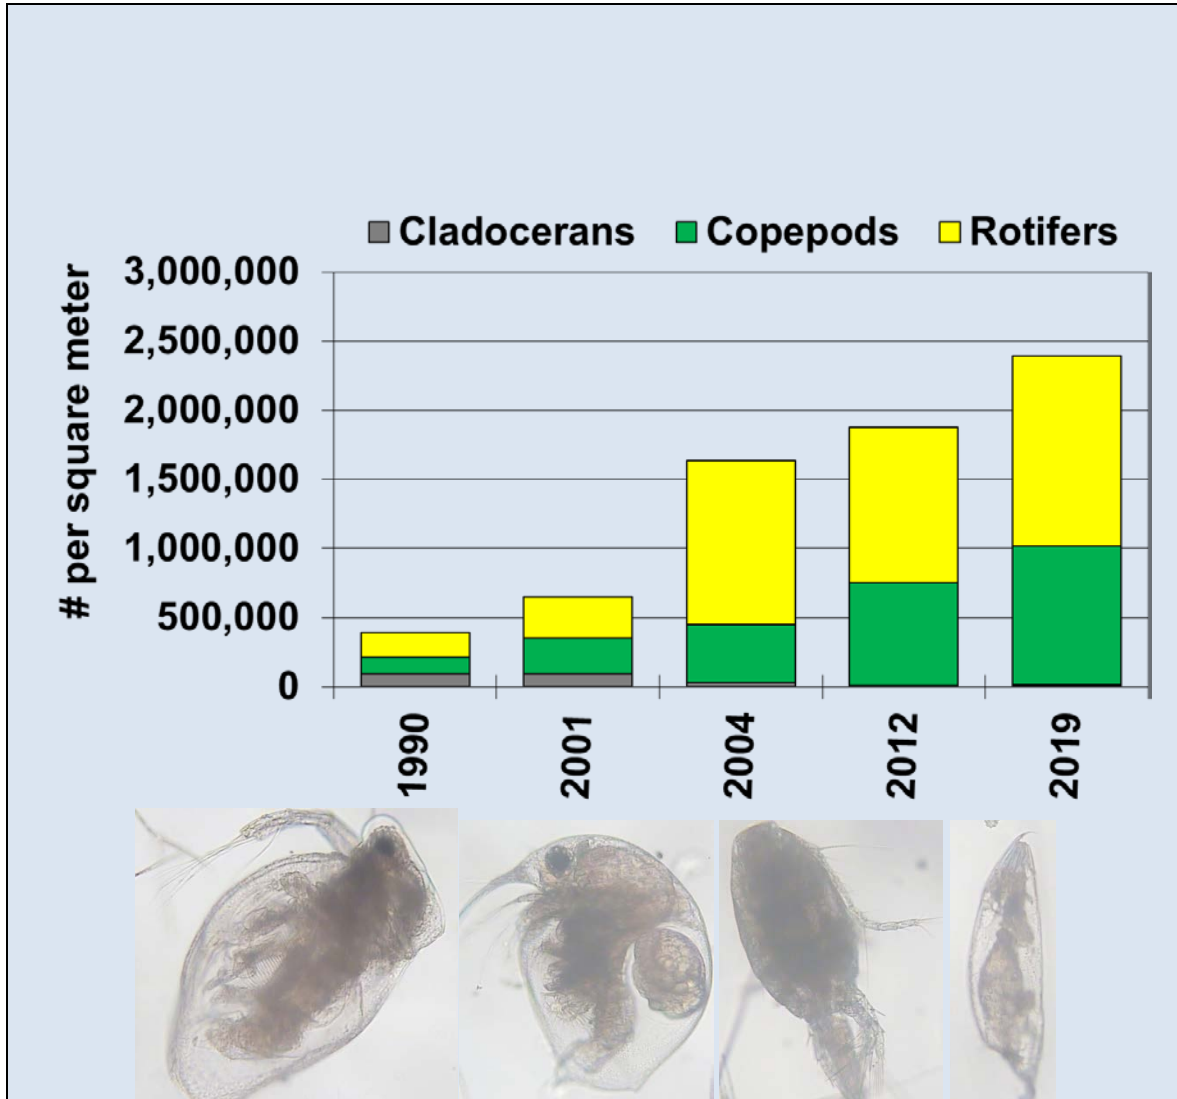
Top, zooplankton numbers and bottom, microscopic pictures of zooplankton species from the lake, from left to right,

the lake. Because of their small size, rotifers are the least preferred by fish and, hence, are least vulnerable to fish predation. Rotifer numbers were consistently higher than cladoceran and copepod numbers throughout the period of record (Figure 5-4). Copepods' ability to escape predation enabled them to be prevalent in the lake throughout the period of record (Figure 5-4).

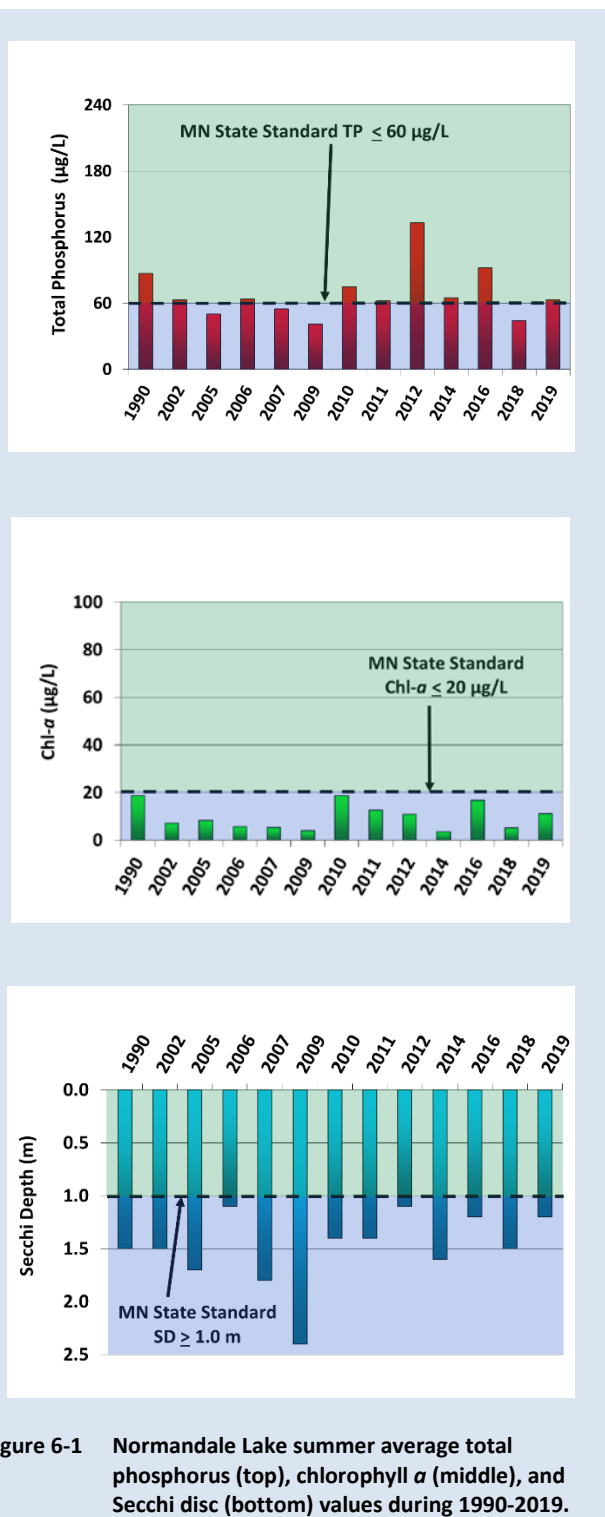
Figure 6-1 Normandale Lake summer average total phosphorus (top), chlorophyll *a* (middle), and Secchi disc (bottom) values during 1990-2019.

Historical water quality data have been periodically collected from Normandale Lake during 1990 through 2019. The 2019 data indicate water quality was within the range of historical data (Figure 6-1). Normandale Lake has historically met the State standards for chlorophyll *a* and Secchi disc depth, but not for total phosphorus. Summer average chlorophyll *a* has ranged from 4 to 19 µg/L and Secchi disc depth has ranged from 1.1 to 2.4 meters. Summer average total phosphorus has ranged from 41 to 133 µg/L, with several years, including 2019, exceeding the State maximum impairment threshold (Figure 6-1).

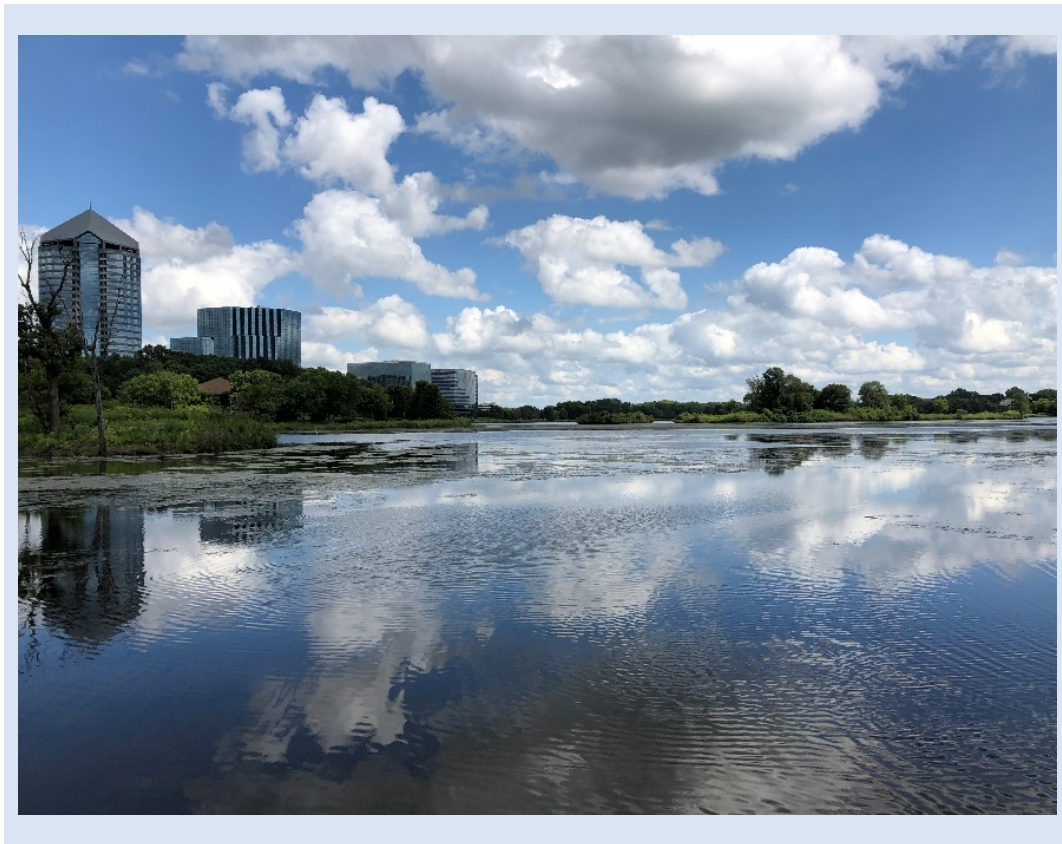
**Figure 6-2 Normandale Lake**

In 2019, the wet weather added higher phosphorus loads to Normandale Lake, pictured above, likely resulting in a summer average total phosphorus concentration that didn’t meet shallow lakes phosphorus criteria.

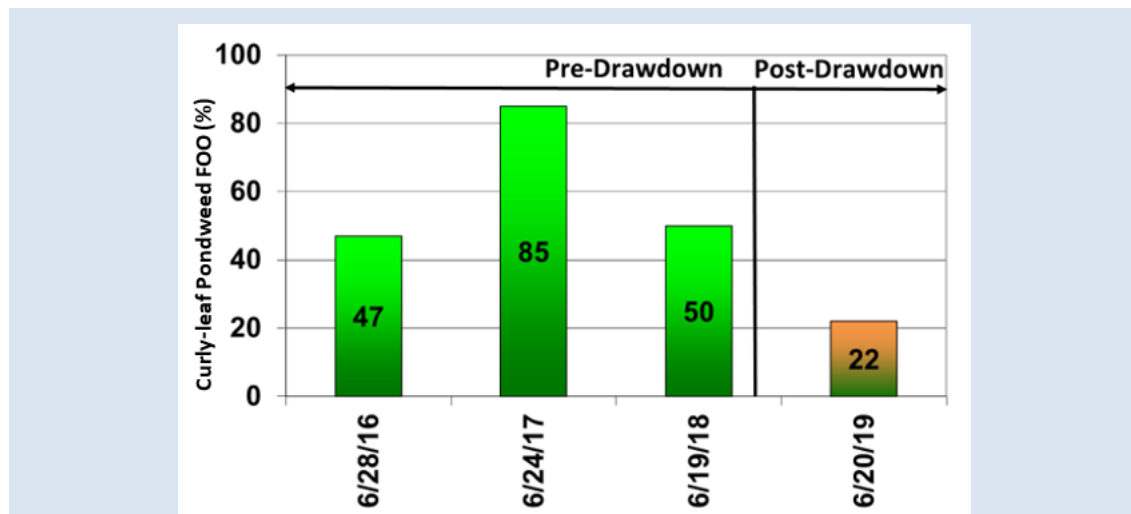
Figure 6-4 2016-2019 Curly-leaf Pondweed Frequency of Occurrence (FOO)

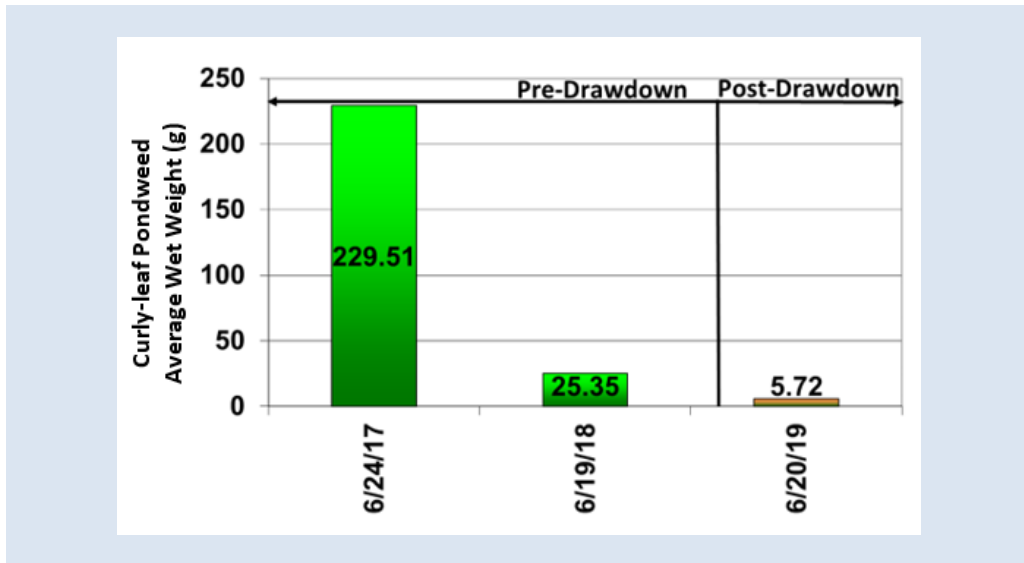
Figure 6-5 2017-2019 Curly-leaf Pondweed Biomass (Average Wet Weight Per Sample Location)

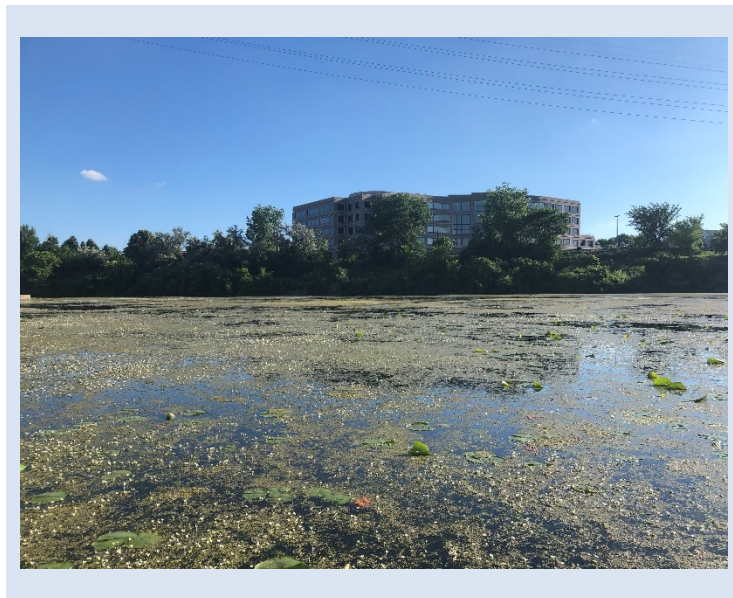
**Figure 8-1 Lake Smetana**

In 2019, a dense plant growth was observed throughout Lake Smetana, pictured above. Coontail (*Ceratophyllum demersum*) and white water crowfoot (*Ranunculus aquatilis*) dominated the plant community. (Photo Credit: Endangered Resource Services, LLC.)

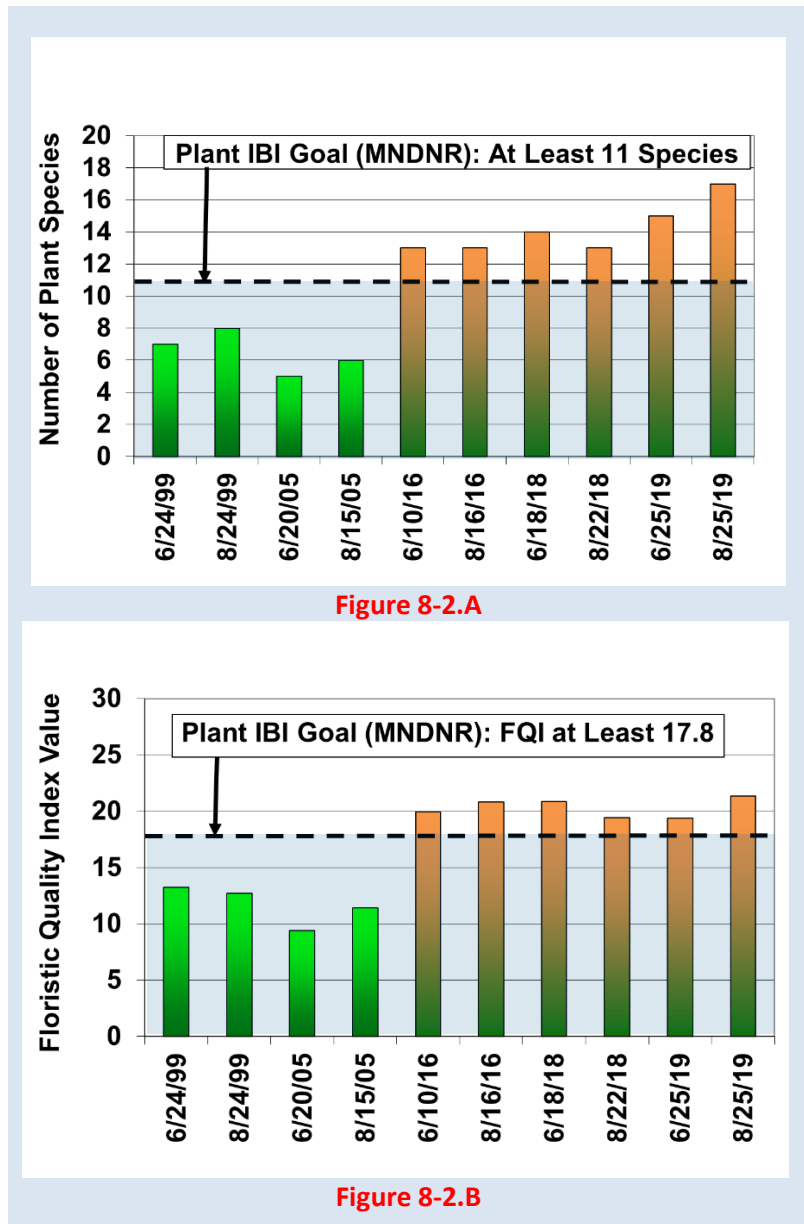
Figure 8-2 1999-2019 Lake Smetana Plant Index of Biotic Integrity (IBI) Values compared with Plant IBI Thresholds: Number of Plant Species (top) and Floristic Quality Index (FQI) Values (bottom).

- Number of species:** A shallow lake is considered impaired when it has fewer than 11 species. During the period examined, the number of species in Lake Smetana ranged from 7 to 17 and has been better than the impairment threshold since completion of the Bryant Lake water quality improvement

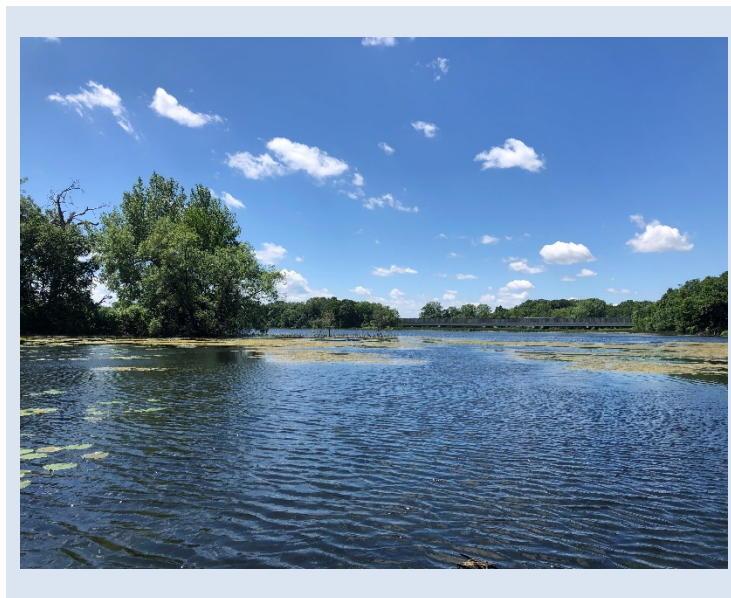
**Figure 9-1** A healthy plant community was found in Southeast Anderson Lake, pictured above in 2019, but several aquatic invasive species were also present in the lake. (Photo Credit: Endangered Resource Services, LLC.)

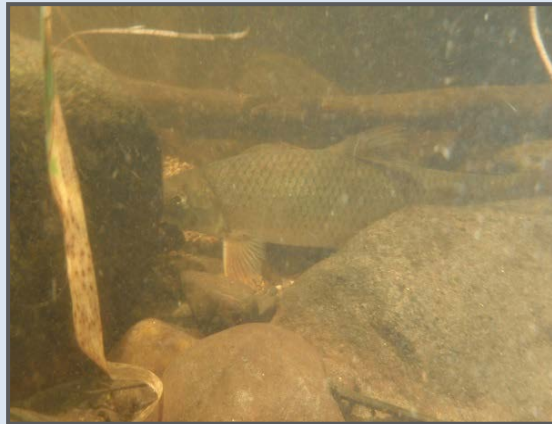
**Figure 10-1 Downstream Main Stem Location ECU-7C (Shorthead Redhorse Fish)**

The primary use of Nine Mile Creek is a place for fish and aquatic life to live, such as the shorthead redhorse fish swimming in downstream Main Stem Location ECU-7C, pictured above.

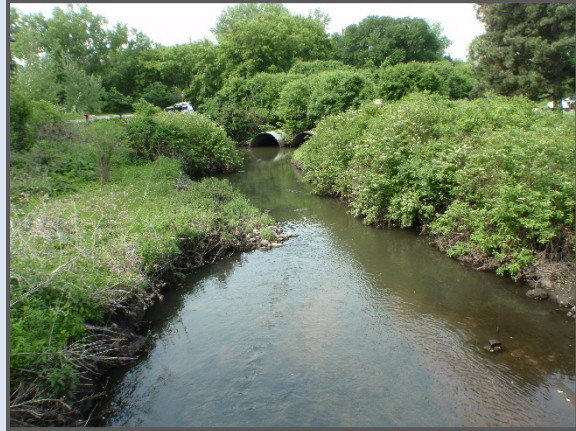
**Figure 10-2 Downstream North Fork Location ECU-2A**  
In 2019, the North Fork average annual specific conductance was lower than annual averages during 2008 through 2018. Pictured above is downstream North Fork location ECU-2A on June 3, 2019.

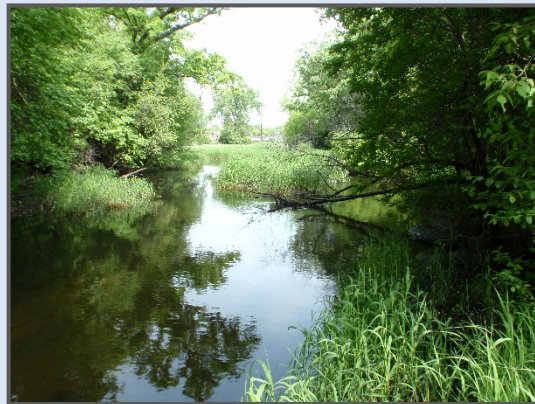
**Figure 10-3 Downstream South Fork Location ECU-5A**  
In 2019, the South Fork met the MPCA dissolved oxygen standard less frequently than the Main Stem and North Fork. Pictured above, the downstream South Fork location ECU-5A on June 3, 2019.

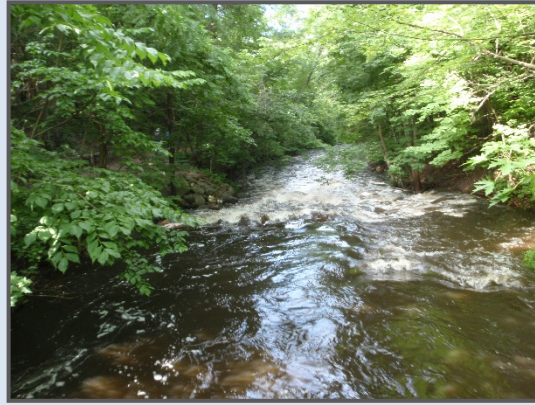
**Figure 10-4 Downstream Main Stem Location ECU-7C**  
In 2019, the average annual discharge at the Main Stem was higher than all annual average values during the period examined. Pictured above, the downstream Main Stem location ECU 7C on July 3, 2019.

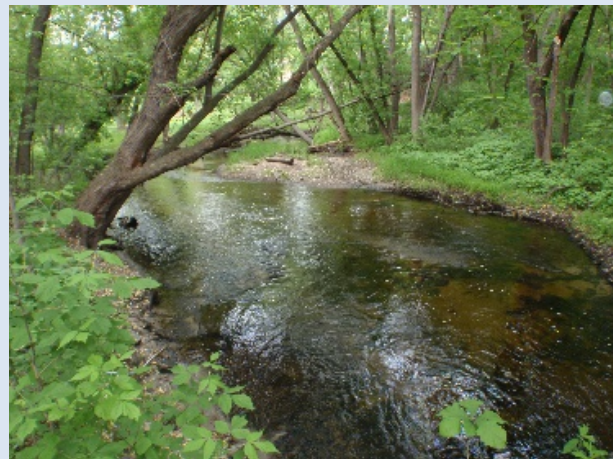
**Figure 10-5 Upstream Main Stem Location ECU-7A**  
In 2018, a tolerant forage fish assemblage, an indicator of average to poor water quality, was observed at the most upstream Main Stem location, ECU-7A, pictured above.

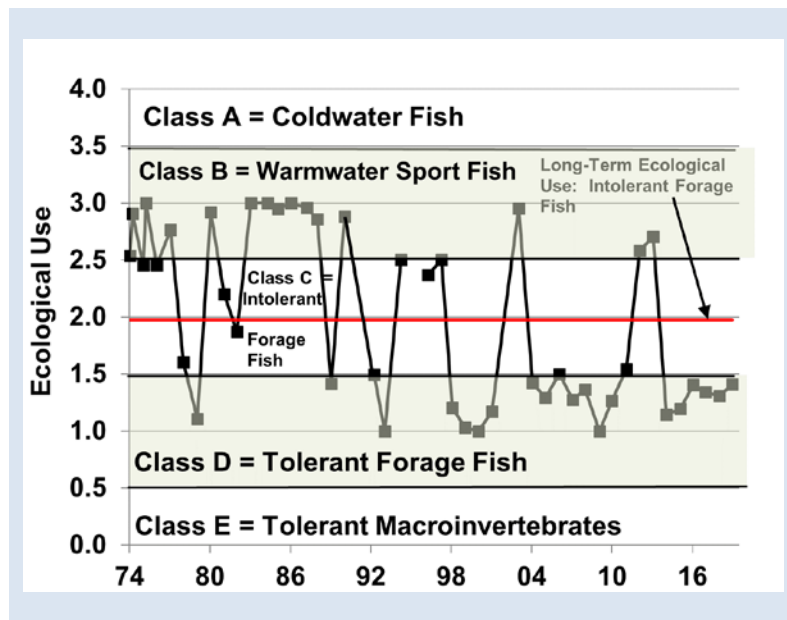
**Figure 10-6 1974-2019 Main Stem ECU 7A Ecological Use (Type of Fish Community)**

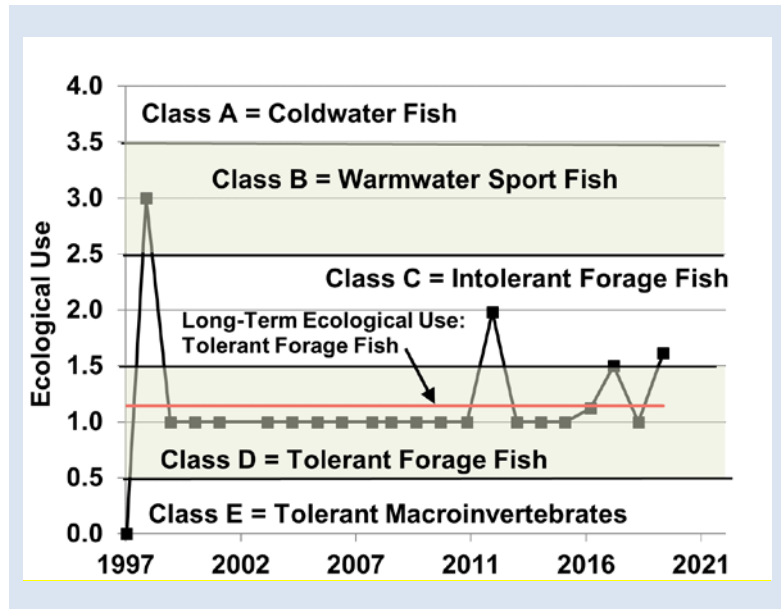
Figure 10-7 1997-2019 South Fork ECU 5A Ecological Use (Type of Fish Community)

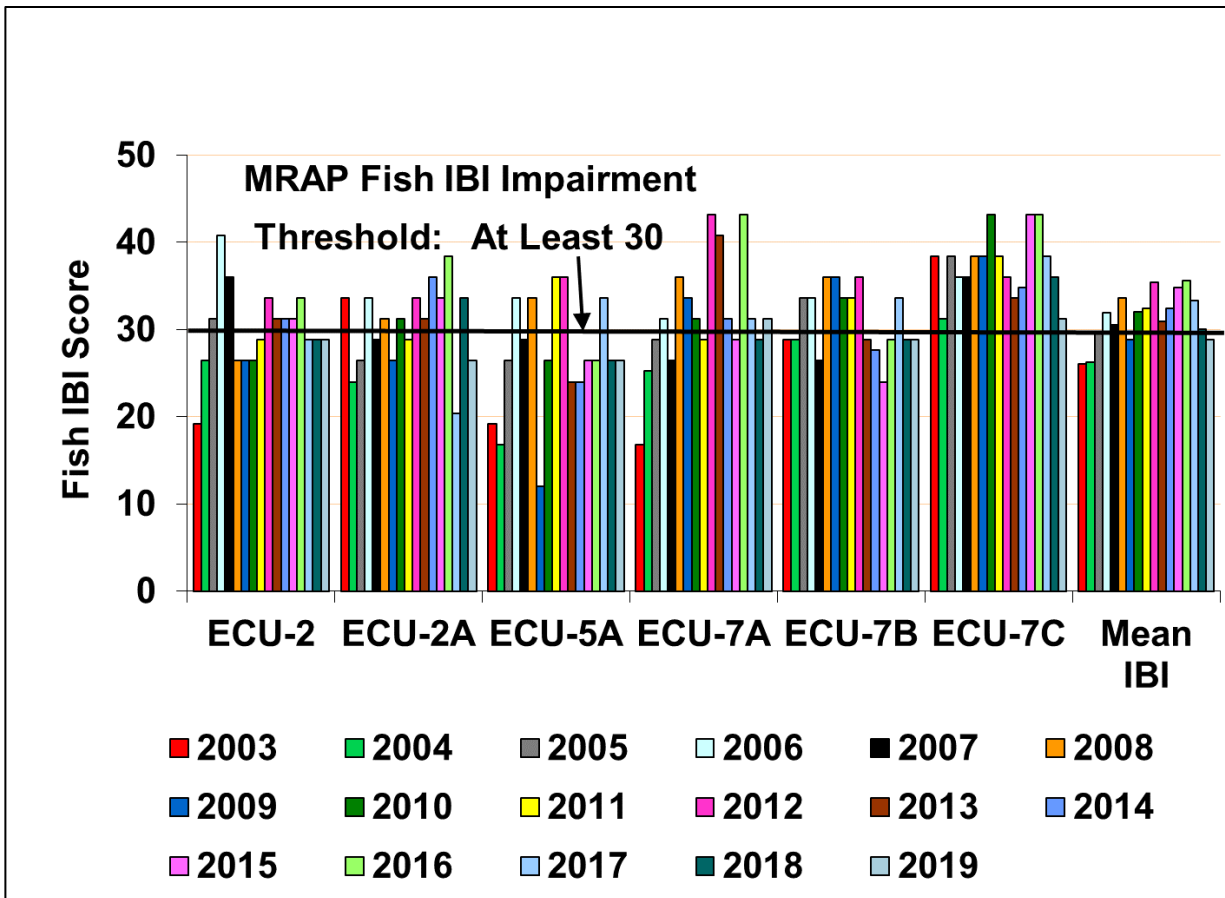
Figure 10-9 2003-2019 Nine Mile Creek MRAP Fish IBI Scores

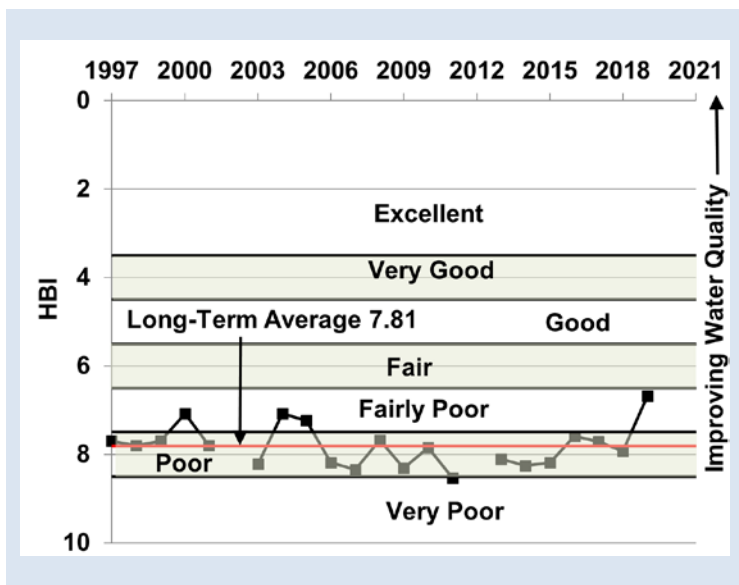
Figure 10-13 1997 - 2019 Nine Mile Creek HBI: Downstream South Fork Location, ECU 5A

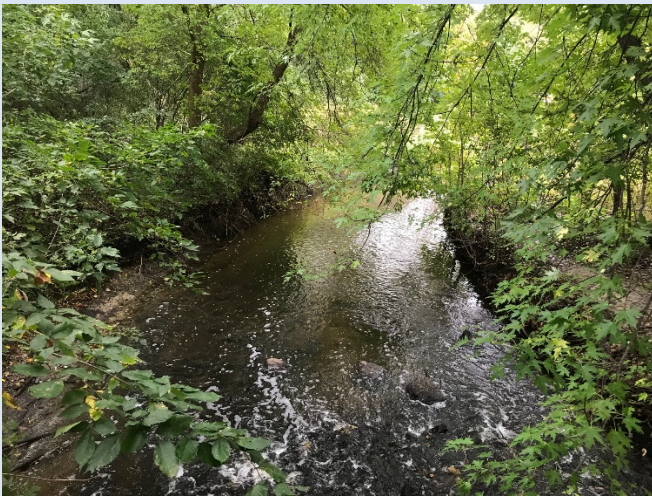
**Figure 10-17 Middle North Fork Location ECU-2**  
In 2019, significant improvement in HBI score and improvement in ICI score were documented for the middle North Fork location (ECU-2) pictured above.

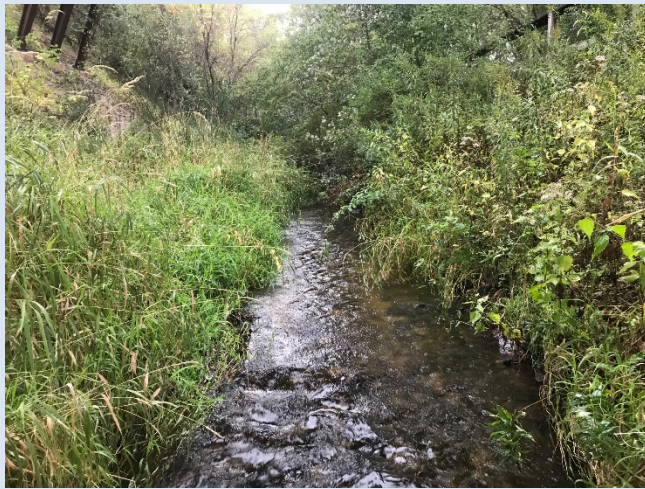
**Figure 10-18 Upstream South Fork Location ECU-3A**

ecological use. In 2019, the fish communities in Nine Mile Creek were consistent with or better than the stream's attainable ecological use. The 2019 fish communities of the North Fork, the upstream South Fork (ECU-3A) (Figure 10-18), and the middle (ECU-7B) (Figure 10-8), and downstream (ECU-7C) (Figure 10-4) Main Stem locations were consistent with their attainable ecological uses. The fish community in the upstream Main Stem location (ECU-7A) (Figure 10-5 and Figure 10-6) was poorer than its attainable ecological use, but was very close to attainment. The fish community at the downstream South Fork location (ECU-5A) (Figure 10-3 and Figure 10-7) was better than its attainable ecological use and was of higher quality than fish communities observed at this location in recent years.

The 2019 fish community in the upstream South Fork location (ECU-3A), pictured above, was consistent with its designated ecological use.
