# Curly-leaf pondweed (*Potamogeton crispus*) Fall Turion Survey Normandale Lake – DOW: 27104501 Hennepin County, Minnesota

Endangered Resource Services, LLC  
Matthew S. Berg, Research Biologist  
St. Croix Falls, Wisconsin  
November 2, 2019

Following the 2019 summer growing season, we conducted a fall turion survey. The goals of the survey were to determine the level of CLP turions within the lake’s substrate following the 2018/2019 fall drawdown that resulted in the freezing of much of the lake’s substrate. This report is the summary analysis of that survey conducted on November 2, 2019.

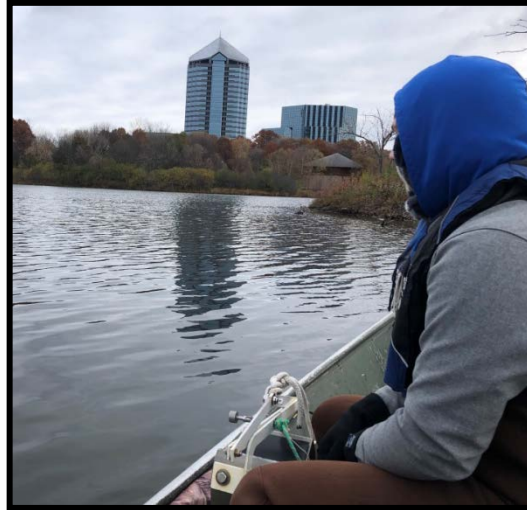
2019 Fall CLP Turion Density

Normandale Lake 11-2-19

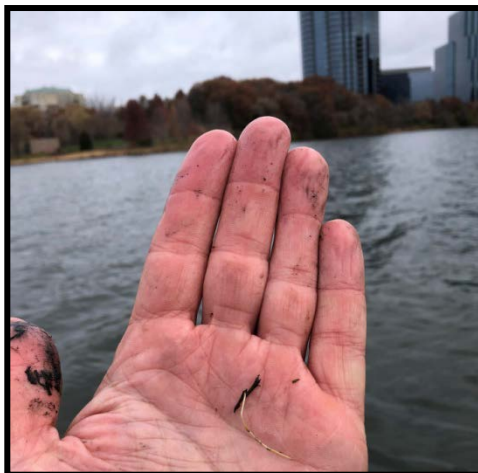
Typical "stick" CLP turion (Berg 2019)

We found Curly-leaf pondweed turions at only 19 of 50 survey points (38.0% coverage) (Table 1), and, collectively, there were just 36 live turions present in the samples. Interestingly, we noticed that every viable turion found was the small “stick” variety that we usually find on small parent plants (see front cover). The only large turions (dime-sized or greater) were rotten and disintegrating. This may mean they were killed by the drawdown.

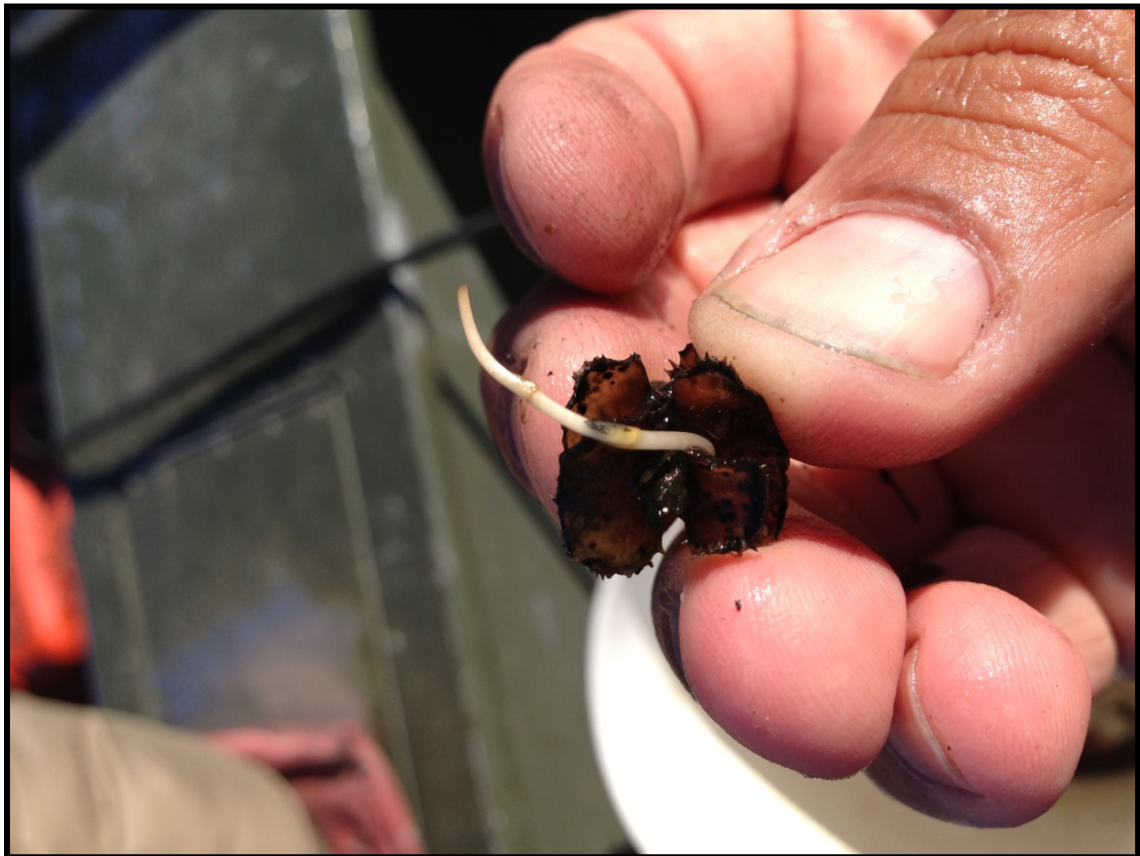
**Figure 1: Germinating CLP Turion**

Although Curly-leaf pondweed occasionally reproduces by seed, the vast majority of plants resprout from stiff overwintering buds called turions that are normally produced in number by the plants prior to their late June/early July senescence (Figure 1). After the pinecone-like turions germinate in late fall or early winter, plants continue to grow slowly under the ice. Following ice out, growth accelerates, and plants rapidly canopy allowing them a competitive advantage over slower growing native species (Capers et al. 2005).

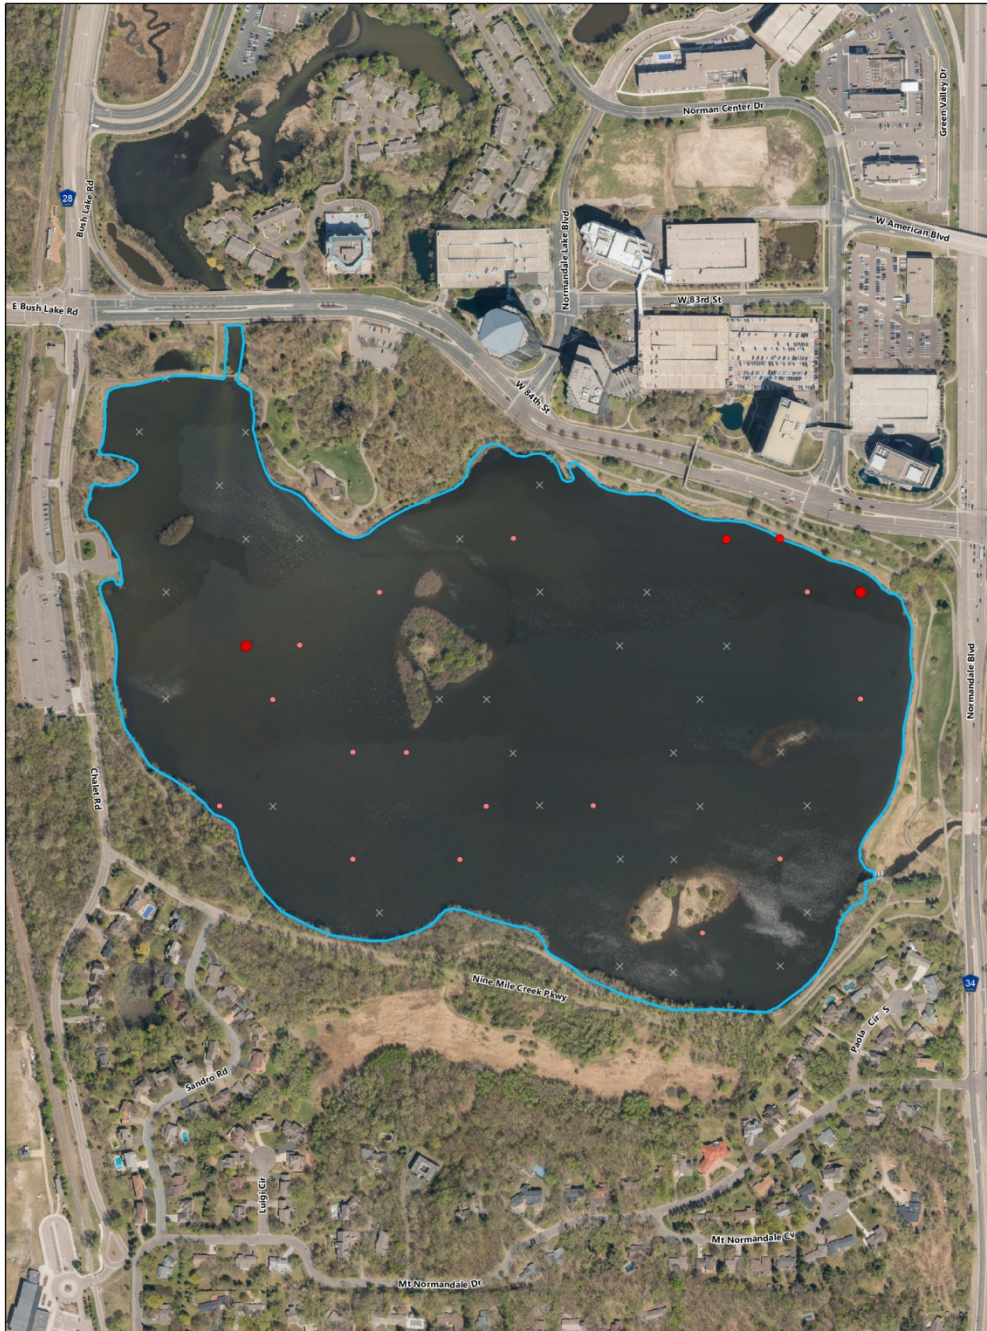
**Appendix II: 2019 Fall CLP Turion Density and Distribution**

**Turion Density/m<sup>2</sup> - Potential for Impairment**

- × None Found
- 1 - 50 - None
- 50 - 100 - Very Low
- 100 - 200 - Low
- 200 - 350 - Moderate
- >350 - High

Four of the survey points topped an estimated 50 turions/m<sup>2</sup> meaning they have at least some potential for navigation impairment (8.0% coverage/21.1% of points with turions). However, none of these points exceeded the expected “nuisance level” of 200/m<sup>2</sup> (Figure 5) (Appendix II).
