# REPORT SUMMARY

## Lake Cornelia and Lake Edina Water Quality Study

Use Attainability Analysis for Lake Cornelia (updated from 2010) and Lake Edina (first version)

Prepared for Nine Mile Creek Watershed District

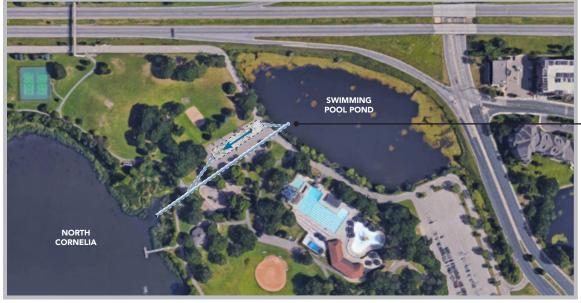
Water moves through the spent lime filtration chamber to remove phosphorus before discharge to Lake Cornelia.

installation of a **spent lime/CC17 treatment chamber** under the parking lot in Rosland Park (see image at right). The innovative spent lime/CC17 treatment chamber would serve as a "polishing" step, diverting a portion of the discharge from Swimming Pool Pond through the spent lime filtration chamber to remove dissolved phosphorus before discharge to Lake Cornelia. Figure 2 shows the predicted improvements in summer-average phosphorus concentrations in all three lakes as a result of the spent lime/CC17 treatment chamber, in combination with the alum and curly-leaf pondweed treatments. While the incremental improvement resulting from the watershed BMP is not significant, reducing the external phosphorus loading will also increase the longevity of the alum treatment (and therefore the frequency of repeat treatments) and reduce future build-up of phosphorus in lake bottom sediments.
