Lake Smetana Water Quality Evaluation Using the Use Attainability Analysis (UAA) Process

Nine Mile Creek Watershed District Special Meeting
February 6, 2020

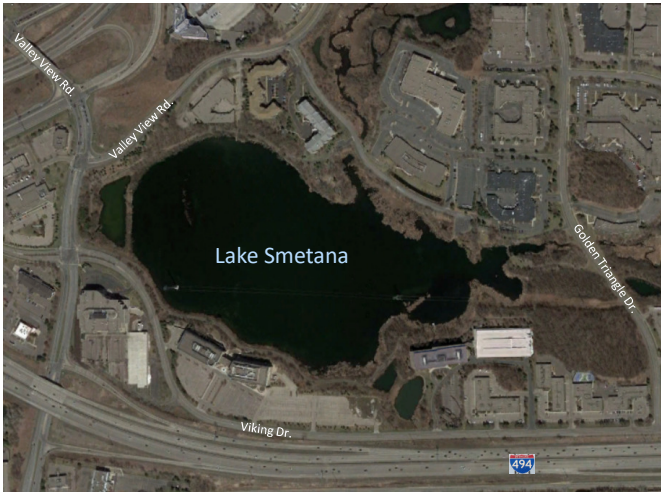
Lake Smetana

- Lake Surface = 56 acres
- Maximum Depth = 10 ft
- Mean Depth = 3.2 ft
- Public ramp access off Smetana Lane
- Lake Use:
 - Aesthetic viewing
 - Walking path
 - Fishing
 - Non-motorized boats
