Lake Cornelia and Lake Edina Water Quality Study

*Use Attainability Analyses for Lake Cornelia (updated from 2010)
and Lake Edina (first version)*

Prepared for
Nine Mile Creek Watershed District

July 2019

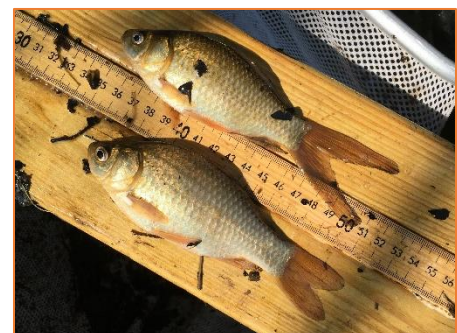
Figure 2 – Goldfish from Northwest Pond.

Non-native fish species captured during the electrofishing surveys included both goldfish (*Carassius auratus*) and common carp. Similar to common carp, goldfish swim along the bottom of lakes and rivers, uprooting vegetation, disturbing sediment and releasing nutrients that trigger excess algal growth. They feed broadly, eating algae, small invertebrates, plant material, and fish eggs. Within the Lake Cornelia system goldfish were found in large numbers (989 fish captured; Table 4). They were the most abundant fish species captured and have an established breeding population. Most of the goldfish captured were YOY or one year old, however, fully-grown fish up to 365 mm (14.4 in) were captured. For a maximum potential size reference, the world's longest goldfish measured 474

mm (18.7in; Guinness Book of World Records). The Northwest pond had the highest catch rate of goldfish at 468 fish/hour which may be the main source for Lake Cornelia (combined 400 fish/hour).

It is apparent that goldfish have established breeding populations in most waterbodies within the Lake Cornelia system. The highest concentration of goldfish did occur in the very shallow Northwest Pond. With the high numbers of goldfish in the system, along with their ability to survive in extremely low oxygen conditions, goldfish may be degrading water quality more than carp at this time. Winterkill frequency is most likely the main control of carp and goldfish populations in the Cornelia system.

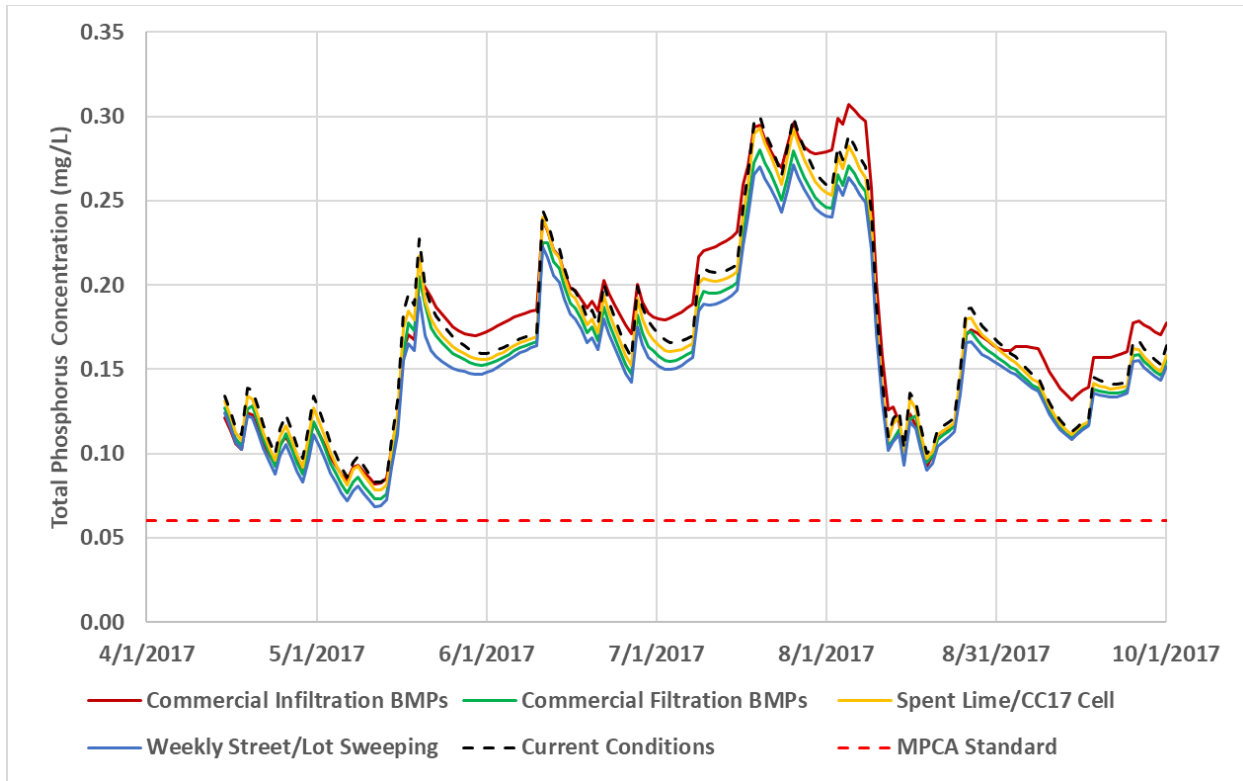
Figure D-3 In-lake phosphorus concentrations that resulted from external management efforts in North Cornelia in 2017

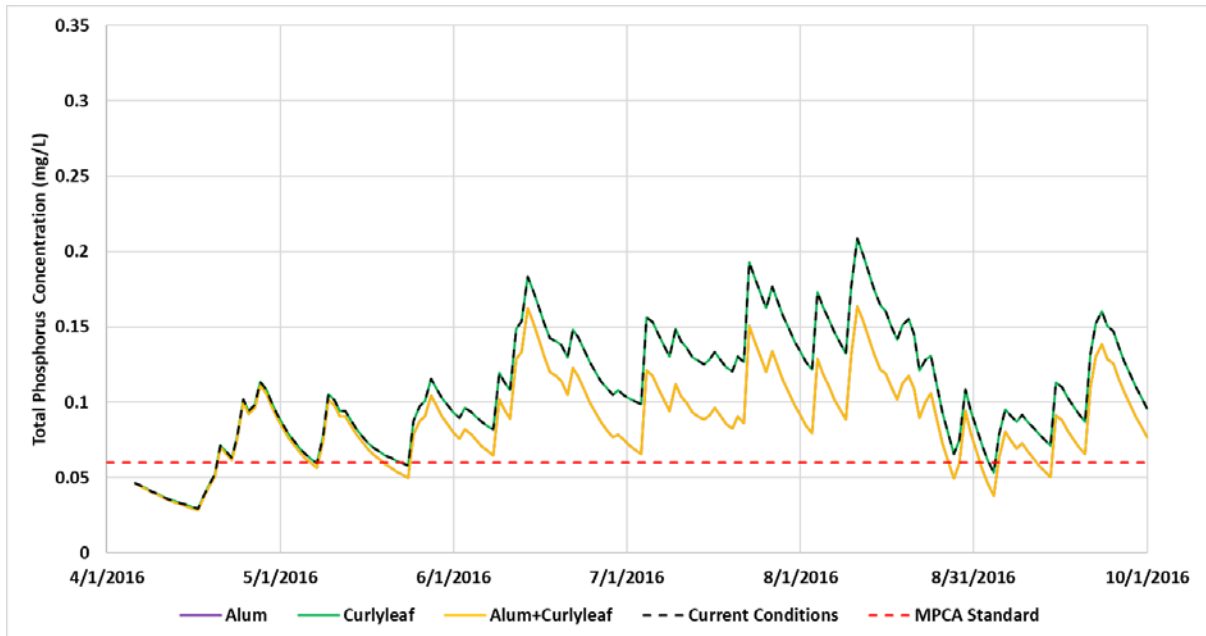
Figure E-2 In-Lake Phosphorus Concentration Changes that resulted from internal management efforts in North Cornelia in 2016

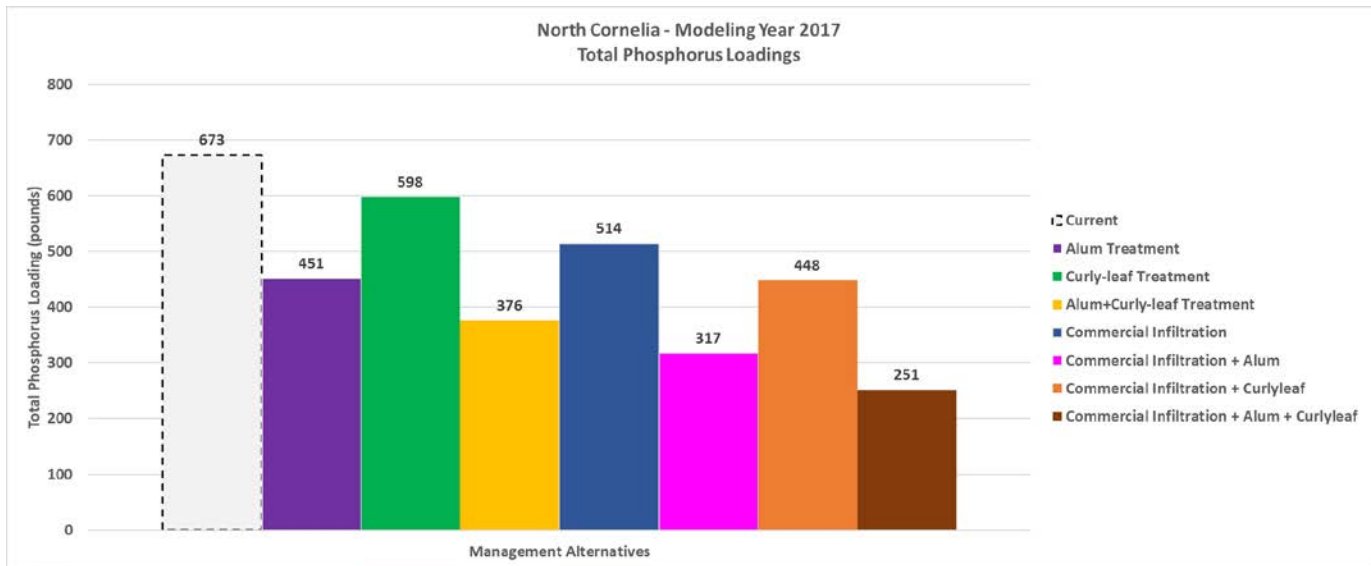
Figure G-3 Remaining Total Phosphorus Load to North Cornelia in 2017 with various combinations of internal and external commercial infiltration management

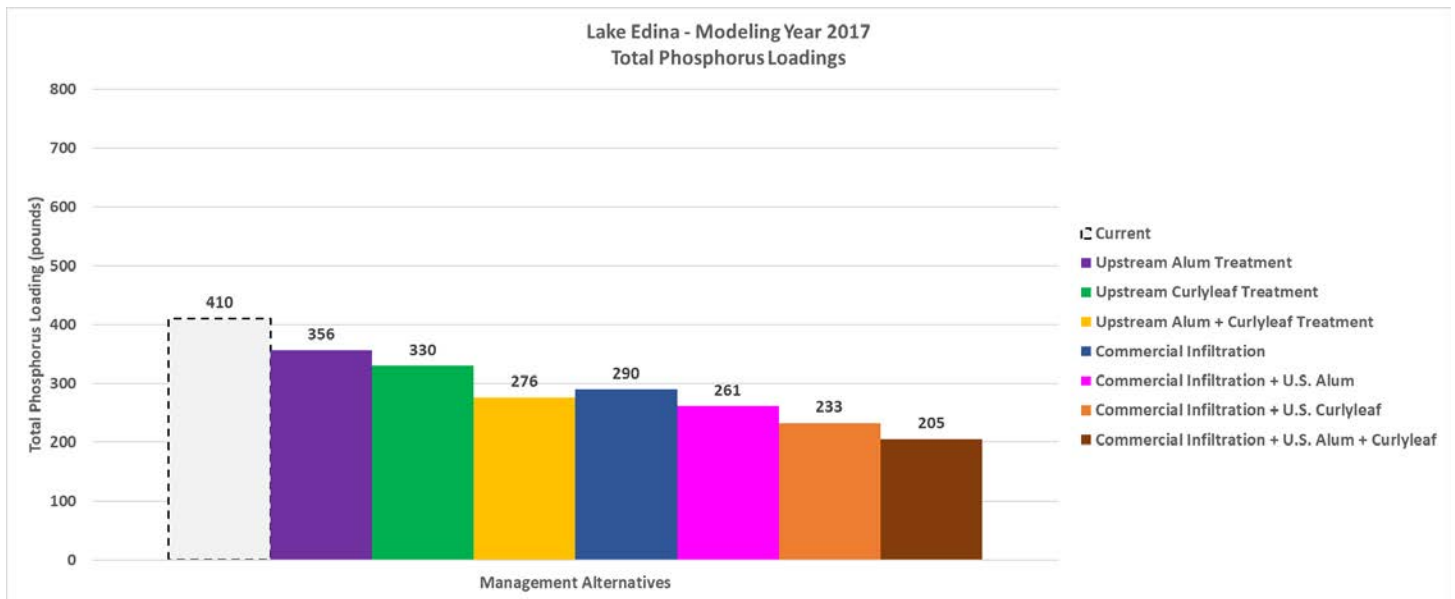
Figure G-9 Remaining Total Phosphorus Load to Lake Edina in 2017 with various combinations of internal and external commercial infiltration management

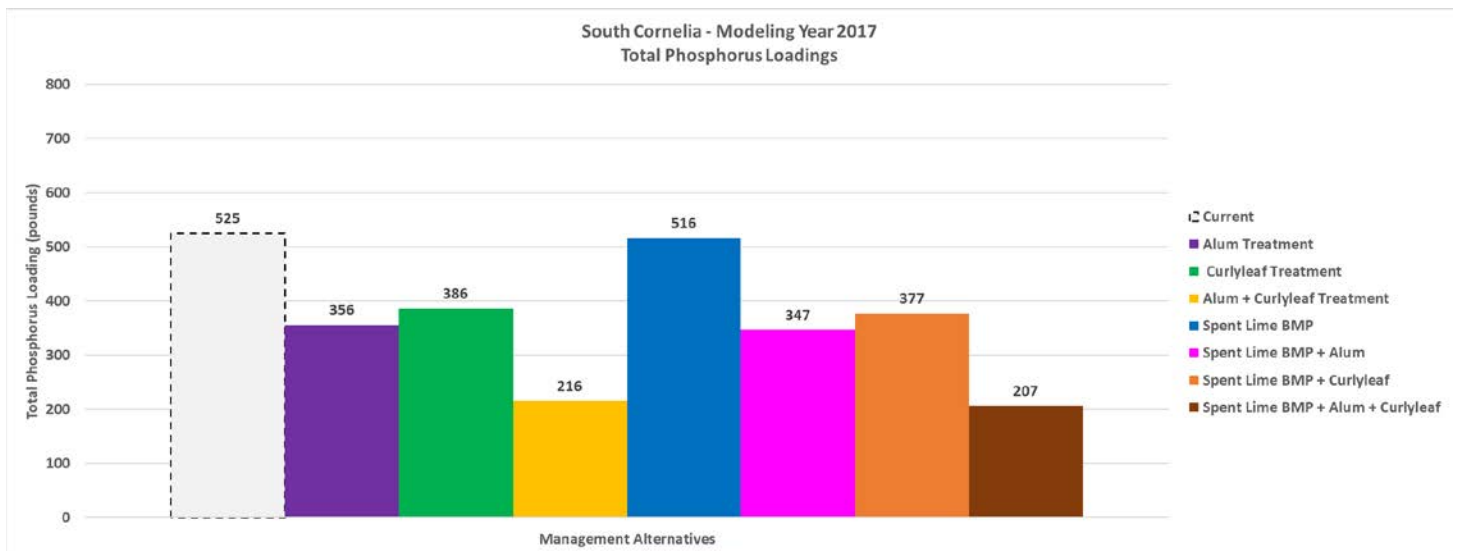
Figure G-15 Remaining Total Phosphorus Load to South Cornelia in 2017 with various combinations of internal and external spent lime/CC17 management

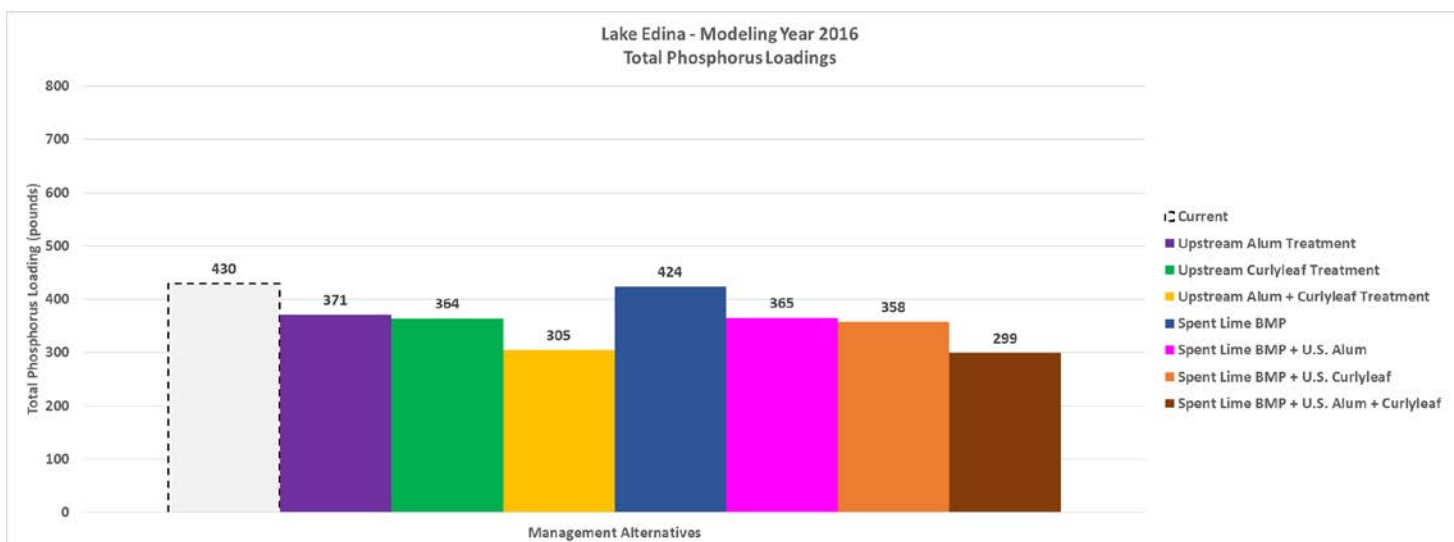
Figure G-17 Remaining Total Phosphorus Load to Lake Edina in 2016 with various combinations of internal and external spent lime/CC17 management
