# Figure 5-8. Project Synopsis: Minnetoga Lake Use Attainability Analysis

## Goals for Minnetoga Lake

### Nine Mile Creek Watershed District

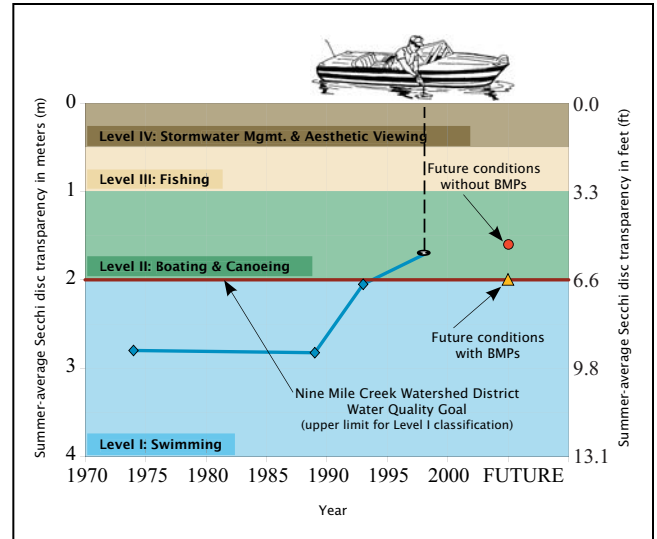
This graph illustrates Minnetoga Lake’s historic and predicted future summer-average water clarity (transparency). Transparency is measured as the depth at which a black-and-white patterned disc (a Secchi disc) disappears from view as it is lowered into the water.

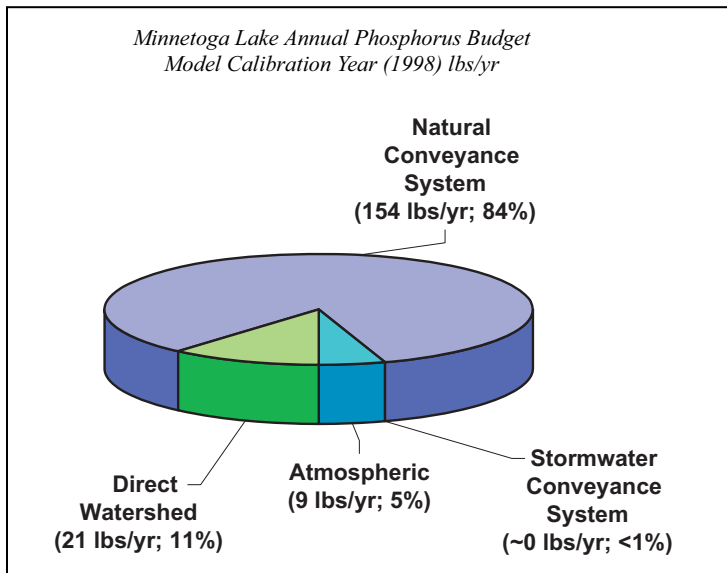
Minnetoga Lake’s natural conveyance system contributes roughly 84 percent of the lake’s annual phosphorus load.

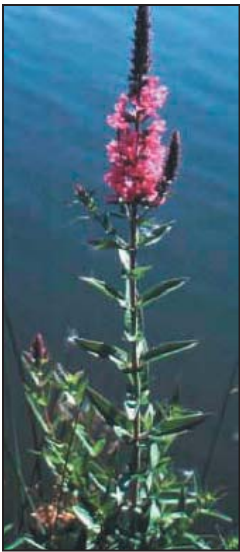
*Purple loosestrife is an exotic species that invades wetlands and lake shorelines. It out-competes native species and, if left unchecked, will eventually become the dominant plant wherever it appears.*

Problem: Exotic lake weed species (see left)

Cause: Purple loosestrife

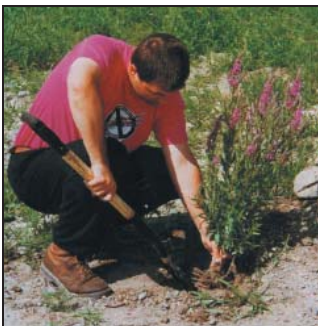
*Digging loosestrife by hand is another possible management method.*

- Aquatic plant management (see left)
