Mirror Lake Water Quality Improvement Project Feasibility Study

Prepared for
Nine Mile Creek Watershed District

Prepared by
Barr Engineering Co.

January 2025

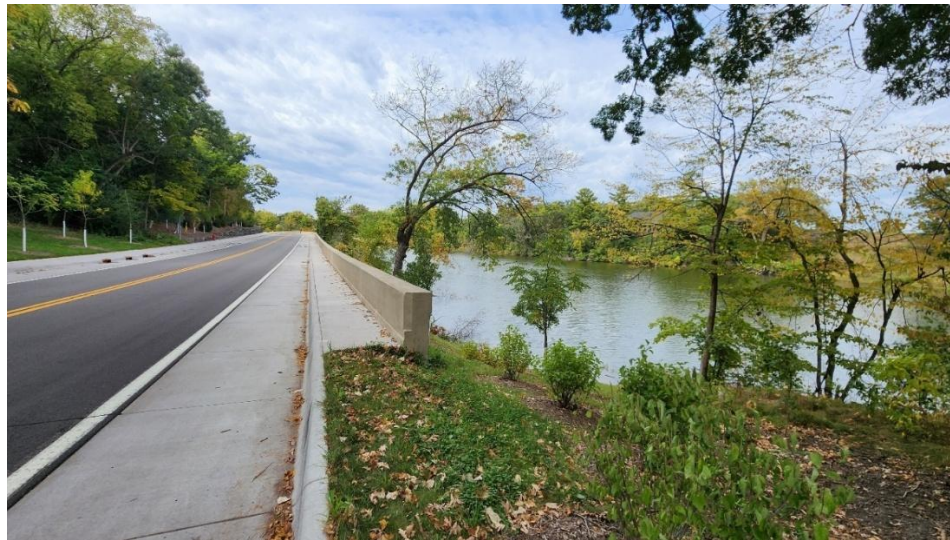
Figure 2-3 Possible chemical tank staging location off Blake Road.

- Coordination with the City of Edina will also be required since the storage tanks will extend slightly beyond the bike lane into the drive lane. A flagger would likely be required during the alum application to ensure vehicular and biker safety (either hired by the contractor or coordinated with the City of Edina).

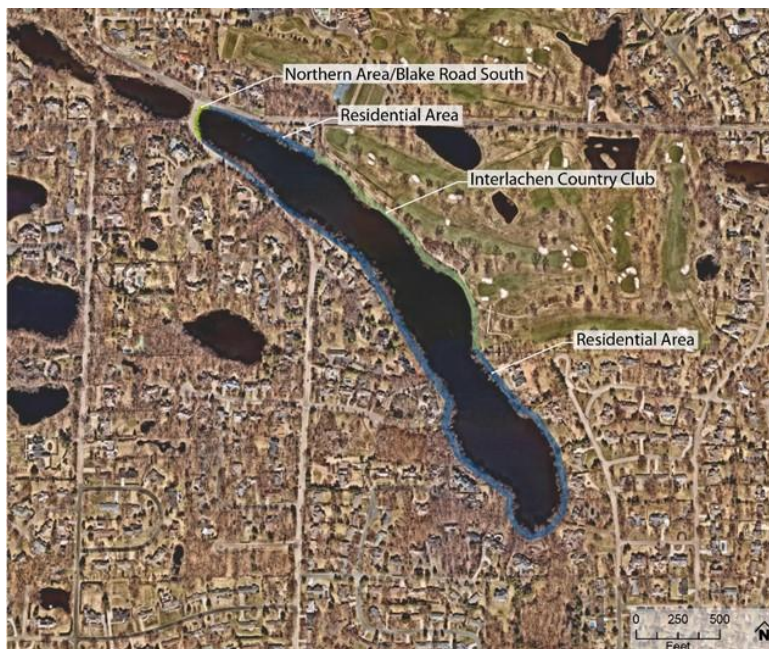
Figure 3-1 Mirror Lake shoreline observation areas

As a part of the *Mirror Lake Water Quality Study* (Barr Engineering, 2023), Barr completed a shoreline erosion and stability general assessment of Mirror Lake in April 2023. The shoreline areas assessed, as shown in Figure 3-1 were divided into three sections: Interlachen Country Club (ICC), the northern area by Blake Road South (city-owned parcels), and the residential areas. The water quality study identified high level shoreline erosion and stability concerns and outlined overarching management practices to improve shoreline stability. As part of this feasibility study, shoreline conditions were further evaluated, and potential stabilization practices were identified on a parcel-by-parcel basis. Conceptual designs for stabilization measures were developed to help the NMCWD and property owners understand the scope and costs of potential remedial measures to stabilize the shoreline and minimize future erosion. Public communication and outreach were also conducted as part of this study in conjunction with NMCWD staff to further assess feasibility of shoreline stabilization since incorporation of shoreline stability practices would require partnerships with private property owners.

The northern area by Blake Road South was under construction as part of a street reconstruction project during the water quality study in 2023, with restoration and erosion control efforts continuing by the city of Edina in 2024. Although not included in the scope of the feasibility study, NMCWD staff did reach out to the City of Edina during the feasibility study to better understand the construction timeline and restoration plans. Besides these communications, the northern area by Blake Road South did not undergo the same assessments as the other two shoreline areas. The subsections below summarize the feasibility tasks that were completed for the ICC parcel and residential parcels.

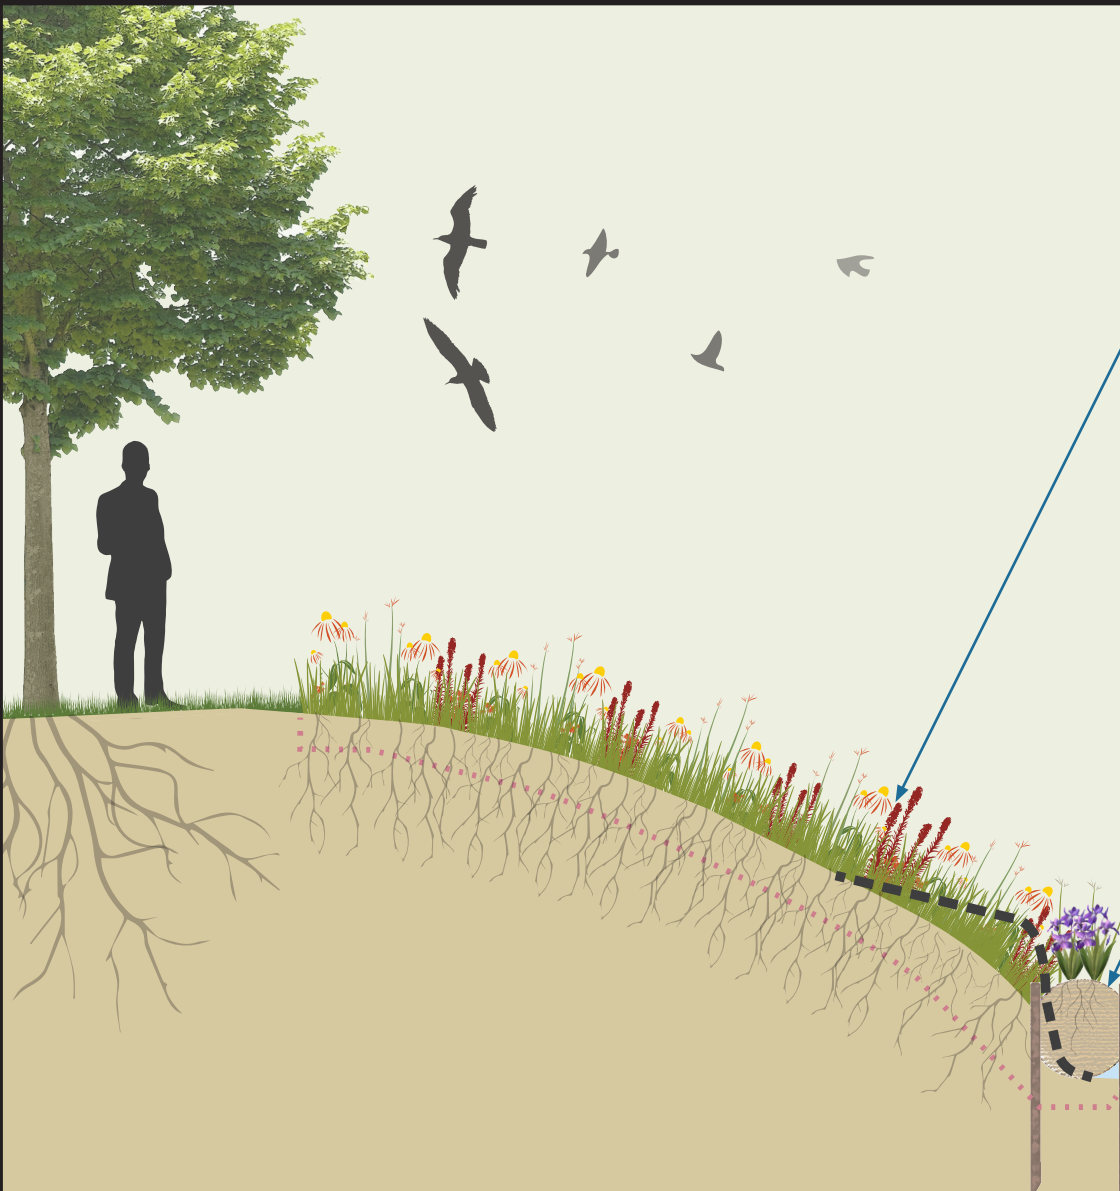
PLANT BUFFER

A plant buffer zone is an unmowed strip of native vegetation along the water's edge, typically 25-50 feet wide. Installing a buffer zone can restore many ecological functions critical to the health of the lake that may have been minimized previously by sod, hard structures, or mowing. Planting native grasses and flowering plants will diversify and enhance your shoreline and provide a seasonal show of color along with a deep root structure to stabilize the soil. Plant buffers can also help trap and absorb nutrients from runoff that may otherwise enter the lake.

SHORELINE STABILIZATION TECHNIQUES FOR MILD SLOPES

As part of the Mirror Lake shoreline stabilization project, several slope stabilization techniques were evaluated to address erosion and promote long-term shoreline stability and improved habitat. Using a desktop analysis of erosion intensity potential along with onsite observations, site-specific recommendations were developed based on the existing severity of erosion and the potential for continued degradation. The residential shoreline stabilization techniques include coir logs, vegetated reinforced soil slopes (VRSS) with riprap toe protection, and native plant buffers. The erosion intensity suitability, advantages, disadvantages, and relative costs of each stabilization technique are presented in Table 3-1. Detailed descriptions of the techniques, example applications, and example photos are also provided in the graphical representations shown in Figure 3-3 and Figure 3-4.

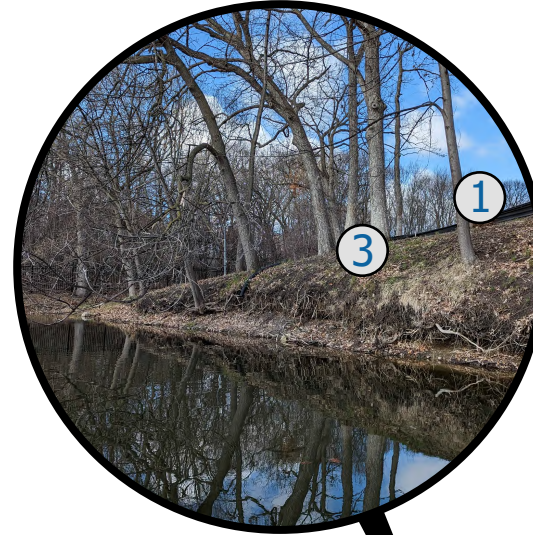
- ① Lack of vegetated buffer and
- ② bare soils throughout the shoreline can lead to high runoff velocities and increased soil erosion.
- ③ Turf extended to the lake water's edge throughout the shoreline can lead to increased erosion due to minimal protection against waves, ice, and weather.
- ④ Vertical, exposed banks throughout portions of the shoreline indicate unstable shoreline conditions, which can lead to increased erosion or bank failure over time.

Examples of the erosion concerns are shown below with the corresponding erosion concern numbers.

This figure shows concept level stabilization recommendations. A final design may be modified based on additional analysis and/or owner preferences.

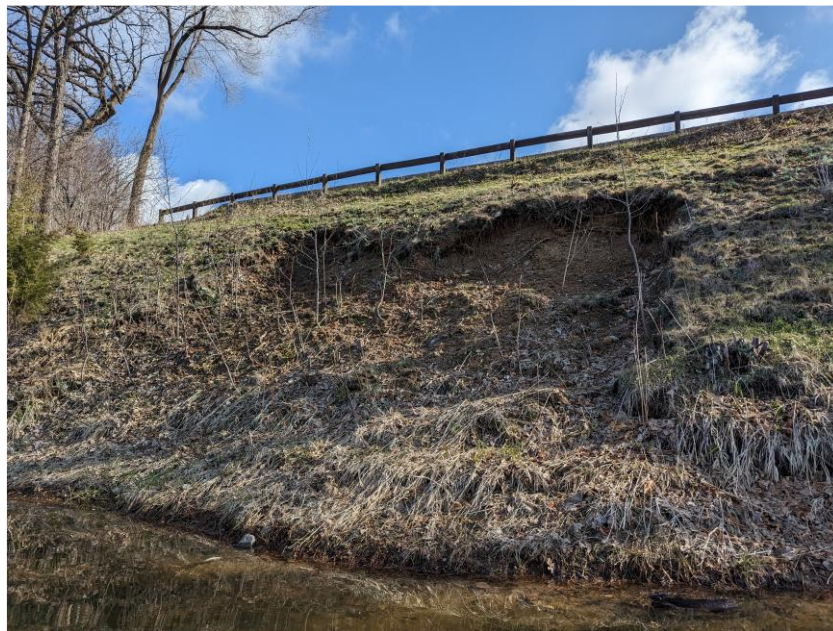
Shoreline stability and erosion concerns were identified along the ICC shoreline during field observations in spring 2023. Barr staff observed turf extending to the lake water edge over approximately 400 feet of the southern section of the ICC shoreline. In this area, near vertical banks were observed, which likely occurred due to wave action, ice movement, and lake level bounce acting on unstable banks comprised of turf grass with shallow roots. Stormwater runoff from hard surfaces such as golf cart trails and the service road may also contribute to shoreline and bank erosion. Additionally, there is an area of notable erosion and slope failure (approximately 30-foot x 40-foot) in the northernmost portion of the ICC shoreline as shown in Figure 3-7.

Figure 3-7 Area of notable erosion and slope failure along the Interlachen Country Club shoreline

As noted above, an important consideration during final design will be to determine the root cause and type of slope failure that has occurred along the northern portion of ICC's shoreline through completion of a geotechnical investigation. Designing appropriate repairs to the slope will require defining if the slope is susceptible to deeper rotational failure as well as surficial slope failure. A surficial failure occurs when a layer of soil or rock slides down a slope, relatively parallel to the existing surface. This failure mode typically involves a relatively shallow layer of soil that is often caused by erosion, rainfall and surface drainage or activities that disturb the surface layer. A rotational failure occurs when a mass of soil or rock moves downward and outward along a curved, concave-upward failure surface. This failure mode typically involves a deeper circular shaped failure surface that may be caused by factors like the weight of the slope material, water pressure, seeps, and varying weak underlying soil layers.

A geotechnical investigation is a crucial step to understanding the subsurface conditions prior to finalizing design of a selected repair alternative. The tasks listed below are recommended as part of a geotechnical investigation for this site. A budgeting cost for the geotechnical investigation is \$30,000-\$40,000.

- Site reconnaissance by a geotechnical engineer to observe site conditions
- Subsurface investigation including up to 4 soil borings by a drilling contractor, followed by laboratory testing.
- Geotechnical analysis including slope stability modeling
- Reporting, including drilling summary and recommendations

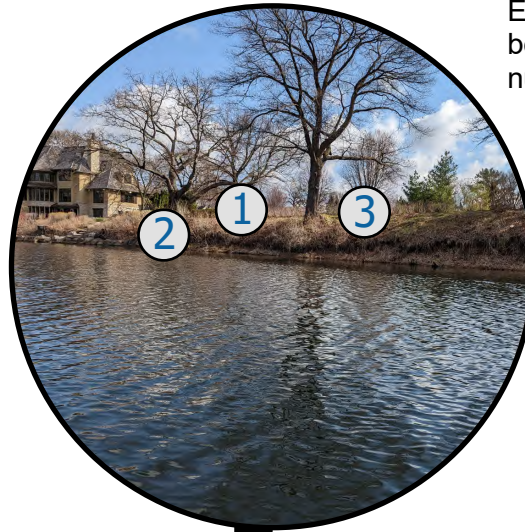
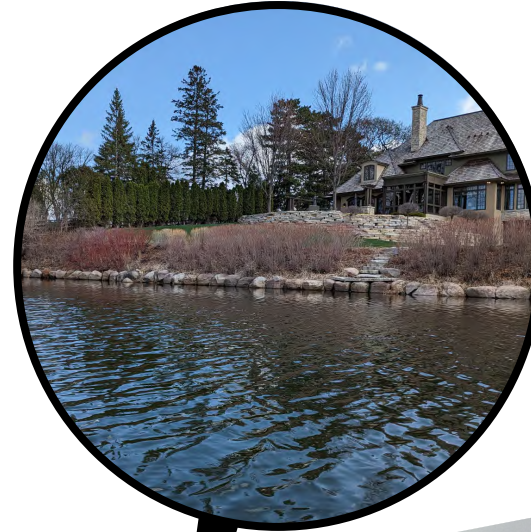
- 1 Lack of a dense native perennial cover on slopes located within the typical shoreline buffer area.
- 2 Vertical, exposed banks throughout portions of the shoreline indicate unstable shoreline conditions, which can lead to increased erosion or bank failure over time.
- 3 Turf extended to the lake water's edge throughout the shoreline can lead to increased erosion due to minimal protection against waves, ice, and weather.

Examples of the erosion concerns are shown below with the corresponding erosion concerns numbers.
