REPORT SUMMARY

Mirror Lake Water Quality Study

Prepared for
Nine Mile Creek
Watershed District

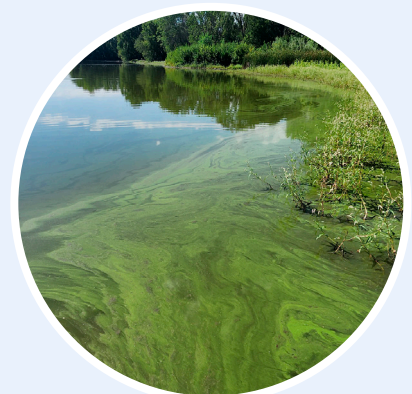
Example blue-green algae bloom

Blue-green algae, or cyanobacteria, have historically been found in Mirror Lake since monitoring began, with a notable increase in abundance in 2021. Blue-green algae are associated with water quality problems and can be a source of health concerns not only for humans who use the lake, but for wildlife.

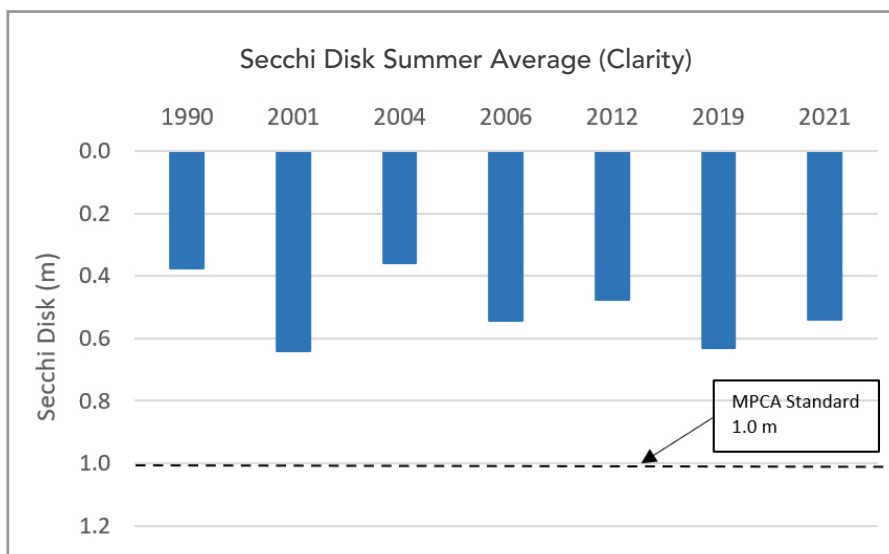
Figure 4
Summer average Secchi Disk transparency depths (clarity) measured in Mirror Lake between 1990 and 2021

- 1) Total Phosphorus, which is a nutrient that can fuel algae and plant growth (Figure 2)
- 2) Chlorophyll-a, which is a measurement of algae growth (Figure 3)
- 3) Secchi disk transparency depth, which is a measurement of lake clarity. (Figure 4)

Monitoring data indicates that Mirror Lake is not meeting Minnesota's water quality standards for shallow lakes in the Twin Cities. The observed summer average (June 1–Sept 30) total phosphorus and chlorophyll-a concentrations have exceeded Minnesota's shallow lake water quality standards (60 ug/L total phosphorus and 20 ug/L chlorophyll-a) for all monitored years since 1990. The clarity of Mirror Lake has also failed to meet the shallow lake water quality standard of greater than one meter for all monitored years since 1990. The poorer water quality is primarily due to excess nutrients, which fuels algal growth and decreases clarity.

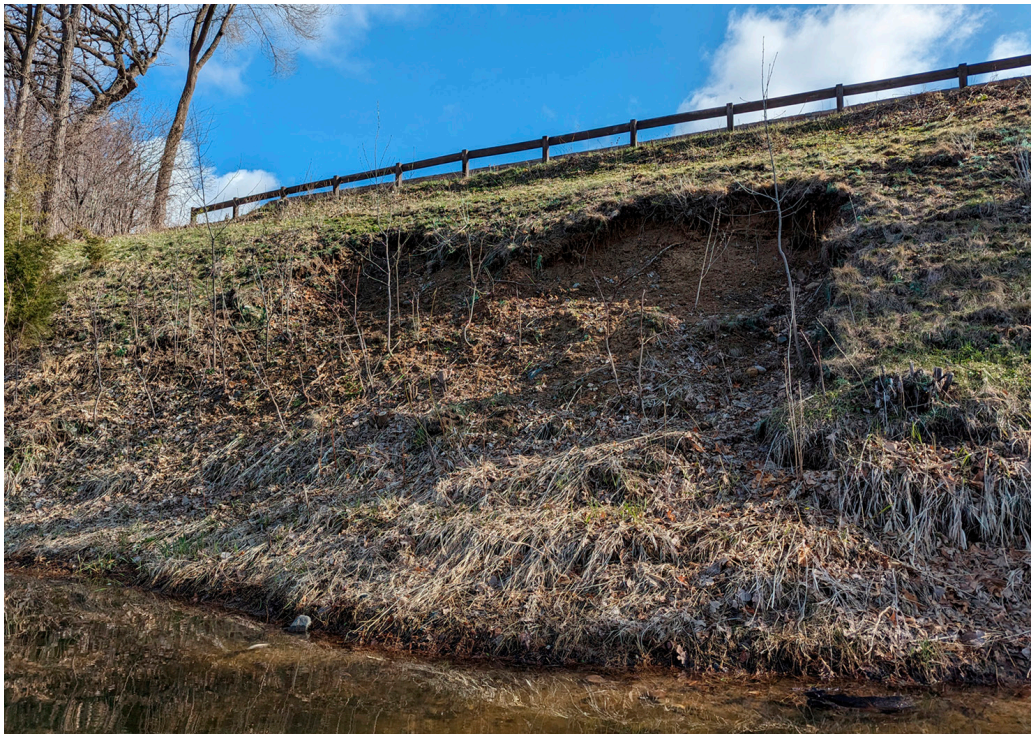
(Above and left)
Mirror Lake shoreline
erosion examples,
April 2023
