Figure 5-12. Project Synopsis: Shady Oak Lake Use Attainability Analysis

Nine Mile Creek Watershed District

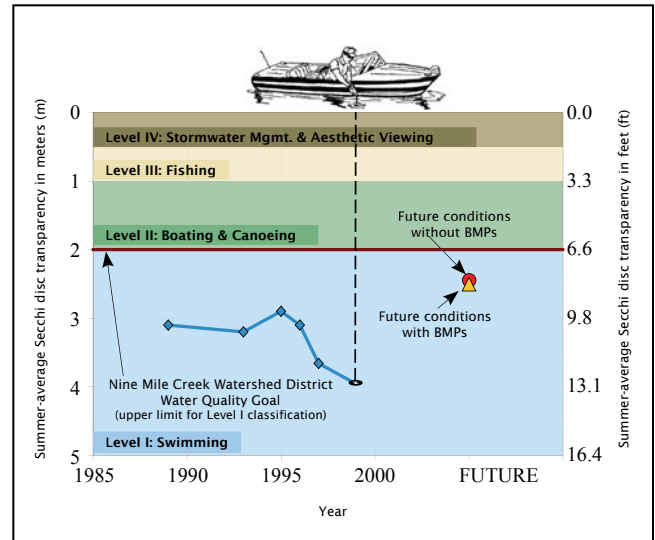
This graph illustrates Shady Oak Lake’s historic and predicted future summer-average water clarity (transparency). Transparency is measured as the depth at which a black-and-white patterned disc (a Secchi disc) disappears from view as it is lowered into the water.

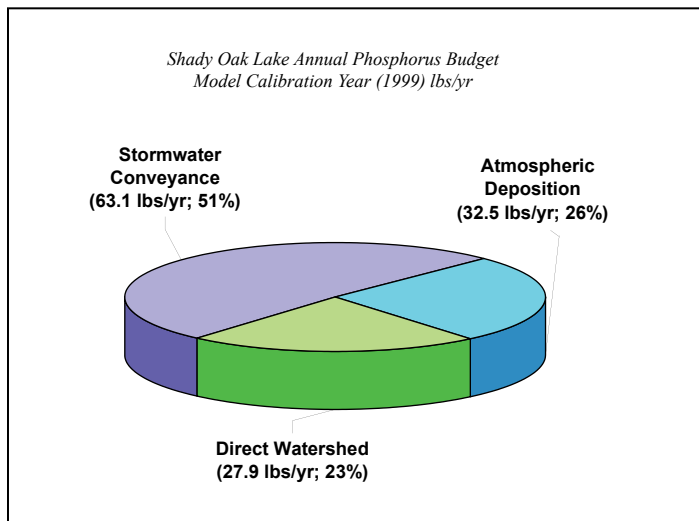
Stormwater conveyance accounts for more than 50 percent of Shady Oak Lake’s annual phosphorus load.

Cause: Urban stormwater runoff conveying large amounts of phosphorus to the lake

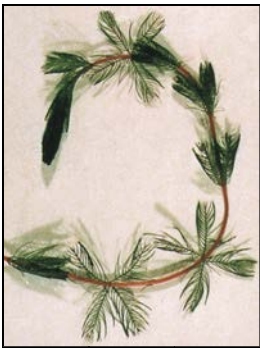
An invasive aquatic plant, Eurasian watermilfoil adversely impacts aquatic ecosystems by forming dense canopies that often shade out native vegetation. It can “travel” from lake to lake via boat trailers.

Cause: Eurasian watermilfoil and purple loosestrife

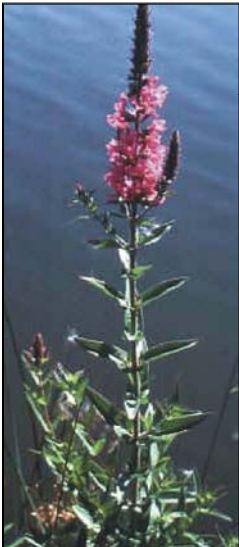
Purple loosestrife is an exotic species that invades wetlands and lake shorelines. It out-competes native species and, if left unchecked, will eventually become the dominant plant wherever it appears.

Purple loosestrife can be managed by releasing root-boring weevils onto the plants.
