**Project Name** | South Fork Nine Mile Creek Bank Stabilization

**Date** | 11/19/2021

**Regarding** | Baseline Stream Assessment

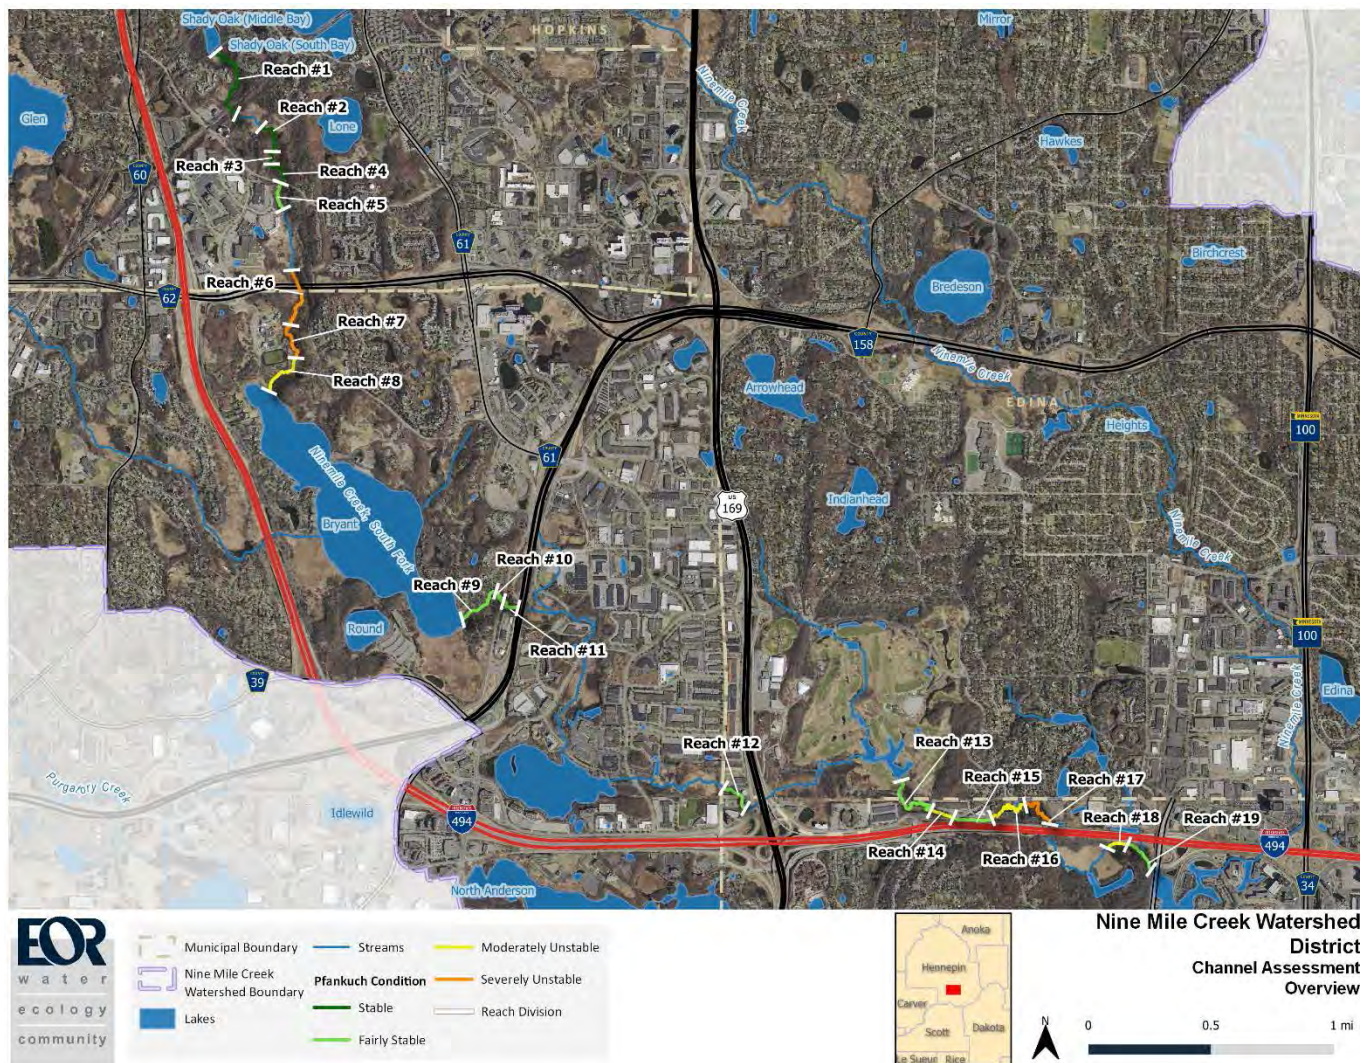
Figure 3. Stream Reaches Assessed along South Fork Nine Mile Creek

The following is a summary of data collection and analyses completed for the project. Nineteen individual stream reaches were assessed from Minnetoga Lake/Jorissen Road to East Bush Lake Road (Figure 3). Stream reaches varied from stable "E" channels in the headwaters area upstream of Rowland Road to severely degraded "F" channels such as the reach between Creekridge Circle and I-494. Major stream issues identified in the degraded reaches included accelerated lateral bank migration, channel incision, floodplain abandonment, and poor riparian vegetation. Individual reach site descriptions can be found in Appendix A and reach photographs can be found in Appendix C.

were Severely Unstable, and 0 reaches were Extremely Unstable (Table 2, Table 3, Appendix D). Reach maps displaying the start and end points of each reach assessed and associated Pfankuch channel conditions are provided in Appendix B. In general, Stable reaches occurred in the headwaters area upstream of Rowland Road where stream gradient is low, riparian vegetation is dense, and limited stormwater inputs occur. As stream gradient and surface runoff increase in the system, the stream channel begins to degrade as reflected in the reaches downstream of Highway 62 and 78<sup>th</sup> Street. Stream channel degradation in these reaches is further exacerbated by poor soils composition (high sand content and/or stratified layers), poor streambank vegetation and surface protection, and high numbers of in-channel obstructions including down trees, log jams, and mid-channel bars that cause high sheer stress along the banks. Stormwater flow rates and sediment loading are attenuated in the larger lake and wetland systems along the creek corridor as reflected in the reaches that scored Fairly Stable downstream of Bryant Lake and the Braemar Golf Course ponds (Figure 3).
