# Lake Cornelia and Lake Edina Water Quality Study

*Use Attainability Analyses for Lake Cornelia (updated from 2010)  
and Lake Edina (first version)*

Prepared for  
Nine Mile Creek Watershed District

July 2019

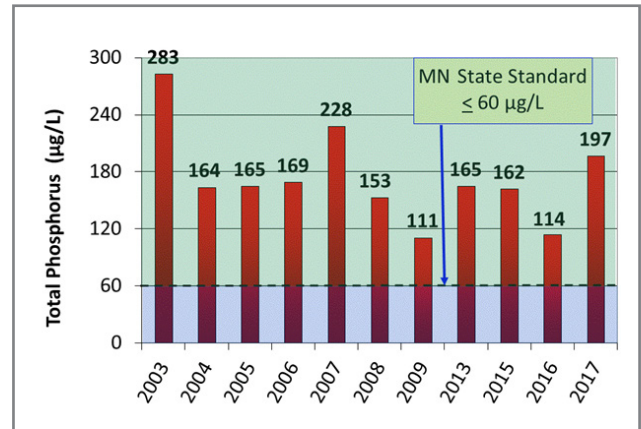
Summer average phosphorus concentrations in Lake Cornelia (North Basin) have historically been well above the state standard for shallow lakes.

Water quality in Lake Cornelia is poor, with summer-average total phosphorus and chlorophyll a concentrations well above the state standard for shallow lakes. The poor water quality is primarily due to excess phosphorus in the lake, which fuels algal growth and decreases water clarity. The phosphorus in Lake Cornelia comes from several sources, including stormwater runoff from the watershed (external source) and internal sources such as nutrient-rich sediments and decomposition of curly-leaf pondweed. Fish activity, specifically the disruption caused by bottom-feeding species such as bullhead and goldfish, may also be decreasing water clarity. The primary sources of phosphorus to Lake Cornelia are described further below.

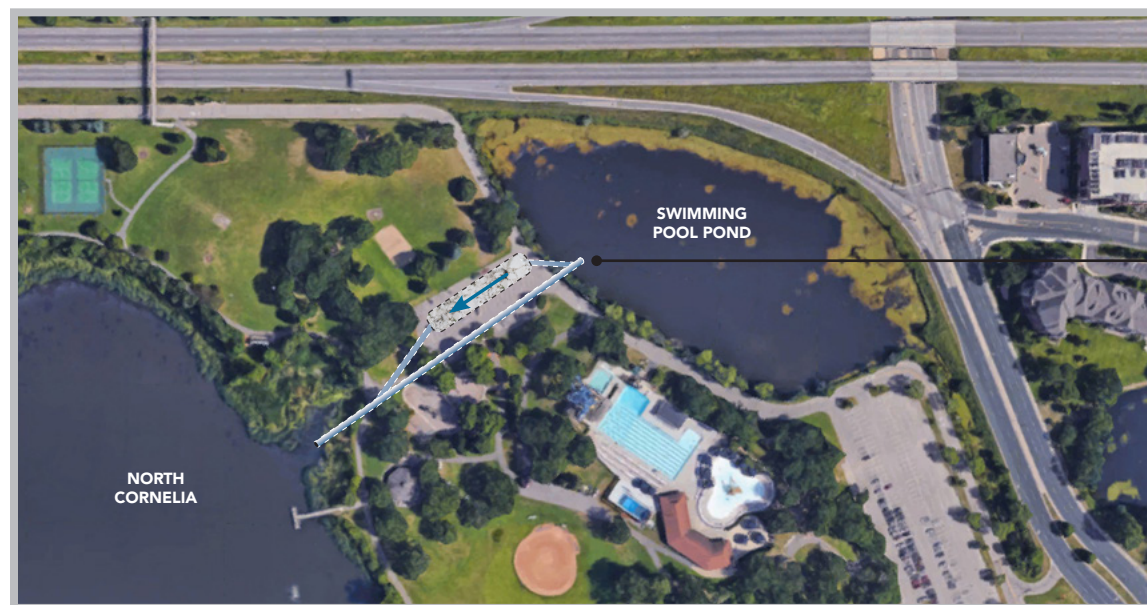
Water moves through the spent lime filtration chamber to remove phosphorus before discharge to Lake Cornelia.

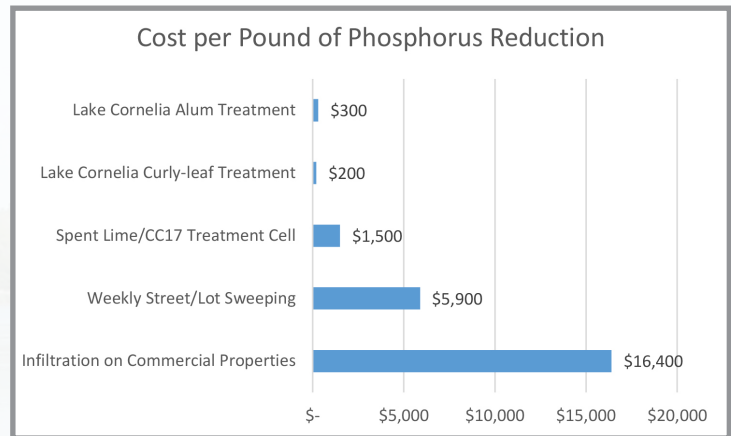
*Cost comparison of various management practices in terms of dollars per pound of phosphorus reduction achieved to North Lake Cornelia during the time period of April through September.*

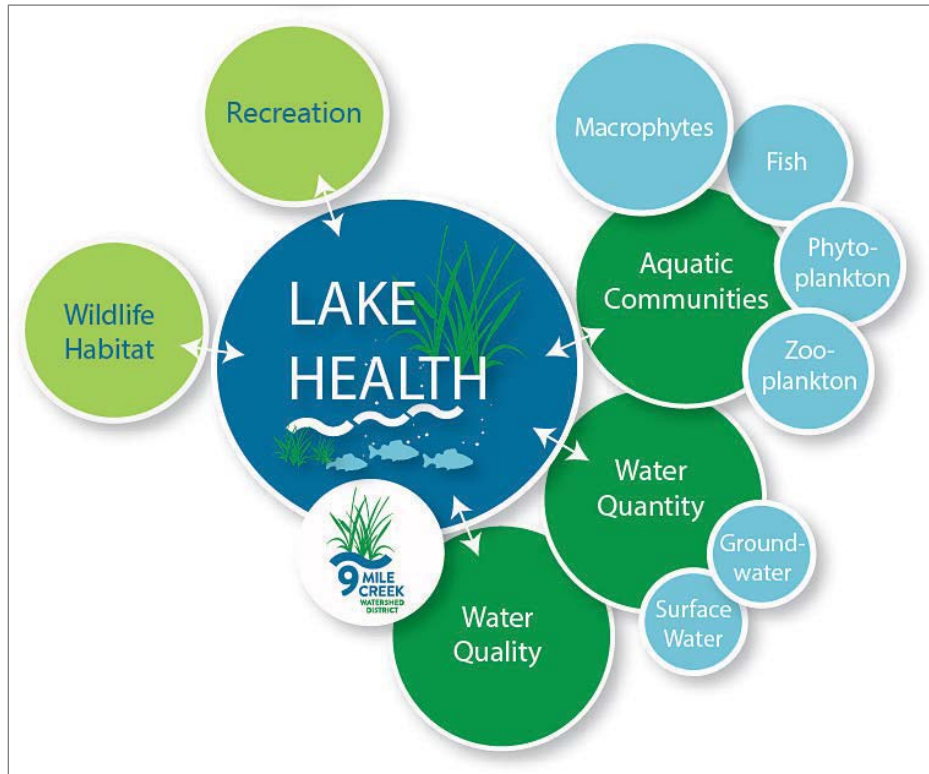
Figure 3-1 NMCWD Holistic Lake Health Assessment Factors (NMCWD, 2017, amended 2019)

The NMCWD's approach to assessing and improving lake health is illustrated in Figure 3-1. The primary factors identified as affecting lake ecological health include chemical water quality (e.g., nutrient concentrations), aquatic communities, and water quantity (groundwater and surface water). The effects of recreation and wildlife habitat on overall lake health are also considered.

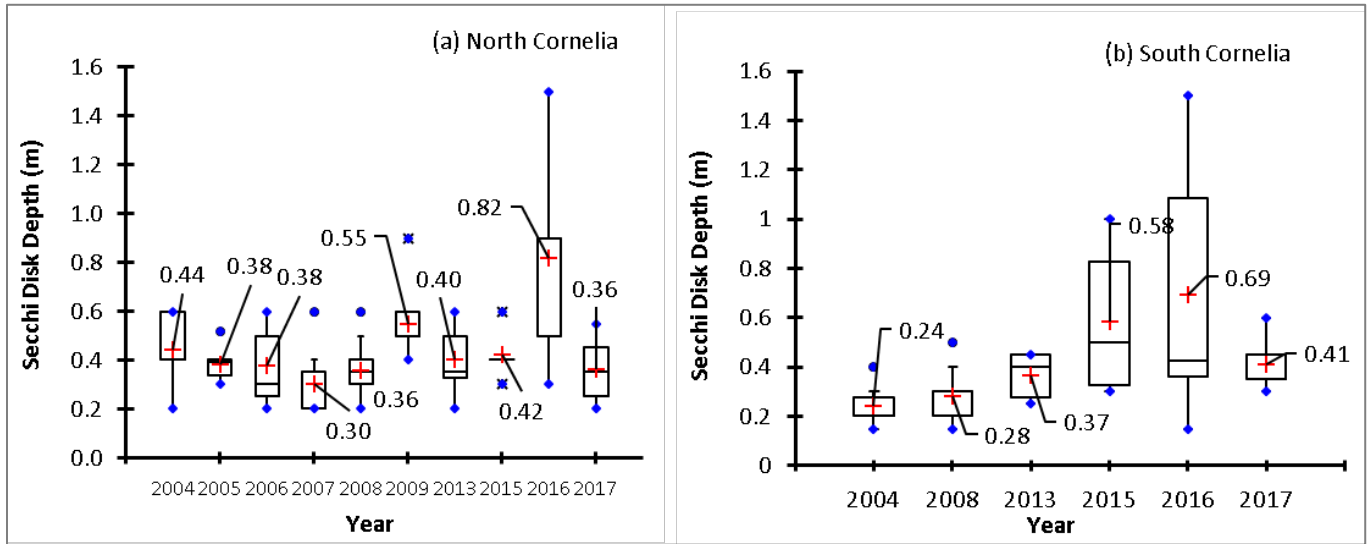
Figure 5-3 Summer Secchi disc depth readings in (a) North and (b) South Cornelia from 2004 through 2017. The red crosses indicate the average of summer (June through September) readings.

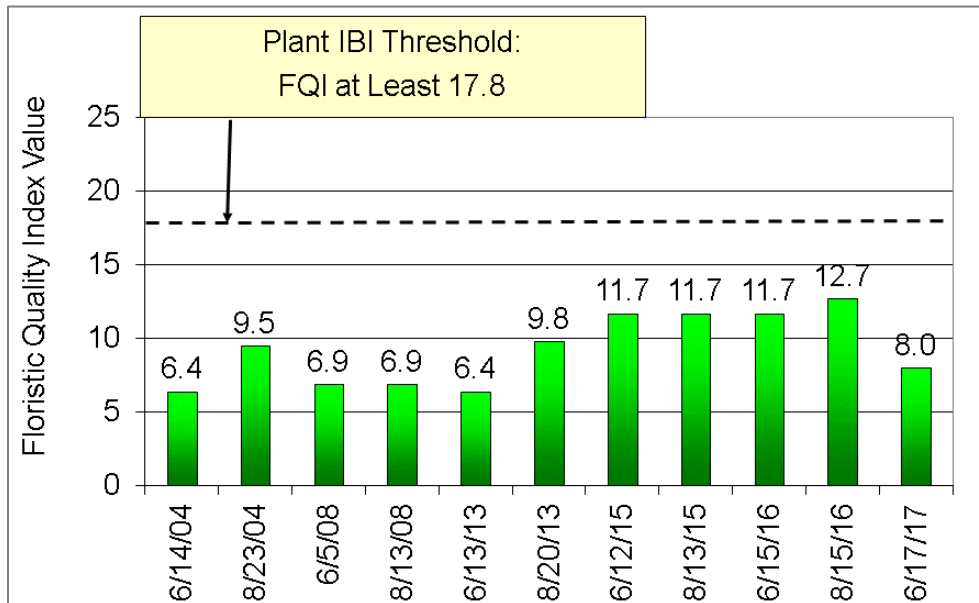
Figure 5-7 North Cornelia Floristic Quality Index (FQI) Compared with Plant IBI Threshold for FQI

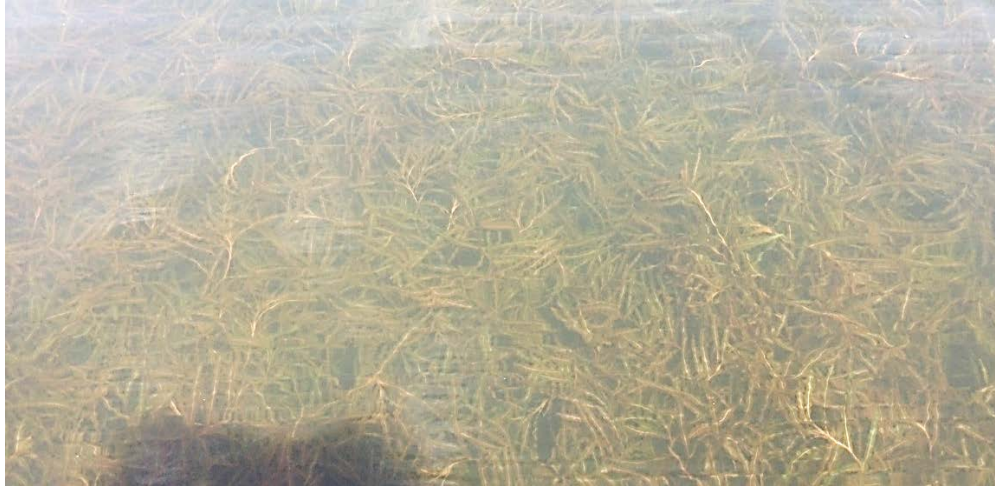
**Figure 5-10** Curly-leaf pondweed growth observed in Lake Cornelia in 2017.

On April 23, 2017, a point-intercept plant survey was completed by the City of Edina. The survey found curly-leaf pondweed forming a solid mat over the entire lake with the exception of a few meters (about 6 feet) buffer near the immediate shoreline (Figure 5-10). The City completed an herbicide (endothall) treatment in May 2017 to manage the curly-leaf pondweed. A post-treatment survey was completed in early-June 2017 and curly-leaf pondweed was not observed in North Cornelia and was only observed at one location in South Cornelia. Thus, the herbicide treatment effectively managed the lake's curly-leaf pondweed infestation.

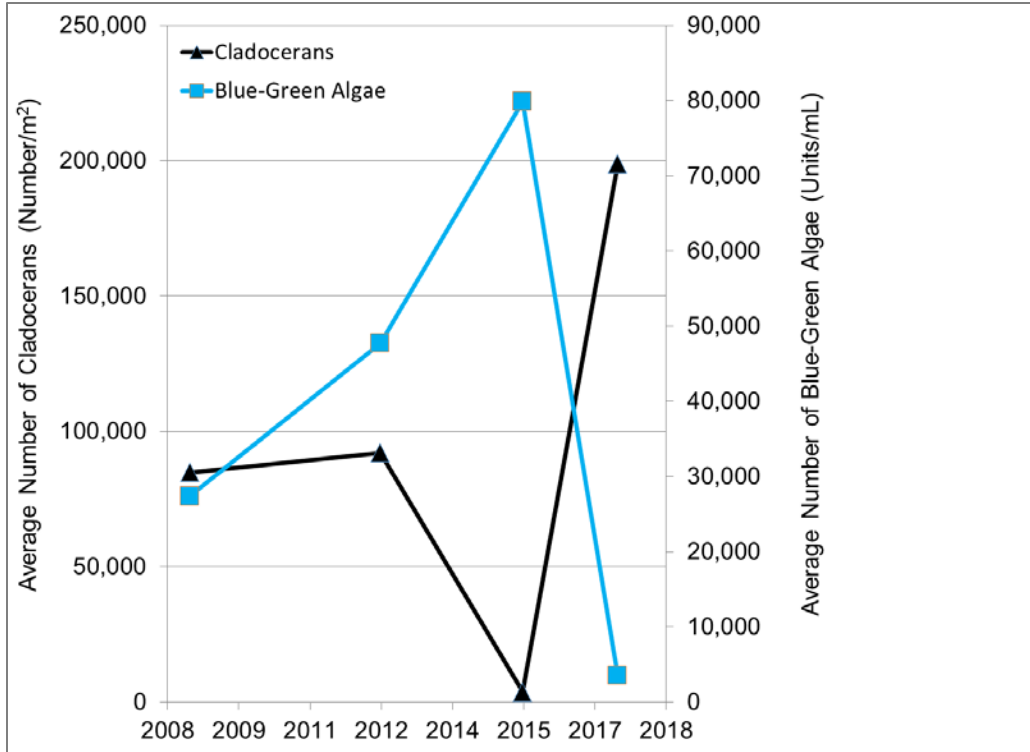
Figure 5-22 Lake Edina average annual cladoceran and blue-green algae numbers comparison

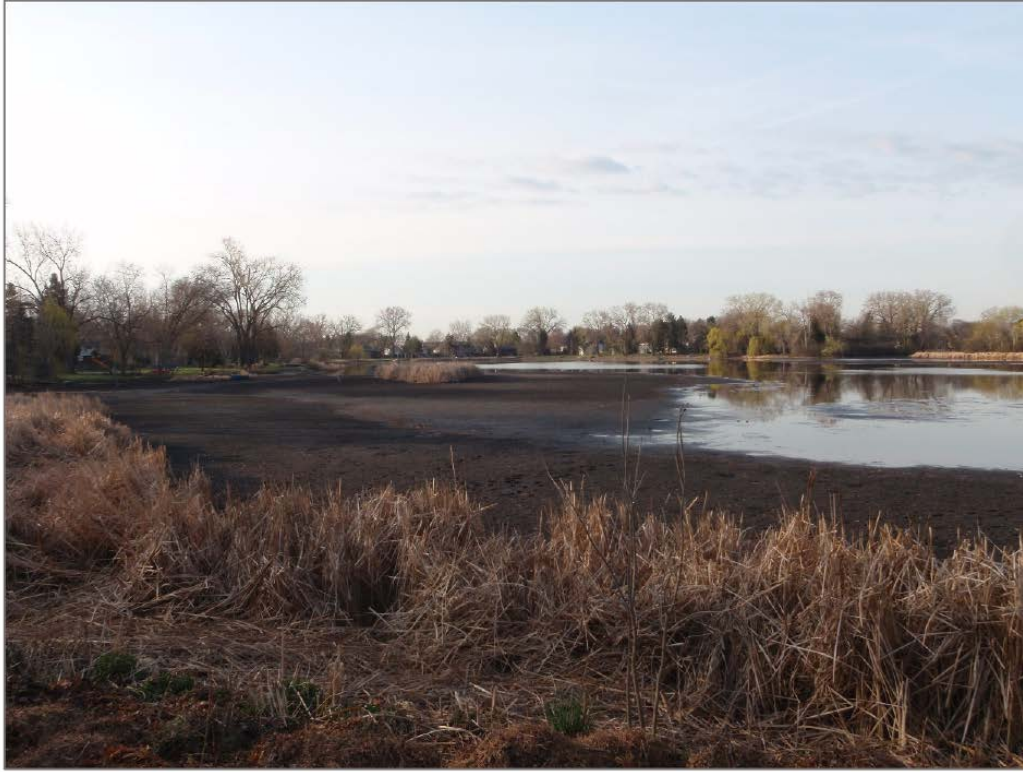
Figure 6-1 Photo taken of Lake Edina low water levels in April 2015

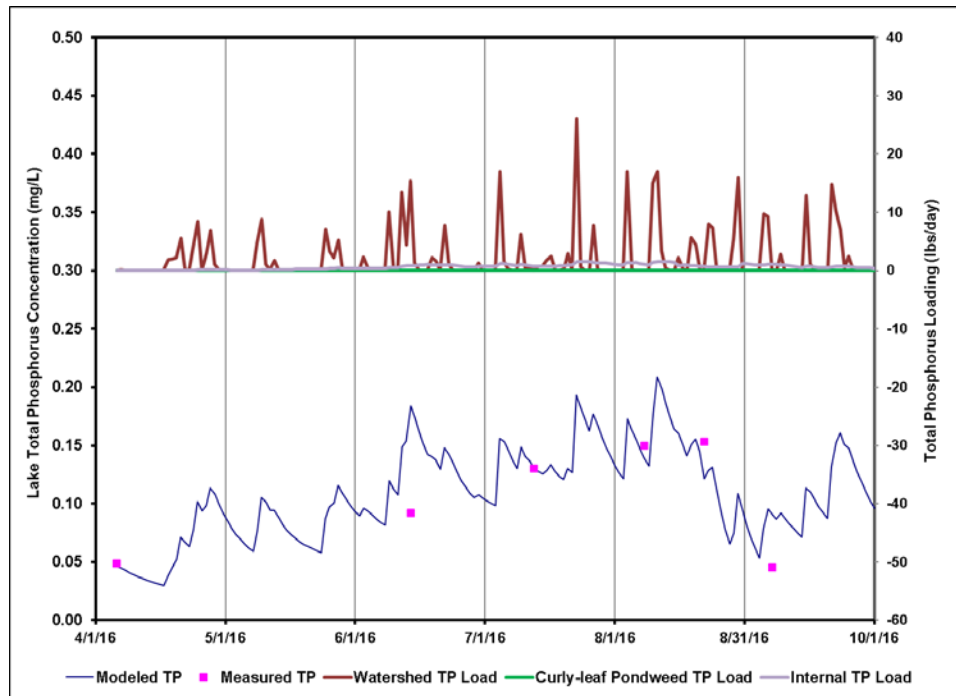
Figure 6-4 North Cornelia In-Lake Calibration Model for 2016

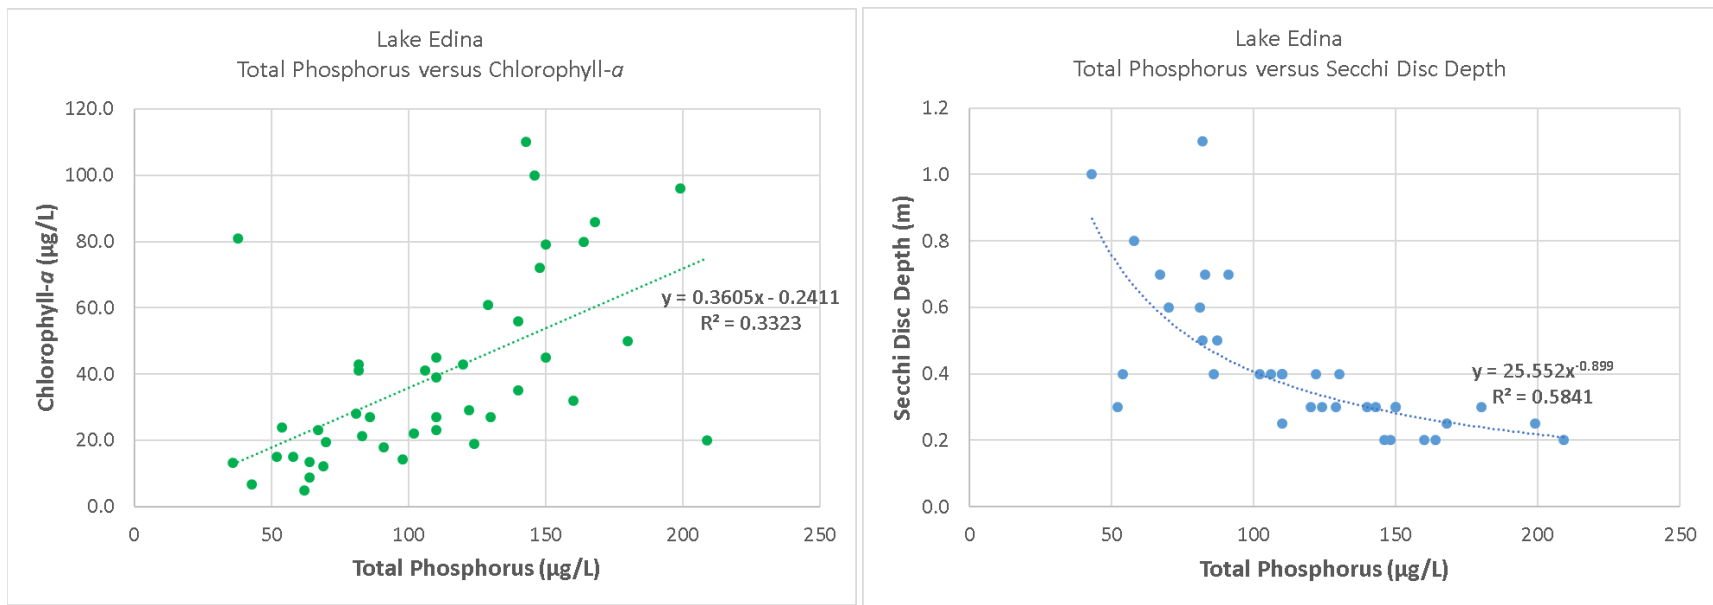
Figure 6-17 Lake Edina relationships between total phosphorus, chlorophyll a, and Secchi Disc Transparency

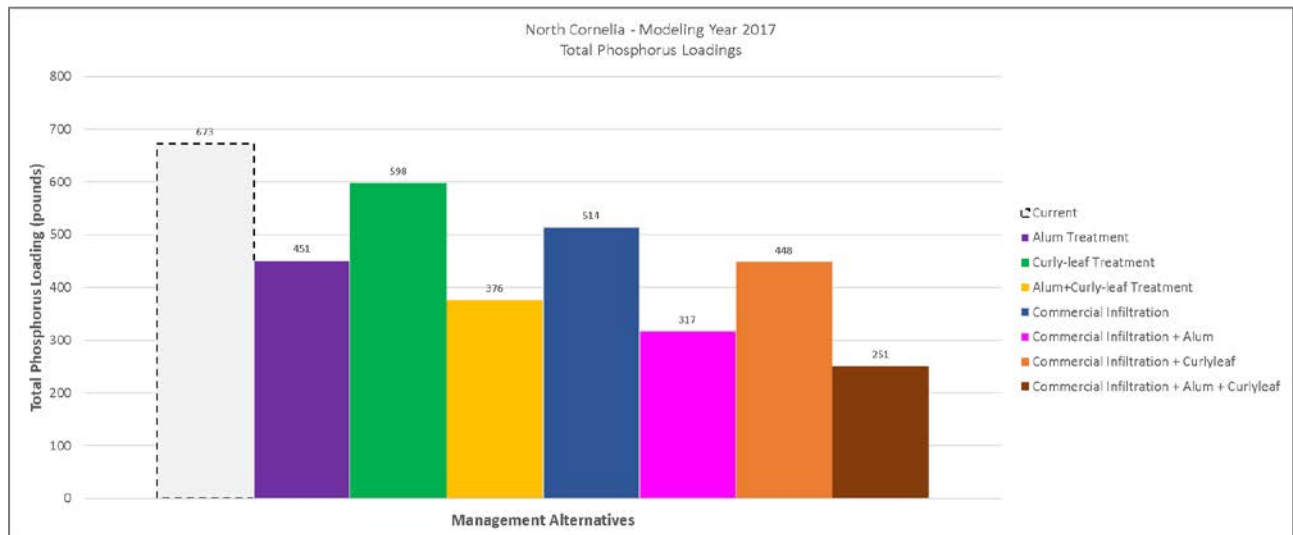
**Figure 8-9** Remaining Total Phosphorus Load to North Cornelia in 2017 with various combinations of internal and external commercial infiltration management

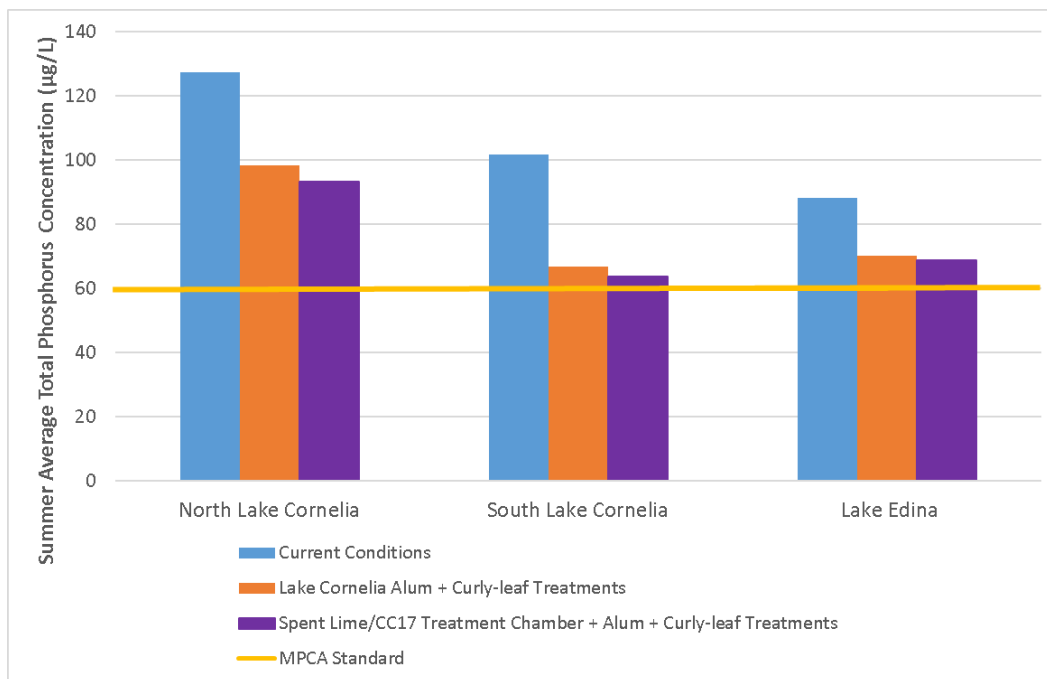
**Figure 10-1 Comparison of summer average total phosphorus concentrations (µg/L) for recommended management alternatives**

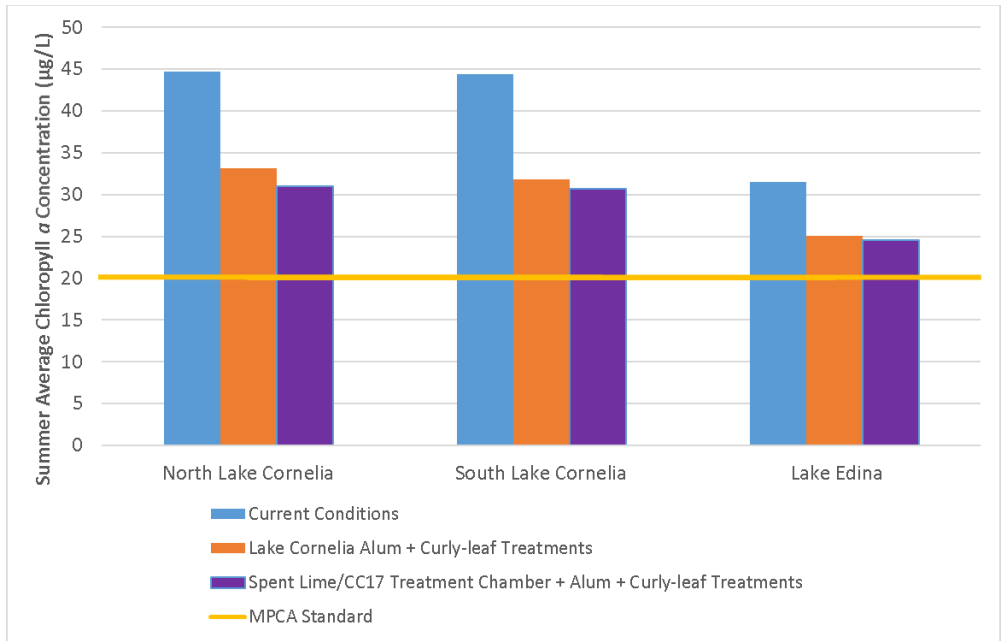
Figure 10-2 Summer average chlorophyll a concentrations (µg/L) for recommended management alternatives
