Overall Health of Birch Island Lake

Birch Island Lake Watershed

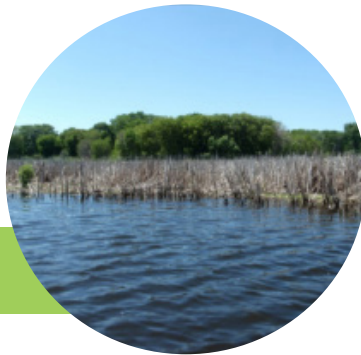
2014 Cattail die off from rapid rise in water levels

Water quality of Birch Island Lake is poor, with average nutrient levels higher than state standards for shallow lakes. Birch Island Lake does have a diverse range of aquatic plants present in the lake. There are a total of 12 different plant species. Typically the plant community in the western two thirds of the lake is primarily comprised of cattails and other wetland vegetation. However, heavy rainfall during June of 2014 raised the water level in the lake by 6 feet, causing cattails to die off. In 2015 the invasive species purple loosestrife was recorded in aquatic plant cataloging.

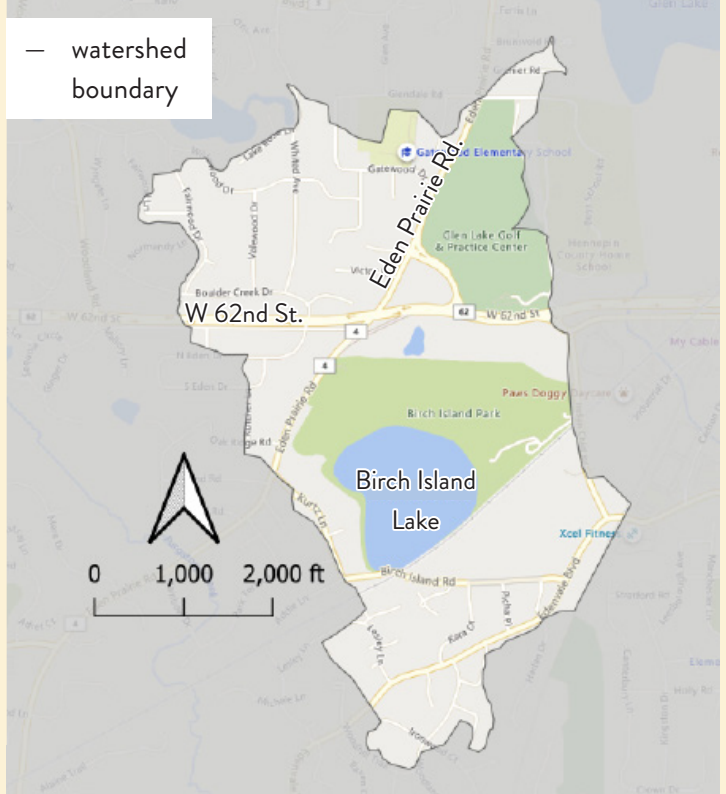
— watershed boundary

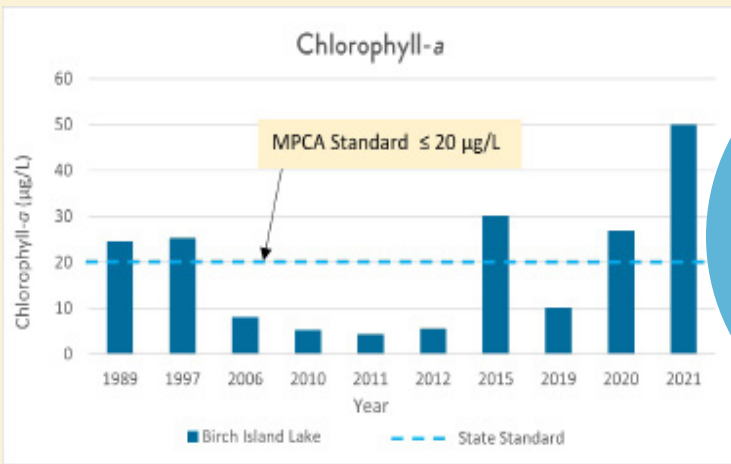
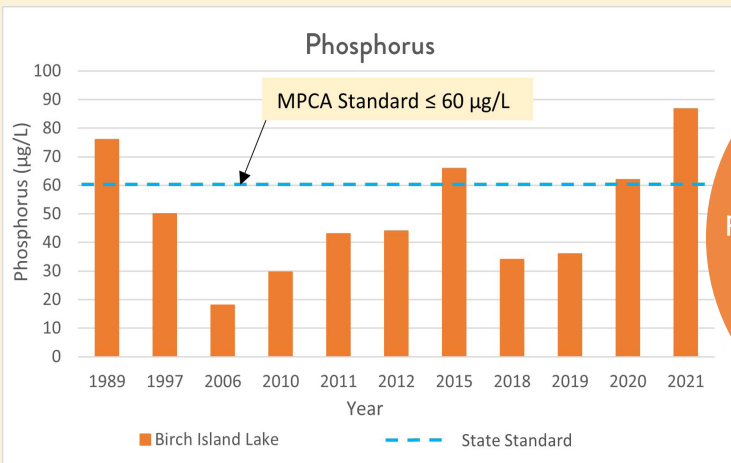
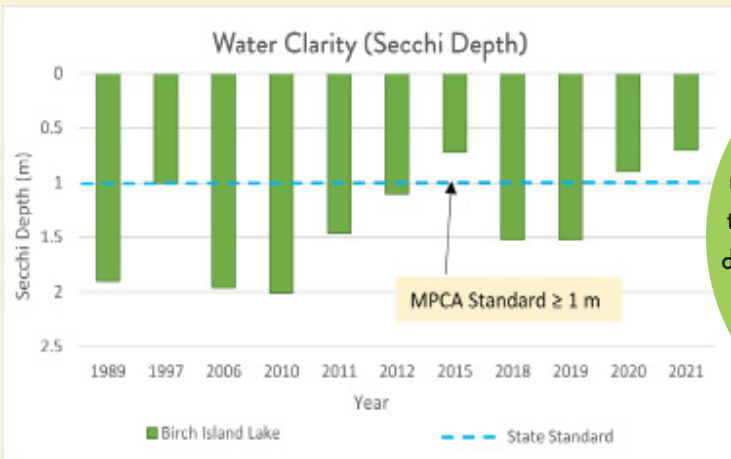
What is Chlorophyll-a?
Chl-a is the chemical that makes algae green. High levels of chl-a can mean that there is too much algae in the water. The higher levels of chl-a in Birch Island Lake indicate that water quality is poor.

What is Phosphorus?
Phosphorus is a nutrient that algae need to grow. Too much phosphorus can “over-feed” algae in a lake, which can lead to algae blooms. Birch Island Lake’s higher phosphorus levels indicate poorer water quality.

What is Secchi Depth?
Secchi Depth is a measurement of water clarity. To take the measurements, a Secchi disk is lowered into the water until it is no longer visible. These low Secchi depth values indicate poor water clarity.
