Figure 5-7. Project Synopsis: Lone Lake Use Attainability Analysis

Nine Mile Creek Watershed District

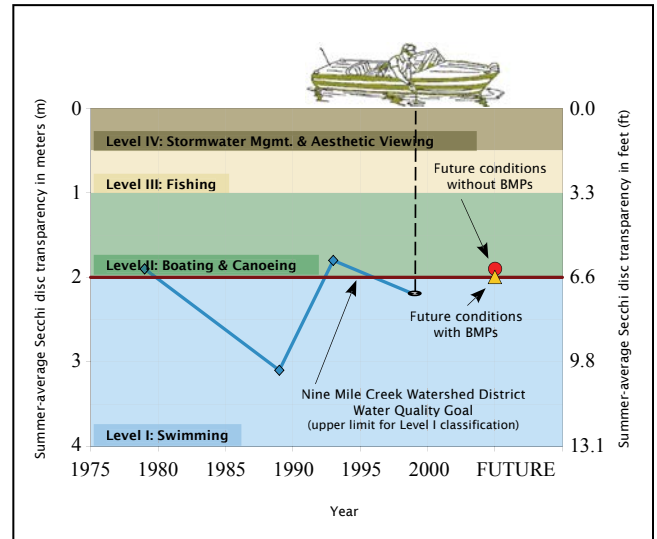
This graph illustrates Lone Lake’s historic and predicted future summer-average water clarity (transparency). Transparency is measured as the depth at which a black-and-white patterned disc (a Secchi disc) disappears from view as it is lowered into the water.

Level I Classification—full support of swimmable use and a Secchi disc reading ≥ 2.0 m.

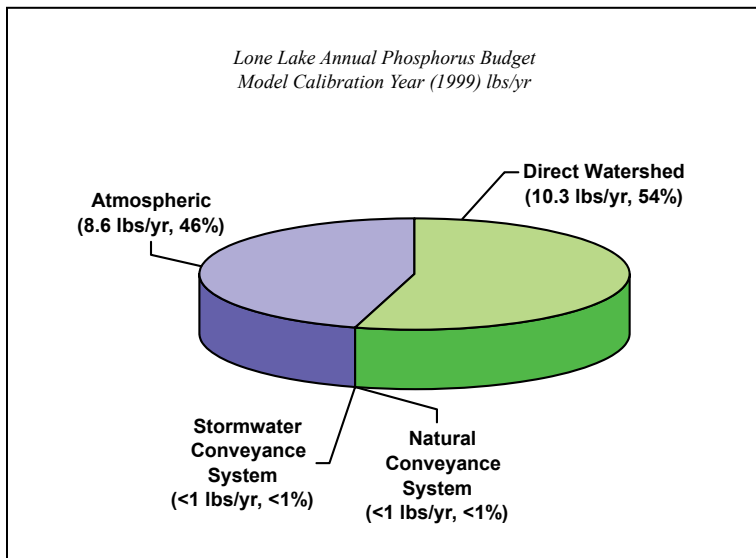
Surface runoff from Lone Lake’s direct watershed contributes roughly 54 percent of the lake’s annual phosphorus load.

Cause: Urban stormwater runoff conveying large amounts of phosphorus to the lake

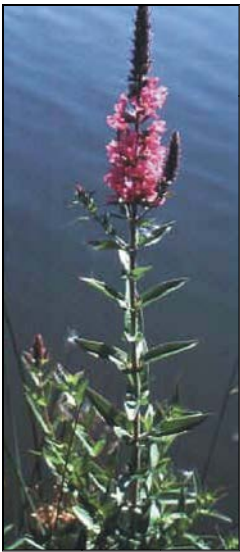
Purple loosestrife is an exotic species that invades wetlands and lake shorelines. It out-competes native species and, if left unchecked, will eventually become the dominant plant wherever it appears.

Problem: Exotic lake weed species (see left)

Cause: Purple loosestrife

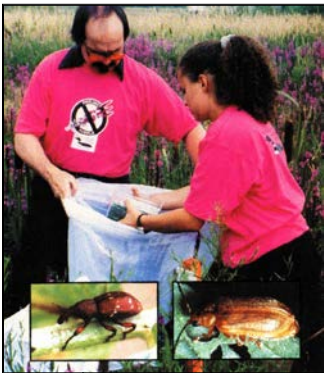
Purple loosestrife can be managed by releasing root-boring weevils onto the plants.

- Aquatic plant management (see left)

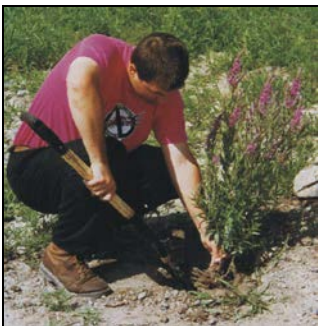
Digging loosestrife by hand is another possible management method.
