### Overall Health of NW Anderson Lake

### Lake Characteristics

### NW Anderson Lake Projects

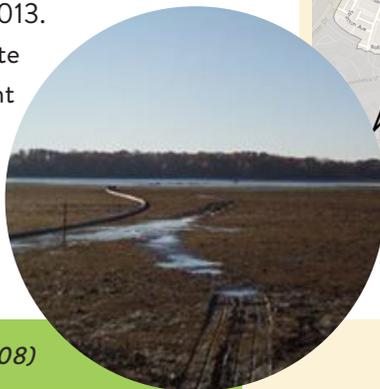
*Lake drawdown (2008)*

The Nine Mile Creek Watershed District conducted a lake drawdown to improve the health of NW Anderson Lake. The project goals were to reduce the amount of curly-leaf pondweed, an invasive aquatic plant, and control phosphorus levels in the lake. The intent of the project was to expose the bottom of the lake to freeze and kill the turions (seed-like structures) of the curly-leaf pondweed plants. The NW Anderson Lake drawdown occurred in the fall of 2008 until the spring of 2009. Follow-up herbicide treatments occurred from 2010-2013.
